FAST PHOTOTHERMAL INSPECTION OF PLASMA-SPRAYED COATINGS OF PRIMARY CIRCULATION SEAL RINGS OF A NUCLEAR REACTOR.

PART TWO: AFTER THE TRIAL RUN

R. Lehtiniemi, J. Hartikainen, J. Rantala, J. Varis, and M. Luukkala
University of Helsinki, Department of Physics
Siltavuorenpenger 20 D, SF-00170 Helsinki, Finland

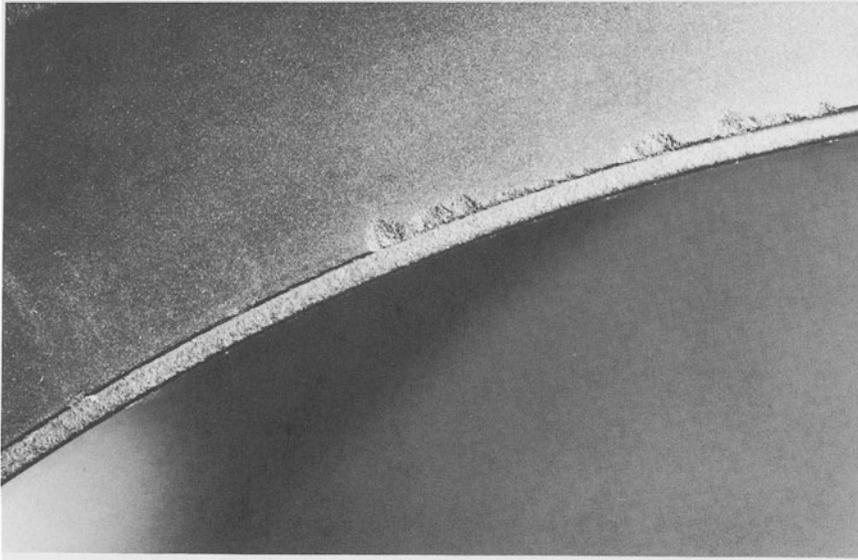
As an example of the measurements, in Figs 2 and 3 a visual microscopic and a thermal image of the same part of the coating are shown. In the visual image, a few areas of surface damages appeared during the trial run are visible near the inner edge of the coating. These damages can be seen also in the thermal area as cooler (darker) areas because of the different absorption and emission characteristics of the damaged parts. However, the actual adhesion defect appearing warmer (brighter, pointed with the cursor arrow) in the thermal image cannot be detected in the visual image. The horizontal stripes in the thermal images are artifacts caused by the digital image enhancement technique used for correcting the effect of the Gaussian heating profile. The dark, vertical stripe below the defect is due to the AC-coupling of the IR detector.

Fig. 2. A microscopic visual image of the coating. A few surface defects are clearly seen.

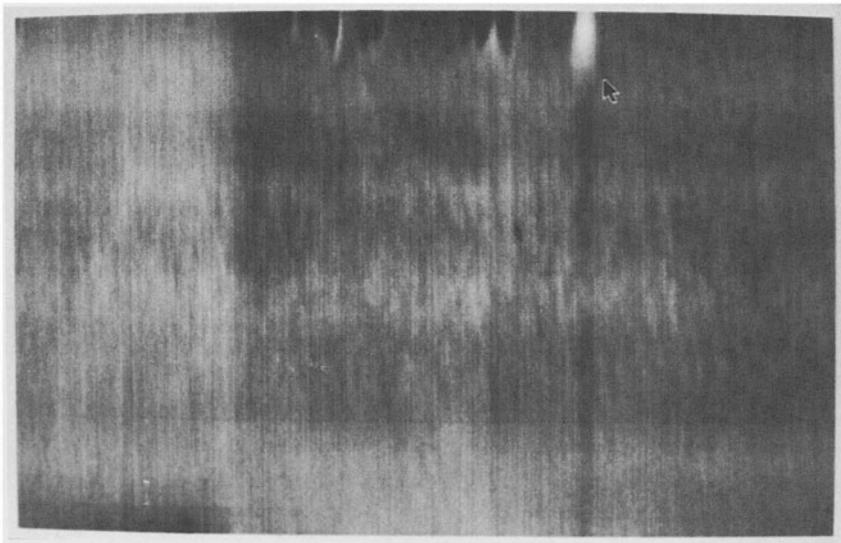
Fig. 3. A thermal image of the coating of the same area as in the Fig. 2. In addition to the surface defects, also an actual adhesion defect that is not detectable in the visual image appears as a brighter area pointed by an arrow.

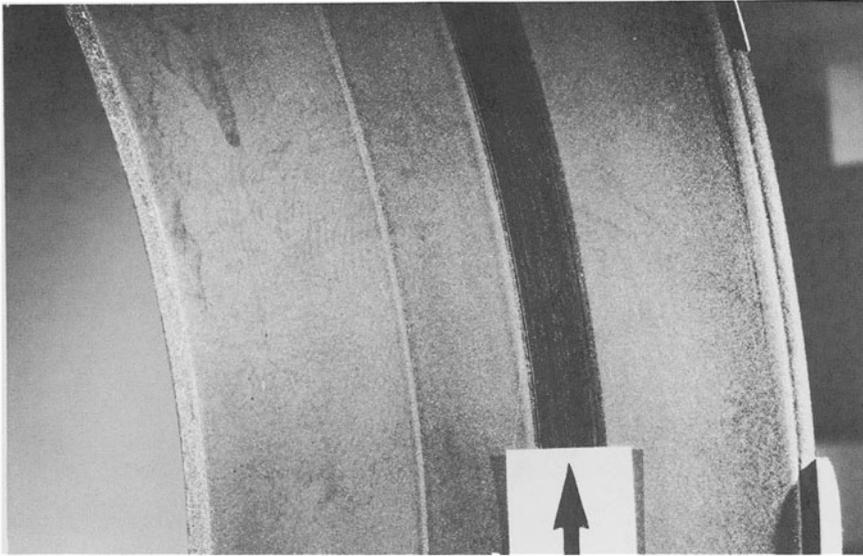
A pair of visual and thermal images is shown also in Figs 4 and 5. In the visual image a narrow ridge and a polished zone (arrow) caused by the trial run are clearly seen. Instead, two adhesion defects appearing in the thermal image cannot be visually detected.

Fig. 4. A microscopic visual image of the coating with surface structure caused by the trial run.

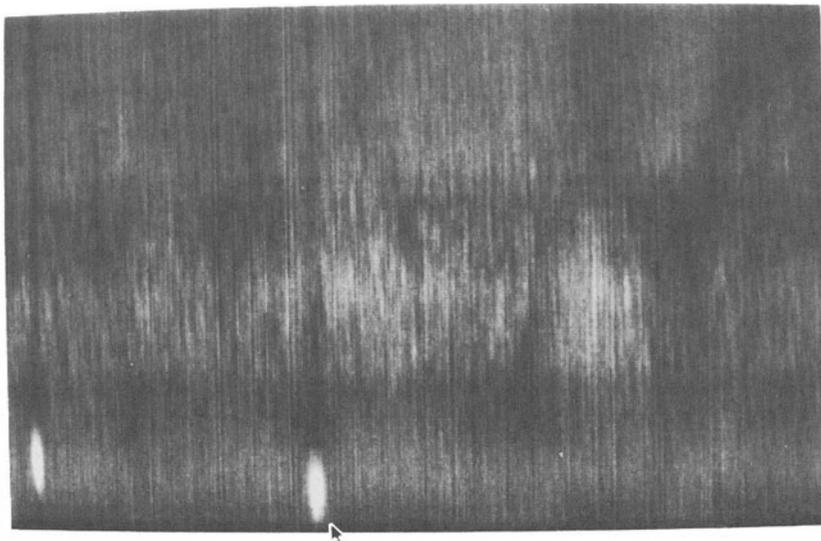
Fig. 5. A thermal image of the coating of the same area as in the Fig. 4. Two adhesion defects which are not detectable in the visual image appear as brighter areas.

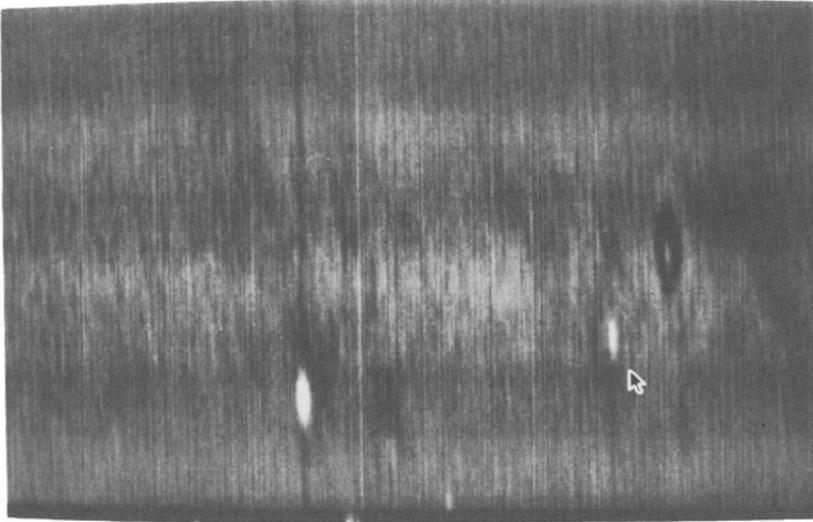
Figs 6 and 7 present a couple of typical measurement results of the areas with adhesion defects. In Fig. 6 two defects are well detectable as warmer areas. In the image also a darker oval-shaped area of higher thermal diffusivity appeared during the trial run can be seen. A few anomalies of this kind could be detected but, however, they do not indicate adhesion defects. In Fig. 7, a common type of the defects found is shown. The warmer defect is surrounded by a cooler area of higher diffusivity. Also a edge worn out into the coating (see Fig. 4) stands out as a warmer area because of its different geometry.

Fig. 6. A thermal image of two adhesion defects which are not detectable in the visual image, but distinguish clearly in the thermal image as brighter areas.

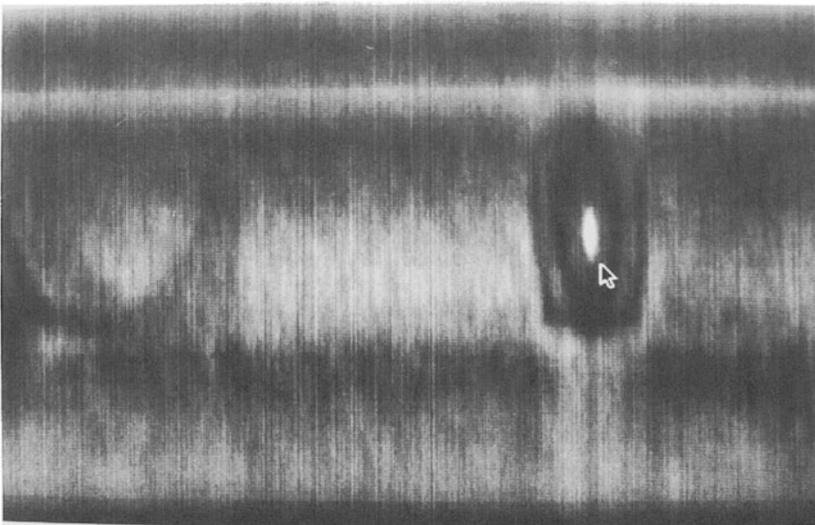
Fig. 7. A thermal image of a defect surrounded by a cooler area of higher diffusivity.

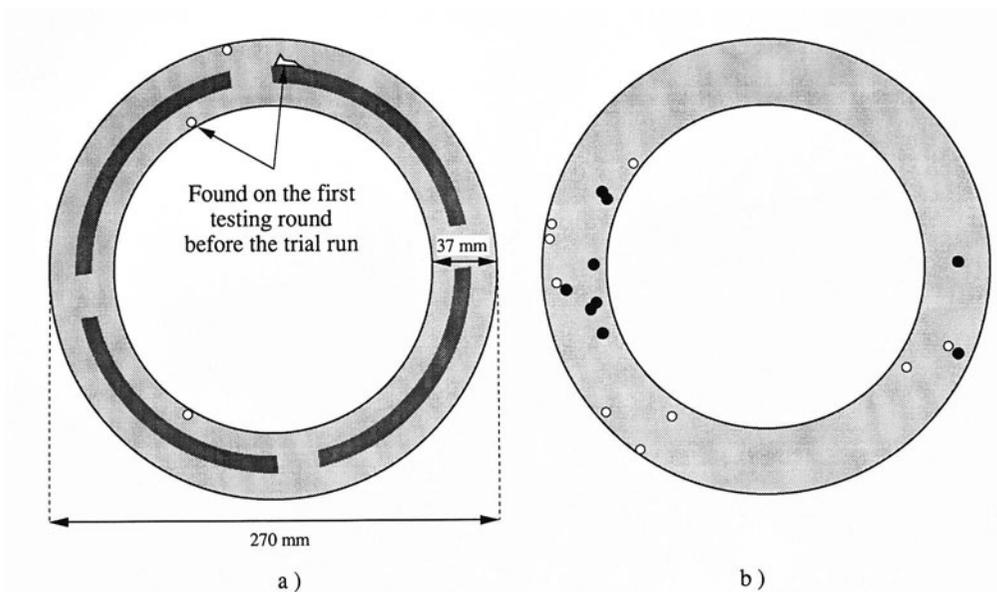
The locations of the detected defects are shown in Figs 8 a) and b). In Fig. 8 a), the defects found from the rotor ring are discerned as white areas. Also the two defects detected before the trial run and some dimensions of the sample are marked in the picture. In Fig. 8 b), the defects in the stator ring are shown. The defects surrounded by areas of higher thermal diffusivity are shown as dark circles.

As can be seen, several defects are physically situated near the edges of the coatings which are quite probable sites for adhesion failures. Typical dimensions of the defects are below 2 mm x 2 mm. The defects in the stator ring are concentrated in certain areas, which may have been under the greatest exertion. About one half of these flaws are surrounded by areas of higher diffusivities. An interesting result is that the defects found already in the first inspection round before the trial run did not grow or become more serious during the trial run. Also, the stator ring seems to have been under greater stress judging by the much larger number of the defects arisen during the trial run.

Fig. 8. A schematic drawing about the locations of the adhesion defects found a) from the rotor ring and b) from the stator ring. Defects surrounded by areas of higher diffusivity are shown as dark circles.
