## ULTRASONIC IMAGING ANALYSIS OF COMPONENT INTEGRITY

M.C. Tsao, R.H. Grills and R.P. Simpson

NDT Technology Development  
General Dynamics/Electric Boat Division  
Groton, CT

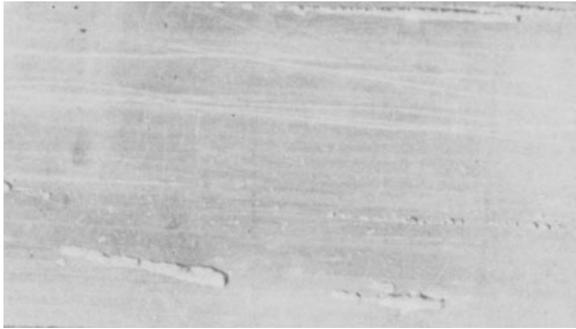
Figure 2(a) shows a photo of the inside surface of a corroded pipe. Water was used as a compression medium in a hydrostatic test for testing the strength of the pipe. With water inside the pipe for two weeks, the pipe was opened for inspection

Figure 2(a).- Photo of the inside surface of a pipe

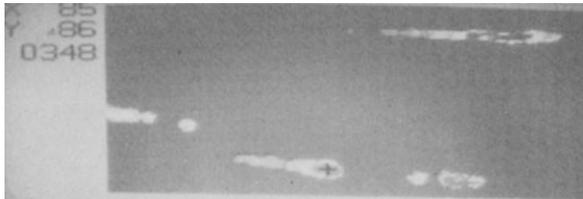
Figure 2(b).- Ultrasonic image of the pipe

and corrosion was witnessed. Figure 2(b) shows the image obtained, using the ULTRA IMAGE III system, from the outside of the pipe. By moving the cursor to any location (x,y) on the screen designated area, the local depth of the pipe wall can be read accurately. As in this case, the depth at pixel point (85,86) is 0.348". Another study of corrosion of an aircraft aluminum alloy gas tank tested with this equipment is reported in Ref (3).

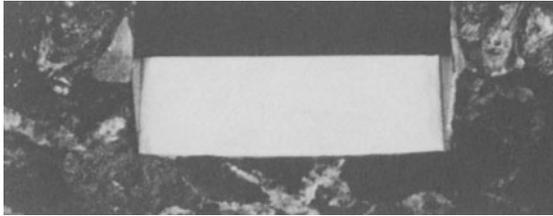
Figure 3(a) shows the photo of a steel specimen machined from a heavy water processing tank taken out of service. With hydrogen sulfide and water flowing inside the processing tank, hydrogen migration from the inside surface of the tank through the steel tank wall has been suggested to have caused the stair-stepped cracking shown in Figure 3(b). The cracks actually have propagated over a wide area with different depths in different color patterns as shown on the top picture of Figure 3(c). With slicing at the cursor position along the X-direction, a cross sectional view of the crack, corresponding to the shape of Figure 3(b), is shown on the lower picture of Figure 3(c).

Figure 3(a).- Photo of a steel plate with a crack

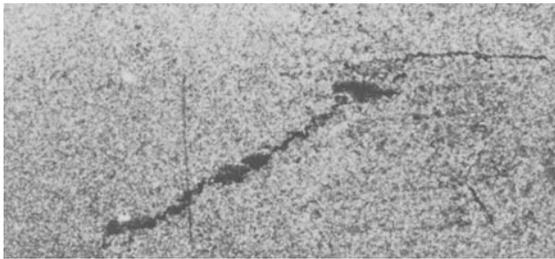
Figure 3(b).- Stair-stepped crack

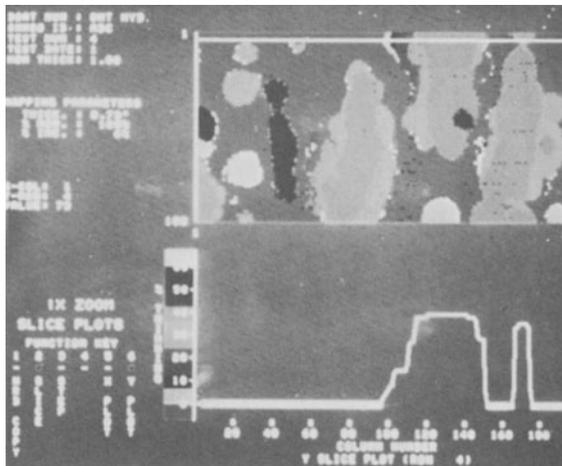
Figure 3(c).- 2-D ultrasonic image of the crack

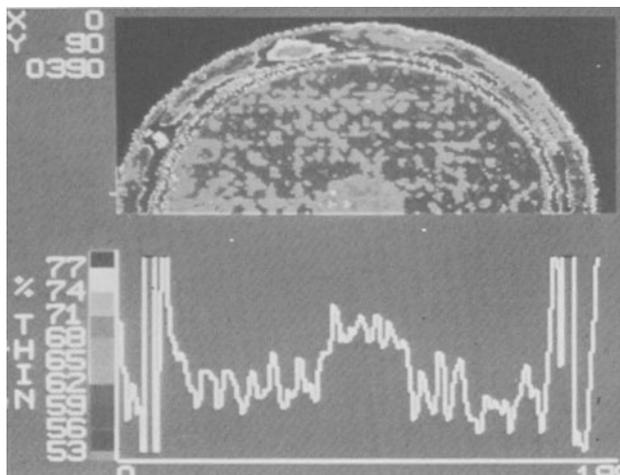
center of one side of the disk. The disk is made of multiple layers of fiber plies mixed with epoxy resins. The disk is then shrink-fit with a retaining ring made of wound plies of graphite fibers mixed with epoxy resins. Figure 4(b) shows the ultrasonic image of the interior structure pattern of the flywheel. The blue and green colors represent the high amplitudes of the ultrasonic signals echoed from the bottom surface of the flywheel, and in turn, they represent the good bonding characteristics of the structure. Around the ring-edge and ring-disk interface areas, only a small portion of the transducer is encountered over the tested area, and hence on these areas, the signal amplitudes are small. Small signal amplitudes are represented by red and pink colors. Aside from the ring-edge and ring-disk interface areas, the red and pink colors represent areas where microvoids are concentrated through the disk thickness such that the ultrasonic signals are attenuated by the clustered microvoids. The flywheel was then spin tested up to 35000 RPM to evaluate the structure integrity at these speeds. In one case, as shown in Figure 4(c), the aluminum hub was separated from the disk and a band of fiber ply was torn from the disk top surface. Figure 4(d) shows the

Figure 4(b).- Ultrasonic image of the flywheel

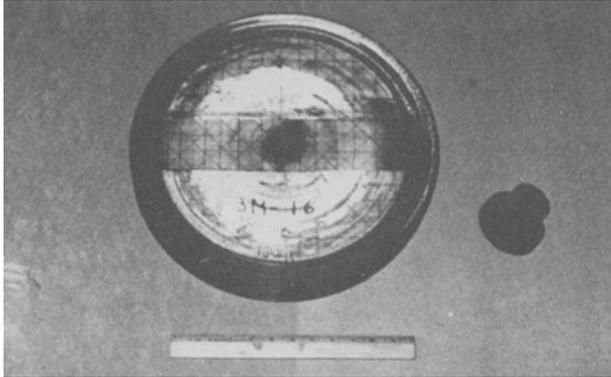
Figure 4(c).- Photo of the flywheel after spin test at 35000 RPM

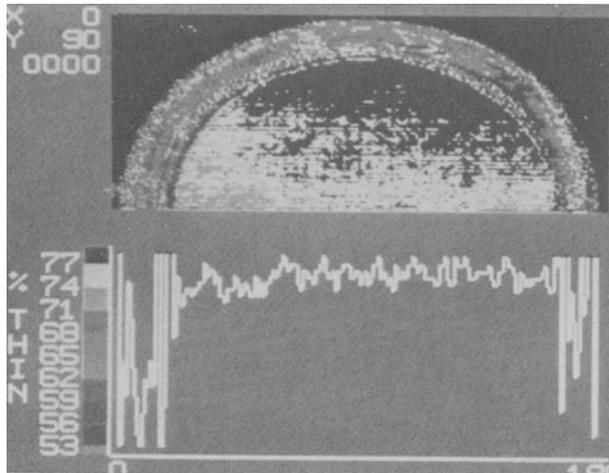
results of the ultrasonic image inspection of the flywheel after spin tested. The pink and red colors suggested the detection of microvoids inside the composite flywheel subjected to high stresses due to the spin test. More details of the ultrasonic testing results of the composite flywheel can be found in Ref (4).

Figure 4(d).- Ultrasonic image of the flywheel after spin test at 35000 RPM
