## COMPUTED TOMOGRAPHY AND ULTRASONIC TESTING OF URANIA FUEL PELLETS

P.D.Sutton and L.R.Hillier  
General Electric Canada  
107 Park Street North  
Peterborough, Ontario, K9J 7B5, Canada

B.D. Sawicka  
Atomic Energy of Canada Ltd.  
Chalk River Nuclear Laboratories  
Chalk River, Ontario, KOJ 1J0, Canada

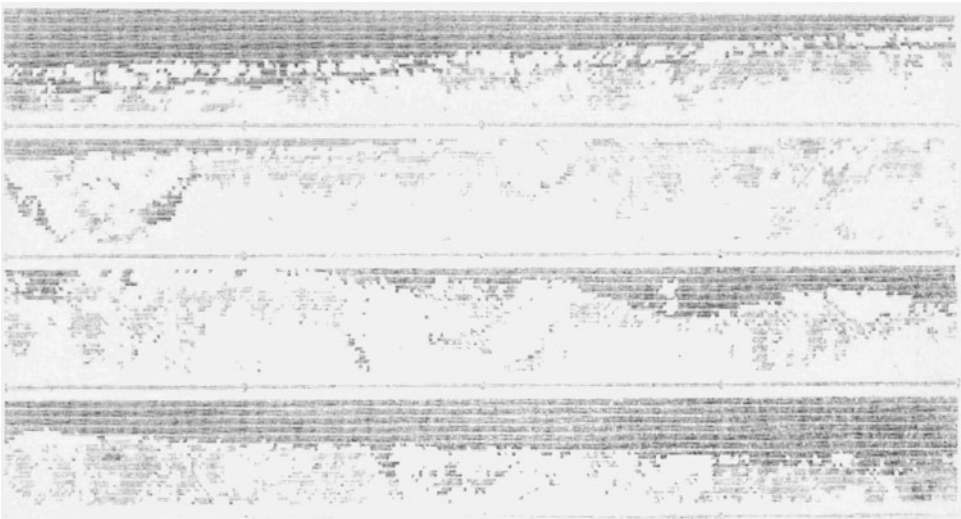
#### Pellet 10 TOP END RADIAL SCAN

Similar to pellet 6 this ultrasonic image in Fig. 5 of the first scan of the green compact shows the distinct areas of chipping that are visible by eye and also a line of high ultrasonic reflections between these chipped areas. On this particular sample the areas of high ultrasonic reflectivity did break away from the pellet during sintering and final grinding.

Fig 5. UT Image of Green Compact Shows Distinct Areas of Chipping

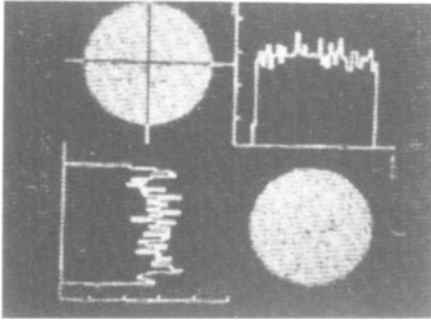
As seen in Fig. 7 from the scan in the plane of the pressing ring ( $Z = 8.4$  mm) density is practically uniform with a slight decrease at the circumference. In all other cross sections there is a substantial density variation along the radius. (i.e. Fig. 8).

Fig 7. CT Image of Green Compact  
Z = 8.4mm; Density is Uniform

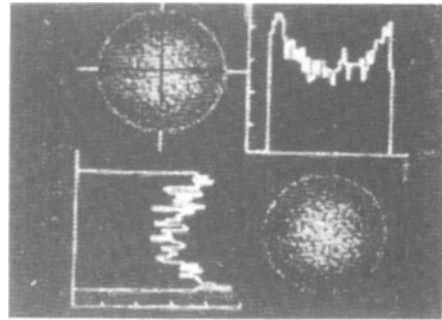
Fig 8. CT Image Showing Density  
Variation in Green compact

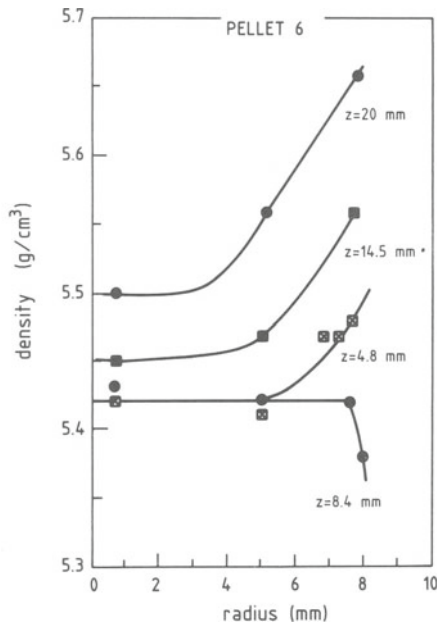
The range of density variations is also shown graphically in Fig. 9. Fig. 10 shows the longitudinal (x-z) scan of pellet 6.

Fig 9. Density Variation for Various Radial Scans

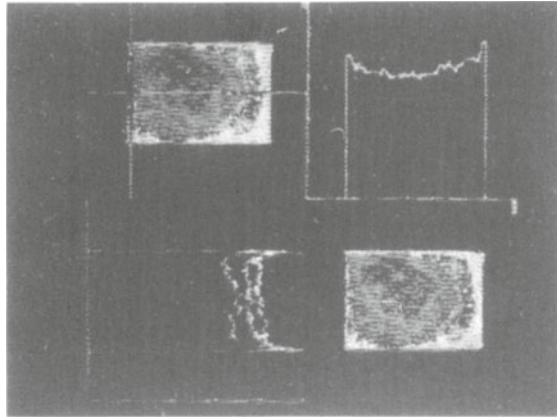
This pellet had a crack, observed visually at the surface close to the top end along a large part of the circumference. The CT scan crossed both the crack area and a non-crack area. The crack area is upper left and the non crack area is lower right. The crack is not seen in the CT image but the density was measured higher in the crack area.

Fig 10. CT Image of Longitudinal Scan of Green Compact

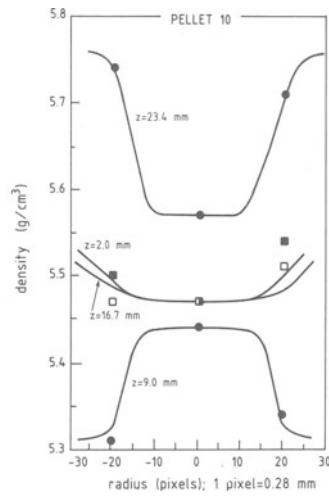
For pellet 10 several (x-y) scans and several (x-z) scans were conducted. Similar to pellet 6, pellet 10 had a crack along the circumference. Density distribution within this pellet, determined from the CT data of the (x-z) scan, is presented in Fig. 11.

The CT data for pellet 10 indicate that the density distribution within the pellet is generally similar to that for pellet 6, but the density variations are stronger (see for example, Figs. 9 and 11).

Fig 11. Density Distribution for Various Radial Scans

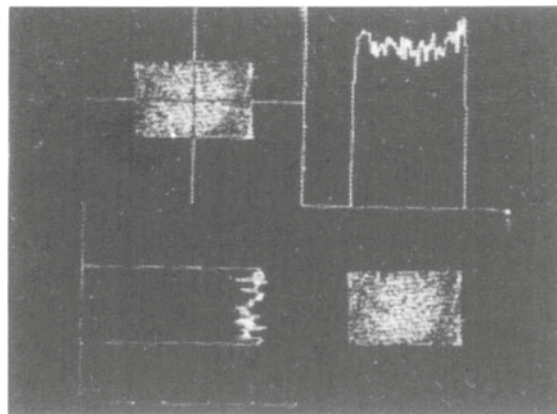
Fig 12. Density Distribution for Sintered Pellet is much more Uniform

The x-z scan for this pellet (Fig. 12) shows that the density within the measured cross section is much more uniform than for green compacts, nevertheless some small density variations are observed. The density distribution is similar to that for green compacts, but the density changes are much smaller, less than 1.5% along the pellet and still smaller across the pellet. Thus, sintering caused a uniformization of the density distribution as expected. However, the original distribution of the material due to powder compaction was still preserved to some degree.
