ADVANCED MAGNETIC METHODS OF FLAW DETECTION

John R. Barton
Southwest Research Institute
San Antonio, Texas

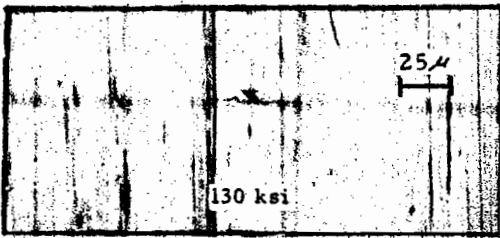
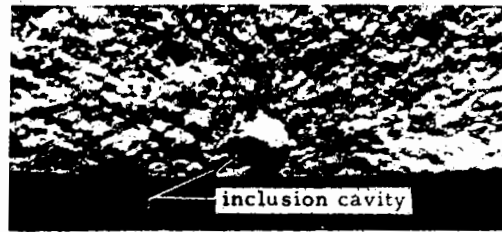
Surface Photomicrographs
at 20,000 Cycles
(For 0- and 130 ksi Static Stress)

Photomicrograph
of Fracture Surfaces
(Fracture at 62,949 Cycles)

Fig. 10. Fatigue crack initiated at subsurface inclusion and subsequent fracture surfaces.

inclusions; fracture is initiated from inclusions deep in the material only at high cycles, $>10^6$. A perspective appraisal of this situation is presented in Fig. 10. This is a composite showing the surface, a very tiny crack, and the source of the crack development is a slightly sub-surface inclusion. If we consider only the region over which the section stress varied by only \pm one percent from the maximum stress, a cylinder 0.2 inch long is obtained. If we calculate the volume of that total cylinder and form the ratio of the volume of that cylinder to the volume of the flaw (inclusion), we find that ratio to be one to 19 million, emphasizing the very critical role that these surface and near-surface inclusions play. In other words although the inclusion could have been any place in this total volume, the fact it was near the surface established that it would play a dominant role in crack initiation. If we consider only the surface layer, we get a slightly different ratio. The number reduces to one part in a million, still, such a large ratio that it shows the significance of the near surface flaw as opposed to flaws being located down in the interior. We have seen a few specimens fail with the flaw down in the interior, but generally with a very long fatigue life, in the order of about one to two million cycles.

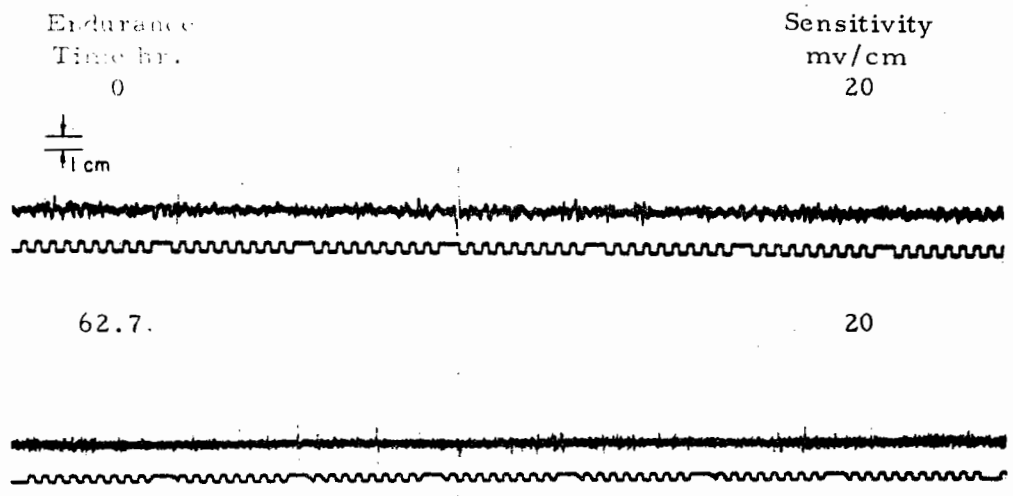
Fig. 16. Magnetic signature and early stage of spall development.

In Fig. 16 a magnetic inspection record made at zero hours shows an outstanding signature. After the bearing had been run 62.7 hours,

it is obvious, from the surface photomicrograph that the surface is beginning to crack. The sectioning result shows a very large inclusion and you can see the little lip of the material tilted up. This would have resulted in a spall; I can not predict the number of hours, but it would not have run a hundred hours.
