A Comparison of Electromagnetic Induction Mapping to Measurements of Maximum Effluent Flow Depth for Assessing Flow Paths in Vegetative Treatment Areas

Paper Number: 097073

**Written for presentation at the
2009 ASABE Annual International Meeting
Sponsored by ASABE
Grand Sierra Resort and Casino
Reno, Nevada
June 21 – June 24, 2009**

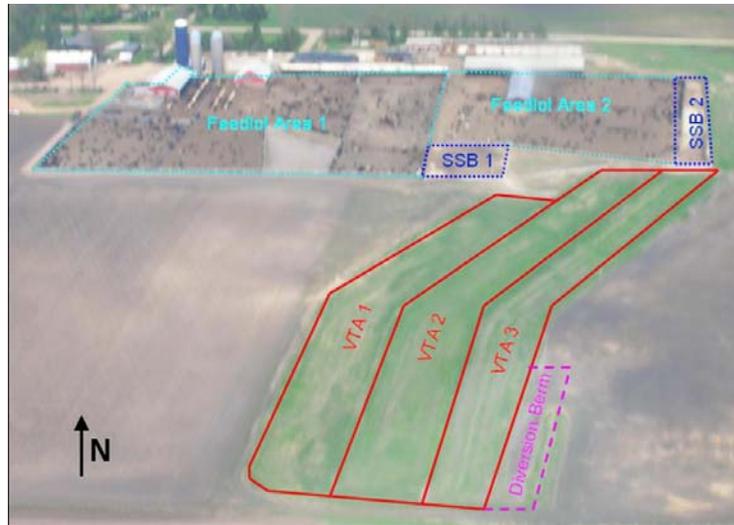
Figure 1. Layout of Central Iowa 1 and the VTS used to control and treat runoff generated by the facility.

The feedlot site, Central Iowa 1, was a 4.2-ha earthen open beef feedlot with a permitted capacity of 1,500 cattle located in central Iowa. The VTS at this site consisted of two solid settling basins, a vegetative treatment area (VTA) divided into three channels, a containment berm located at the southeast corner of the VTA, and a vegetated waterway (located on the eastern edge of the VTA). The VTS was divided into two portions, the pilot and the non-pilot system. The western lot (labeled Feedlot Area 1 in Figure 1) was the pilot portion of the feedlot. This was a 3.09-ha earthen feedlot area permitted for 1,000 head of cattle. Feedlot runoff drained into a solid settling basin (labeled SSB 1) designed to hold 4,289 m³ of effluent. Effluent captured in the settling basin was then released onto the two western channels of the VTA (labeled VTA 1 and VTA 2). These two VTAs were operated in parallel, i.e., effluent was released onto both VTAs (VTA 1 and VTA 2) at the same time; both channels received similar effluent loadings. Each of these VTAs was 24 m wide with an average length of 311 m, giving a VTA to feedlot area ratio of 0.5:1. During 2008, three earthen berms were constructed within each of the VTAs. These berms helped slow the flow of water through the VTAs, redistribute effluent over the width of the VTAs, and provide some effluent storage within the VTAs. A final berm, prior to the outlet from the pilot VTA, was added in mid-June 2008.

Initial treatment of the feedlot runoff occurred in the solid settling basins. The downstream end of the settling basin was surrounded by concrete walls, while earthen berms were used for the settling basin sidewalls. The settling basin has a maximum depth of 1.2 m with 223 m² of concreted area. The remainder of the SSB bottom was constructed with a compacted earth bottom. The settling basin was designed with a porous dam outlet; the outlet was constructed on the downstream end of the settling basin with vertical pieces of 2" x 4" lumber spaced 1.9 cm apart. After flowing through the porous dam outlets the effluent entered two, 20-cm diameter pipe outlets which directed flow to VTA 1 and VTA 2. During the summer of 2007, a V-notch weir and knife-gate were added behind the porous dam outlet of the pilot system settling basin in an attempt to improve solids retention in the SSB. The knife-gate provided the producer with more control over when, how much, and at what rate effluent was released from the settling basin onto the VTA.

The effluent in the settling basin was released onto concrete pads which direct the effluent into a concrete level spreader at the upper end of each VTA. The level spreaders were the width of the VTA, 3 m long, and 0.15 m deep. The spreaders encourage uniform application of the settling basin effluent over the width of the VTA. The three VTA channels were constructed parallel to each other and "stair stepped" down in elevation with VTA 1 being the highest and VTA 3 the lowest. This design minimized the amount of cut-and-fill required during construction of the VTAs. The VTAs were designed to have a 0.5% slope along the length and to be level across its width. As mentioned, during the summer of 2008 the producer added three earthen flow spreaders to each VTA. These earthen spreaders were installed to increase effluent retention time in the VTA and to improve flow distribution over the VTA. Only the flow distribution of VTA 2 was monitored as part of this study.

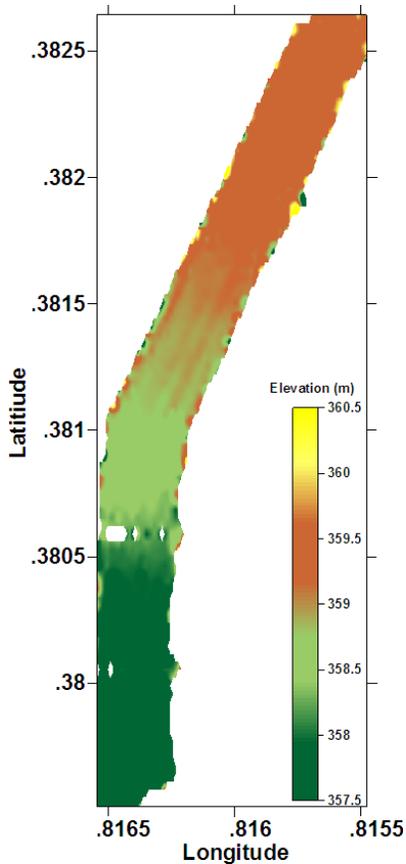
Figure 2. Elevation survey of the VTA conducted in 2008. Areas in dark green represent the lowest elevation and areas in yellow the highest elevation.

Twenty sampling sites were co-located with EC_a data using the spatial response surface sampling design (RSSD) program contained in USDA-ARS ESAP (EC_e Sampling, Assessment, and Prediction) software package (Lesch et al., 2000). These sites were selected to optimize the understanding of the EC_a variability while maintaining independence of the individual sites. Justifications for the sampling procedures used during this study are provided in Eigenberg et al. (2008) and Woodbury et al. (2009). The ESAP-Calibrate program in the ESAP suite was used to analyze the data and develop the MLR models for predicting water depth based on EC_a values. Contained in the GPS data are positional elevation measures (approximately 20-40 cm accuracy). These high density elevation data were used to construct an elevation map of the VTA (Figure 2).

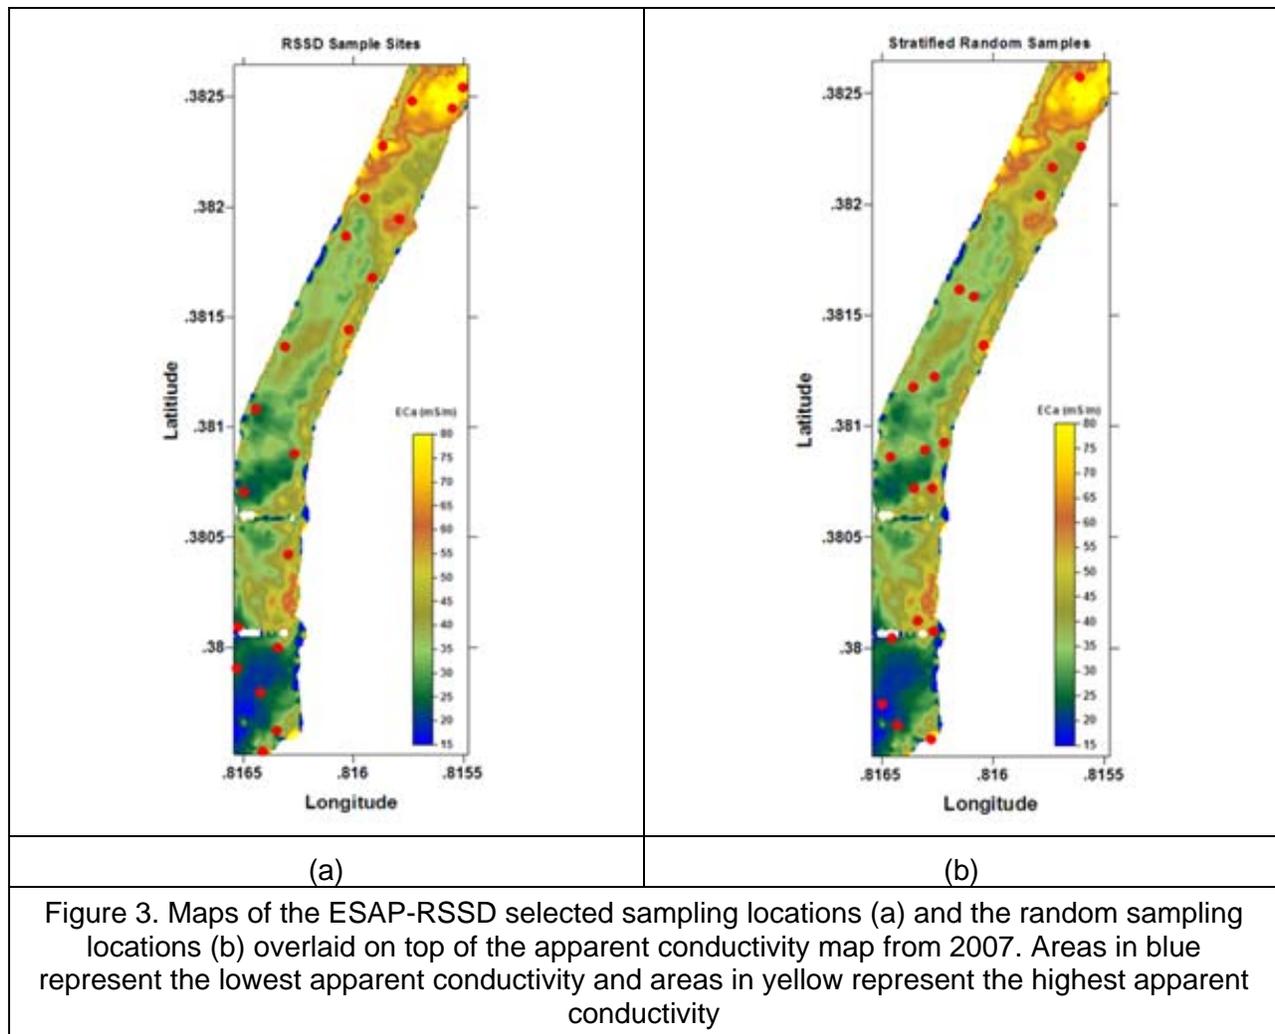
Figure 3. Maps of the ESAP-RSSD selected sampling locations (a) and the random sampling locations (b) overlaid on top of the apparent conductivity map from 2007. Areas in blue represent the lowest apparent conductivity and areas in yellow represent the highest apparent conductivity

Of the 60 locations monitored, twenty were located based on grid sampling, twenty were chosen randomly within the VTA, and twenty were determined using the 2007 EC_a data and RSSD program in the ESAP software suite. The RSSD sampling points are shown in Figure 3a. Locations of the random sampling locations are shown in Figure 3b. Additionally grid samples were collected. The grids were laid out along transects at 0.38014, 0.38068, 0.38106, 0.38160, and 0.38213. Four sample points were installed along each transect. These points represented a location of 1/8, 3/8, 5/8, and 7/8 of the distance along each transect.

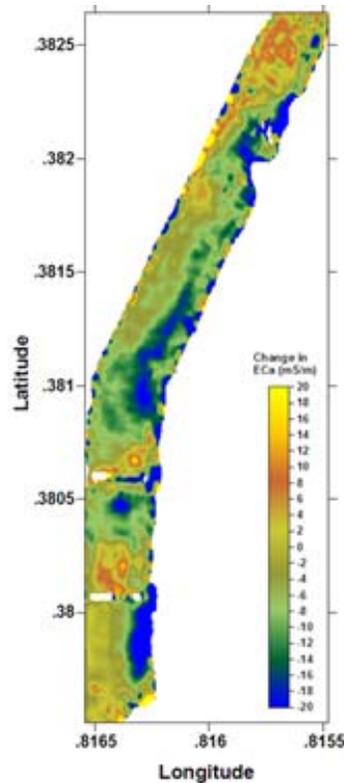
Figure 4. A map showing the difference in apparent electrical conductivity from the fall of 2007 to the fall of 2008. Areas in blue represent a decrease in apparent conductivity areas in green represent no change in conductivity, and areas in red and yellow represent an increase in conductivity.

A map showing the change in apparent electrical conductivity of VTA 2 between 2007 and 2008 is shown in Figure 4. In general it appears that the first ¼ of the VTA area saw the largest increase in apparent electrical conductivity followed by two areas farther down the VTA. These two additional areas are located in front of two of the earthen spreader berms that were constructed in the VTA. It appears that many of the other areas actually saw a decrease in apparent electrical conductivity. Specifically, the eastern edge of the VTA tended to see the

largest decrease in apparent electrical conductivity. Apparent electrical conductivity surveys in previous years tended to indicate that these areas were seeing the largest increase in apparent electrical conductivity. Thus it would appear the management changes, such as installation of the earthen berm spreaders within the VTA had a large impact on flow distribution within the VTA.

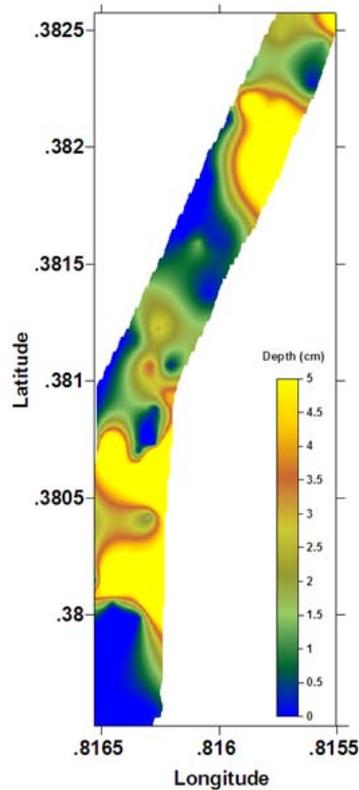
Figure 5. Map of the measured flow depths within the VTA. Areas in blue and green represent the shallowest flow areas. Areas in orange and yellow represent the deepest flow areas.

A map of flow paths was generated based on the flow depth measurements using all sixty locations. A krigged image plot of the flow depths is shown in Figure 5. A visual comparison of the flow depth map and the change in apparent electrical conductivity map allowed an assessment of the uniformity of the two measurement methods. There are three areas that appeared to have received higher loadings of effluent. Two of these areas were located just ahead of the earthen berms in the VTA. The third area is near the inlet of the VTA and is located up-gradient of the first berm in the VTA. Comparing this data with the change in apparent electrical conductivity in the soil we see a good correspondence between the increase in apparent electrical conductivity and the flow depth, especially for the two locations just ahead of the earthen berm. In general there was good correspondence between the measured flow depths and the increase in apparent electrical conductivity; however, this correspondence was not as strong near the inlet of the VTA. Specifically, the areas where flow depth was monitored to be the deepest saw little to no increase in apparent electrical conductivity. This may have been due to rainwater accumulating in the area. This accumulated rainwater would have low electrical

conductivity, but still result in reading a significant depth of flow reading. Additionally, this map tends to indicate that deeper flow paths tended to be along the eastern edge of the VTA. This is not in agreement with the EC_a generated map, which suggested that this edge of the VTA actually saw a decrease in EC_a .

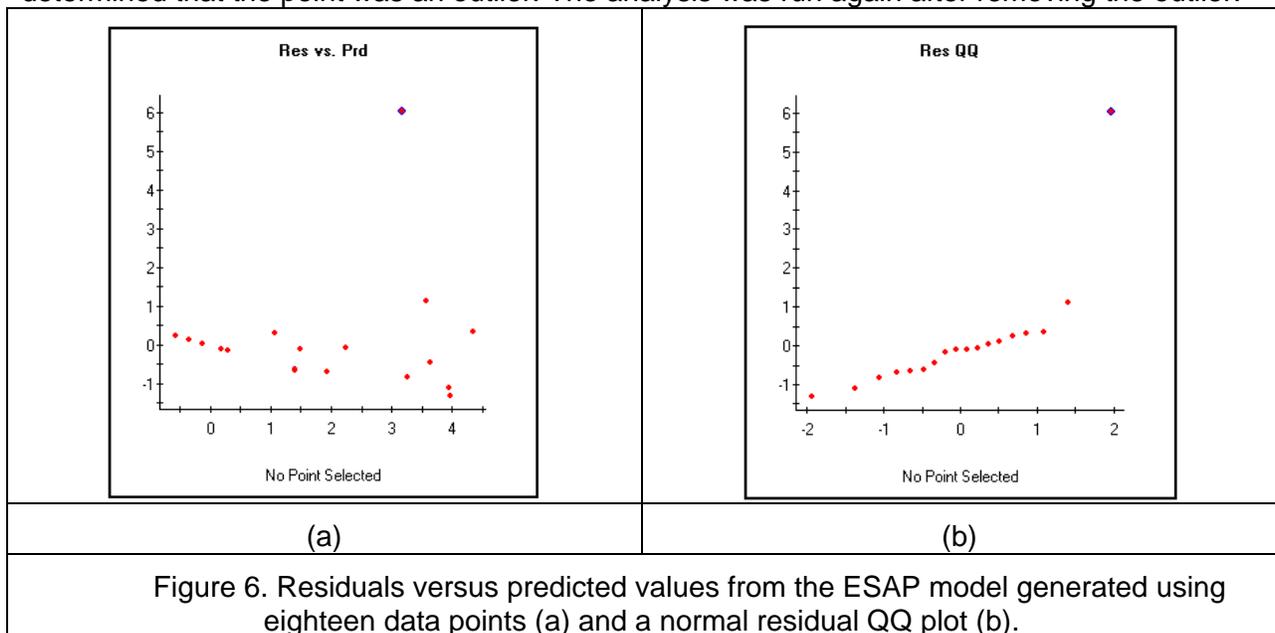
Figure 6. Residuals versus predicted values from the ESAP model generated using eighteen data points (a) and a normal residual QQ plot (b).

A MLR analysis with all eighteen data points was then conducted and produced an overall model fit of $R^2 = 0.336$. The low quality of the model fit did not warrant further predictive analysis. A plot of the residuals versus the predicted values was then analyzed. This plot is shown in Figure 6a. Based on this plot it appears that one of the points is an outlier (This point is highlighted as a larger diamond). This point was located before the first earthen berm in the VTA where deeper effluent flow, but little to no increase in EC_a was seen. As discussed earlier, this could have been caused by rain water accumulating at this location. A residual normal QQ plot is also shown in Figure 6b. In this plot the residuals should appear linear with a mean of zero. In this case the proposed outlier lies far from the line, indicating again that this point is an outlier. Grubbs' test for outliers was performed on the residuals. Based on this test it was determined that the point was an outlier. The analysis was run again after removing the outlier.

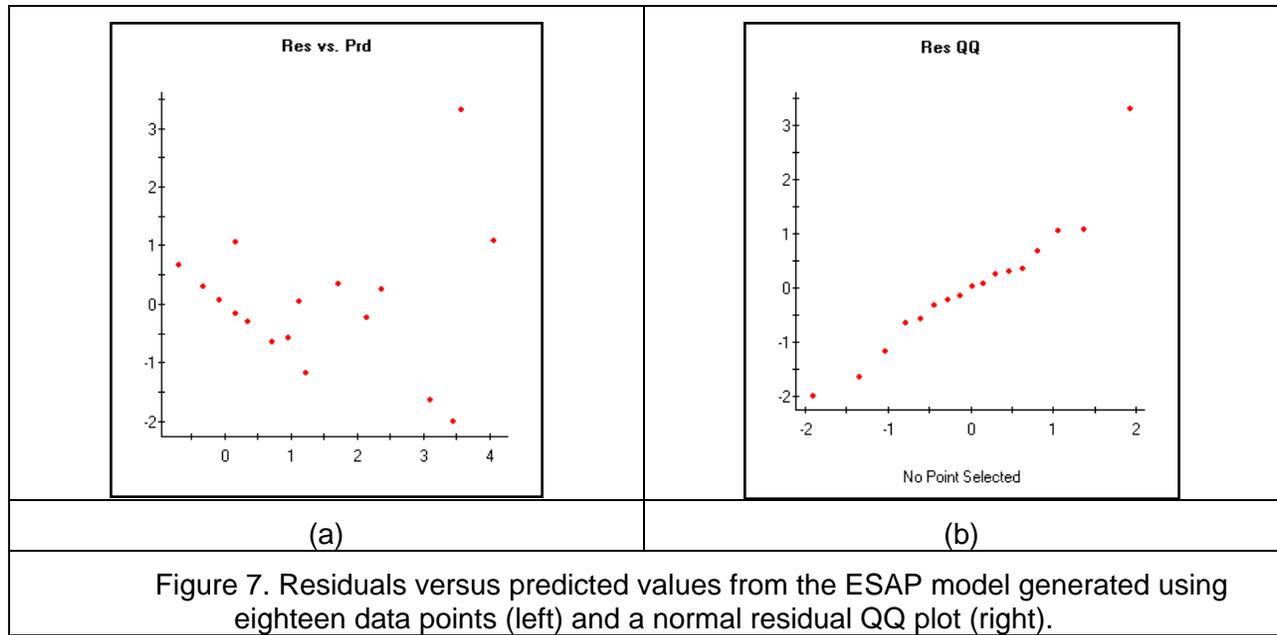
A plot of the residuals versus the predicted values from the analysis with seventeen data points is shown in Figure 7a. In this case the residuals appear to be random and approximately normally distributed. Also a residual normal QQ plot is shown in Figure 7b. In this case the points form an approximately straight line with a mean of zero, indicating that the data are approximately normal. After removing the outlier the MLR model fit improved to $R^2 = 0.656$ which was sufficient for further predictive analysis.

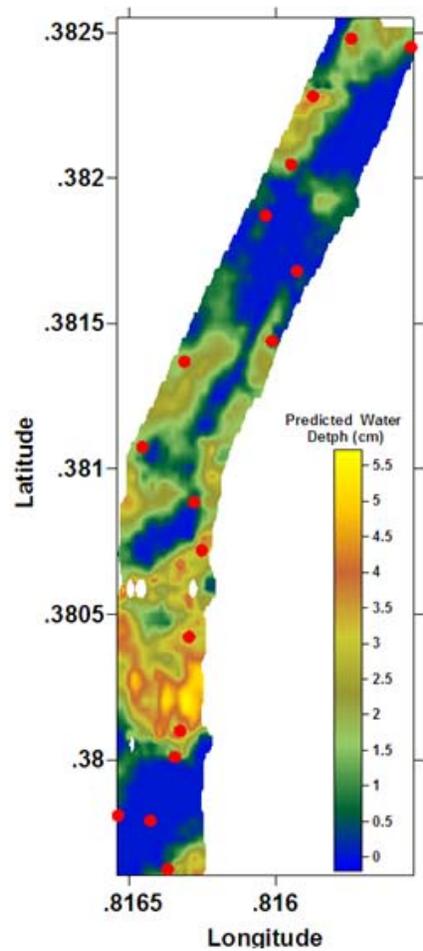
Figure 8. Predicated flow depths generated using the apparent electrical conductivity data and the measured flow depths. Areas in blue predict where no flow occurred, areas in orange and yellow represent where the deepest flow areas occurred.

Figure 8 shows the predicted flow depths from the ESAP model. Also included on this map are dots to represent the seventeen sampling locations used in creating the ESAP model. In general the predicted flow depths are similar to those monitored with the exception of the ponded area near the first earthen spreader in VTA. Water tended to pond for extended periods (approximately one week) of time after a rainfall in this location. During SSB release events, effluent from the settling basin would mix with this rainwater before infiltrating. Also, there were very few flow depth readings taken in and around this area. It is believed that more sampling locations, specifically near this area, would have increased the accuracy in modeling flow depth.
