Comparative Performance of Concrete Pavements with Recycled Concrete

Aggregate (RCA) and Virgin Aggregate Subbases

Sunghwan Kim¹, Halil Ceylan², Kasthurirangan Gopalakrishnan³, David J. White⁴, Charles T. Jhren⁵, and Thang Huu Phan⁶

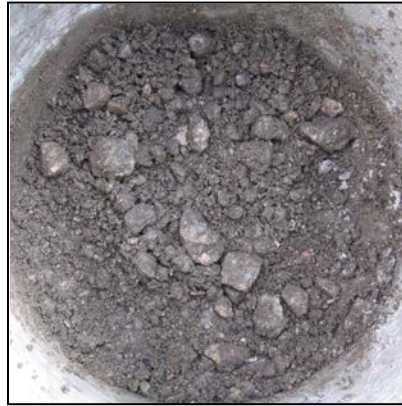
Figure 1. RCA subbase condition underneath concrete slab after coring.

Visual distress surveys were conducted to gather current detailed pavement surface condition information including the extent and severity of the distress. Core samples were taken during the visual distress survey to confirm that the selected pavement sites were indeed concrete pavements with RCA granular layer. Typical RCA granular layer condition after coring is illustrated in Figure 1. The distress survey methodology used in this study was the one described in the Strategic Highway Research Program's (SHRP) "Distress Identification Manual for the Long-Term Pavement Performance (LTPP) Project." (Miller and Bellinger, 2003). The distress types and severity levels were identified using the Distress Identification Manual and recorded on the distress map sheets with the symbols. Visual survey distress map was prepared for individual test section.

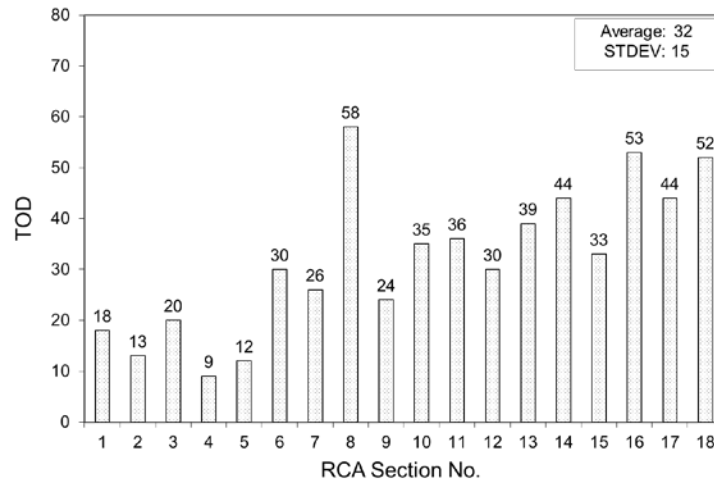
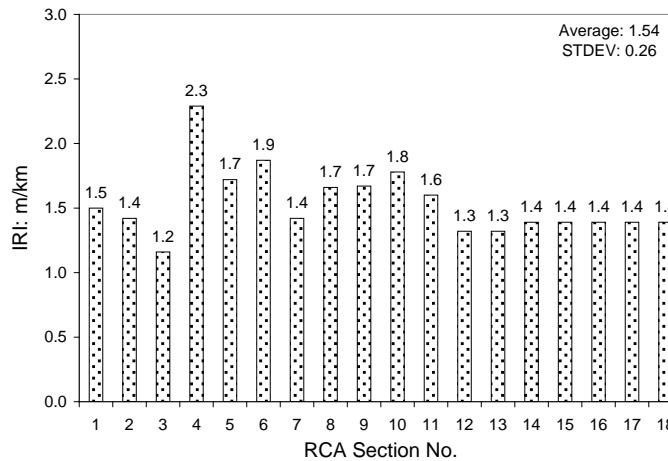
Figure 2. Summary of pavement performance results.

The pavement performance results for the surveyed test sections are summarized in Figure 2. The total number of distress (TOD) shown in Figure 2 (a) is the sum of number of distresses identified through the visual distress survey. Although a few popouts were observed in certain sections, these numbers were not added in the calculation of TOD since popouts do not result from subbase problem. The values of PCI and IRI in Figure 2 (b) and (c) represent the most current measurements (2006). The average TOD, PCI and IRI value of RCA sections are 32, 78%, and 1.54 m/km, respectively. These indicate fairly good of pavement surface condition.

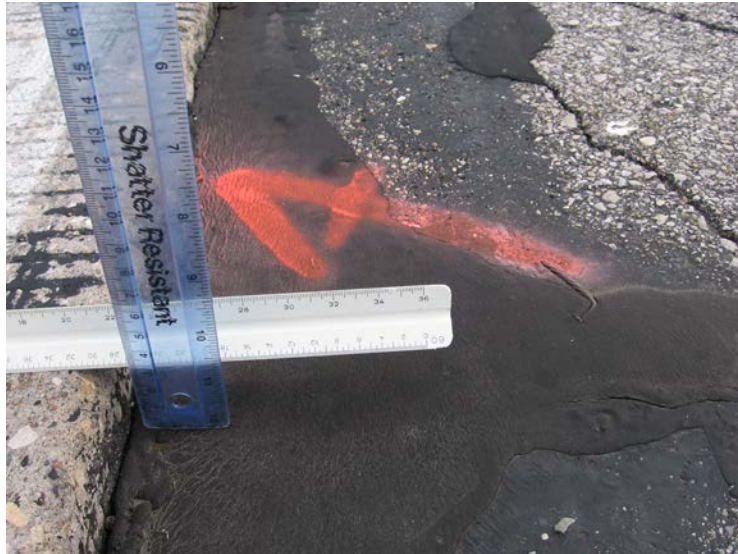
Figure 4. Lane to shoulder drop off in test section of RCA/5 (I-35 in Hamilton county mile post 131.40 to 131.45).

As seen in Figure 3, few longitudinal and transverse cracks were observed in the surveyed field test sections. The predominant distress exhibited along the all surveyed test sections are joint sealing damage and spalling. Especially, the lane-to-shoulder separation and/or the lane-to-shoulder drop off as shown in Figures 3 and 4 are often observed in the most RCA test sections. These observations are consistent with those reported by Rollings et al. (2006), who concluded that the cause of the distresses between lane and shoulder is probably due to sulfate attack on the RCA used as fill and granular layer.

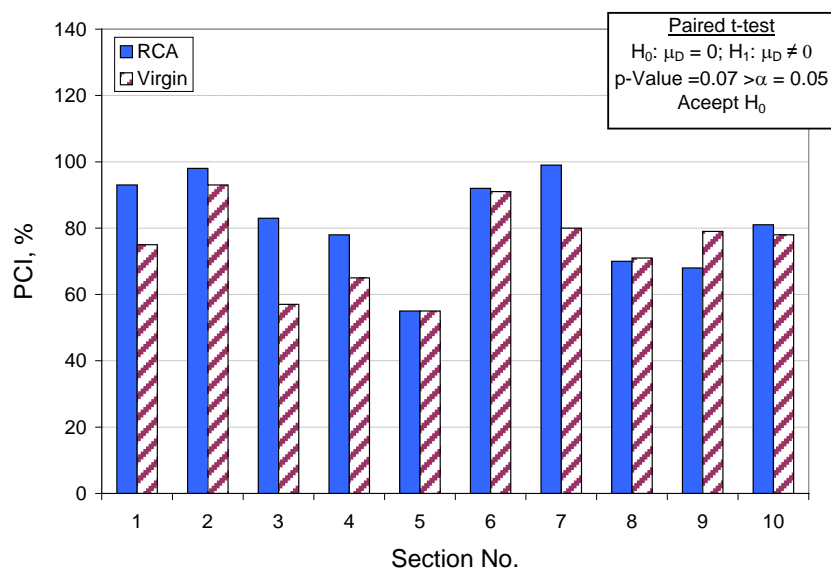
The average PCI of RCA aggregate sections are 82 % with 14% of standard deviation while those of virgin aggregate are 74% with 13% of standard deviation. The average IRI of RCA aggregate sections are 1.65 m/km with 0.31 m/km of standard deviation while those of virgin aggregate are 1.48 m/km with 0.20 m/km of standard deviation. The paired t-tests were performed to evaluate if the PCI and IRI obtained under the RCA sections are statistically different from those under the virgin aggregate sections. A paired t-test uses the mean of difference between the observations in one group and the matched observations in the other group (SAS, 2005). In the Figures 5 and 6, the symbol ' μ_D ' indicates the mean of differences between the PCI or IRI in the RCA sections and those in the corresponding virgin aggregate section; thus accepting null hypothesis, i.e., the PCI or IRI values in both of test sections are not significantly different. These results indicate that the RCA granular layer provides at least similar, if not better performance compared to the virgin aggregate layer in Iowa pavements and are performing adequately.

Figure 5. PCI values for the RCA and the virgin aggregate sections.

DOT's PMIS. Figures 5 and 6 present comparison results of the RCA/1 to RCA/10 sections in Table 1 with those of virgin/1 to virgin/10 in terms of PCI and IRI.
