# Structural evaluation of rubblized concrete pavements in Iowa

## **Structural Evaluation of Rubblized Concrete Pavements in Iowa**

H. Ceylan, K. Gopalakrishnan & S. Kim  
*Iowa State University, Ames, USA*

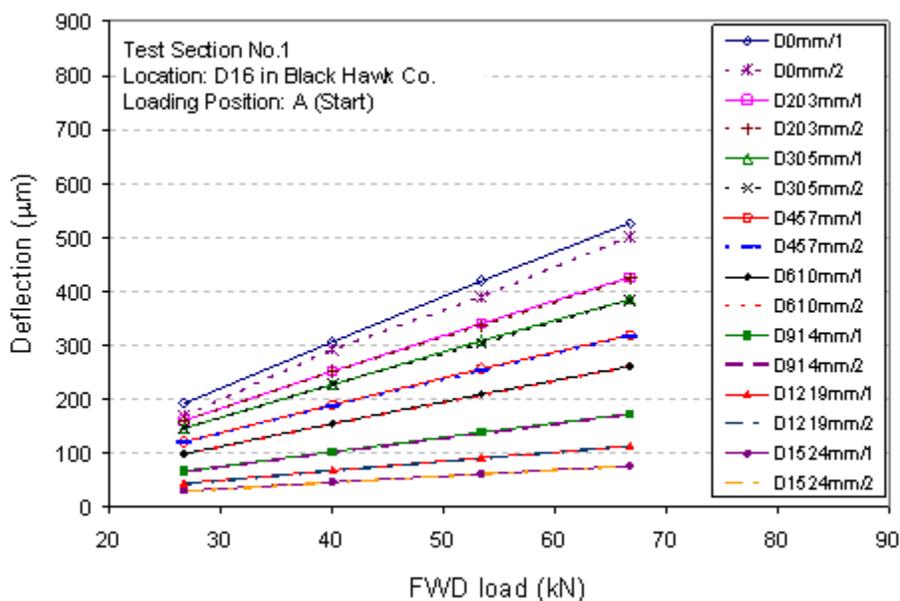
The measured deflections on geophones showed a linear trend with increasing FWD loads (see Figure 2). This indicates that the deflections at different FWD load levels can be normalized to one FWD load level. The measured deflections at 27, 53, and 67 kN of FWD loads were all normalized to 40 kN FWD load. Figure 3 presents the average of normalized maximum FWD deflections ( $D_{0mm}$ ) for each test section.

Figure 2. FWD deflections with loads.

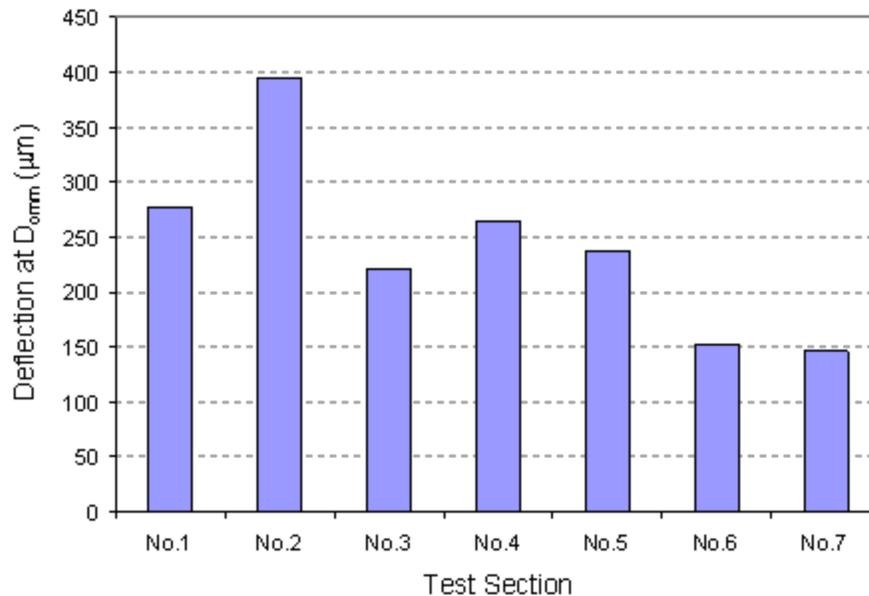
Figure 3. Normalized FWD maximum deflections ( $D_{0mm}$ ).

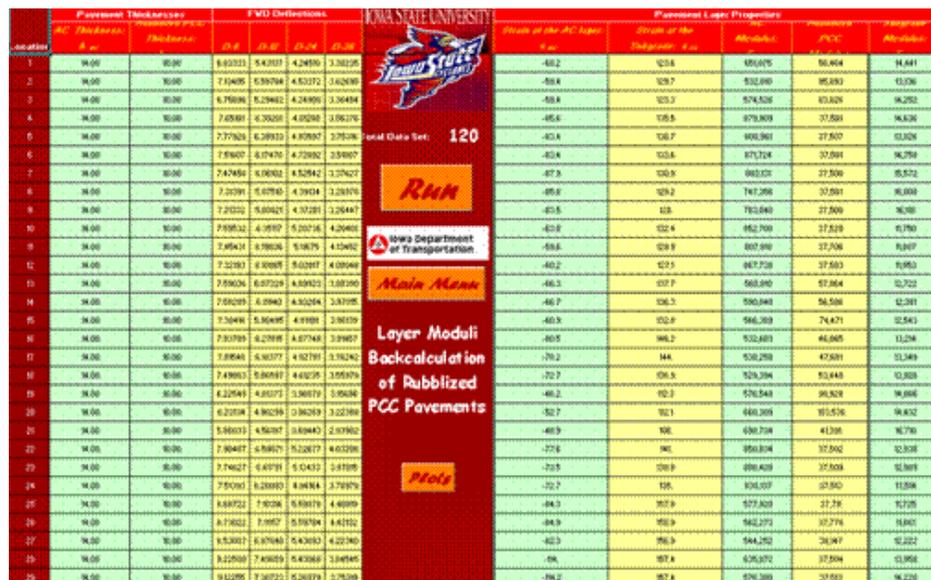
The pavement layer modulus is an important property representative of the pavement structural condition as well as a required input in the MEPDG. Recently, researchers at Iowa State University (ISU) developed a user-friendly, spreadsheet-based software for layer moduli backcalculation of rubblized PCC pavements (see Figure 4). This program employs Artificial Neural Networks (ANN)-based structural models for predicting not only the moduli of pavement layers based on FWD deflection data, but also the critical structural responses. The ANN-based structural models were developed by relating the structural responses (strains and deflections) to layer thicknesses and moduli values using a synthetic database. A synthetic database was generated using an Elastic Layer Program (ELP) by computing the critical strains for a wide range of layer thicknesses and moduli values. Details of the development and validation of ANN based structural models are described by Ceylan and Gopalakrishnan (2007).

Figure 4. ISU rubblized PCC pavement layer moduli backcalculation program.

The FWD surface deflections obtained for rubblized sections were inputted into the ISU rubblized pavement layer moduli backcalculation program to predict the moduli of HMA, rubblized PCC and subgrade. The modulus of HMA is more temperature-sensitive than the modulus of rubblized PCC and subgrade. The computed HMA moduli at different temperature conditions were adjusted to the HMA moduli at a reference temperature (25 °C) using Eq. (1) reported by Nouredin (1994).

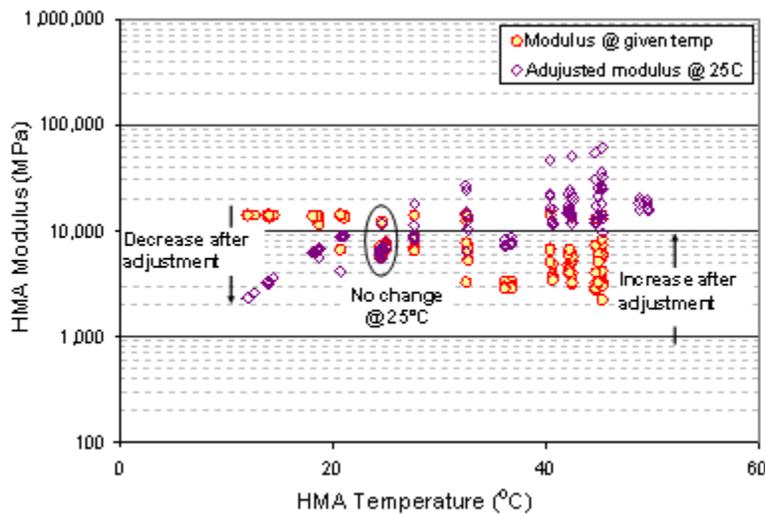
Figure 5 clearly illustrates the effect of temperature on HMA modulus. The backcalculated HMA modulus below 25 °C decrease and the modulus above 25 °C increase after adjustment to the reference temperature of 25 °C.

Figure 5. HMA moduli before and after adjustment to a reference temperature of 25 °C.

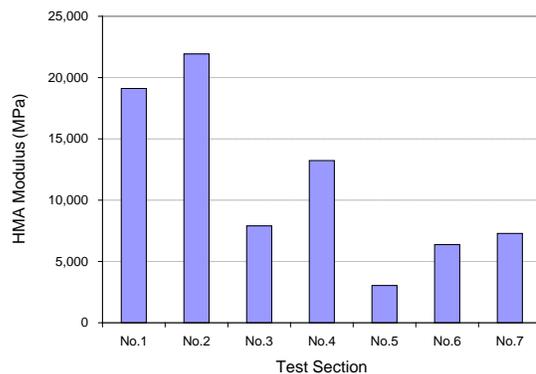
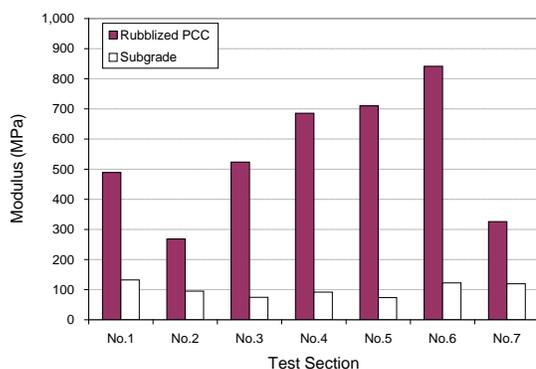
Figure 6 summarizes the layer moduli results for each of the rubblized sections. Table 2 presents the overall statistical summary for layer moduli results. The average rubblized PCC modulus in this study was found to be 539 MPa (78 ksi). This is numerically closer to the modulus value of 448 MPa (65 ksi) recommended by Wisconsin DOT study (Von Quintus et al. 2007). Both of them are lower than the default modulus value of 1034 MPa (150 ksi), which is currently used in MEPDG (NCHRP 2004) and recognized as a quite conservative value (Von Quintus et al. 2007). The backcalculated rubblized PCC modulus values in this study ranged from 259 to 1,120 MPa (38 to 162 ksi). This variation might be due to factors such as the condition of the existing PCC pavement, type and level of distress, type of construction equipment, environmental conditions, traffic, and type and thickness of HMA overlay. A similar range of values, 247 to 827 MPa (35 to 120 ksi), was reported by Wisconsin DOT study (Von Quintus et al. 2007). These values are similar to those determined from deflection basin testing of HMA overlays placed over rubblized PCC pavements – both from the Long-Term Pavement Performance (LTPP) Specific Pavement Studies-6 (SPS-6) experiment and actual construction projects reported by Von Quintus et al. (2000).

Figure 6. Backcalculated pavement layer moduli: (a) HMA; (b) Rubblized PCC and subgrade.

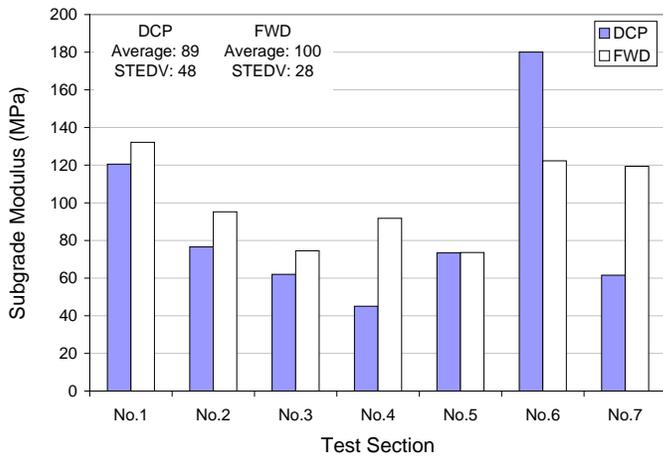
The average  $DCPI_{wtag}$  and CBR values for test sections are 26.2 mm/blow and 15.9%, respectively. As shown in Figure 7, the average subgrade modulus value of 89 MPa (12ksi) obtained from DCP test results is slightly lower than the backcalculated subgrade modulus value of 100 MPa (14 ksi) obtained from FWD data using the ISU ANN-based backcalculation program. This result indicates that the ISU ANN-based backcalculation program provides good predictions for subgrade modulus.

Figure 7. Comparison of subgrade modulus values from DCP and FWD.

The average rubblized pavement subgrade modulus value of 89 and 100 MPa (12 and 14 ksi) meets the minimum strength requirement 69 MPa (10 ksi) of the foundation layers for rubblization project specified by Wisconsin DOT (2007). Considering the fact that the DCP and FWD tests were conducted in summer, the results seem to indicate that the foundation layer of Iowa rubblized sections can provide enough strength.

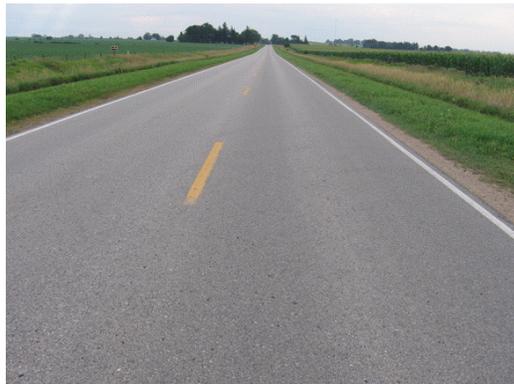
Figure 8. Picture of distress-free HMA surface on rubblized PCC (test section no. 4: C23 in Franklin county).

The visual distress survey results are summarized in Table 3. In general, no load-associated distresses, such as fatigue cracking, were found in any of the test sections as shown in Figure 8. The predominant distresses observed in the rubblized PCC sections are longitudinal cracking and low-temperature cracking as shown in Figures 9 and 10, respectively. No reflection cracking was observed in these rubblized PCC sections. The test sections were also well drained. These results tend to indicate that the rubblized pavement sections in Iowa are performing very well under the structural conditions identified in this study.

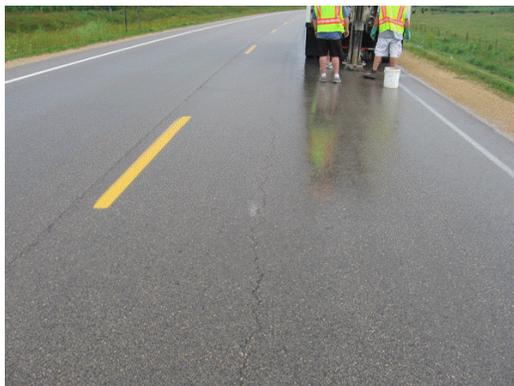
Figure 9. Picture of longitudinal cracking on HMA overlaid rubblized PCC (test section no. 3: IA3 in Delaware county).

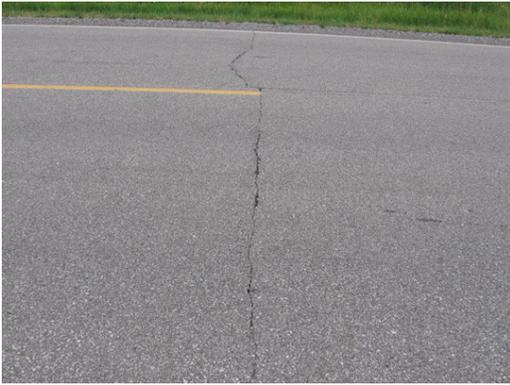
Figure 10. Picture of low-temperature cracking on HMA overlaid rubblized PCC (test section no. 1: D16 in Blackhawk county).
