Non-destructive evaluation of in-place rehabilitated concrete pavements

Abstract

Non-Destructive Evaluation of In-place Rehabilitated Concrete Pavements

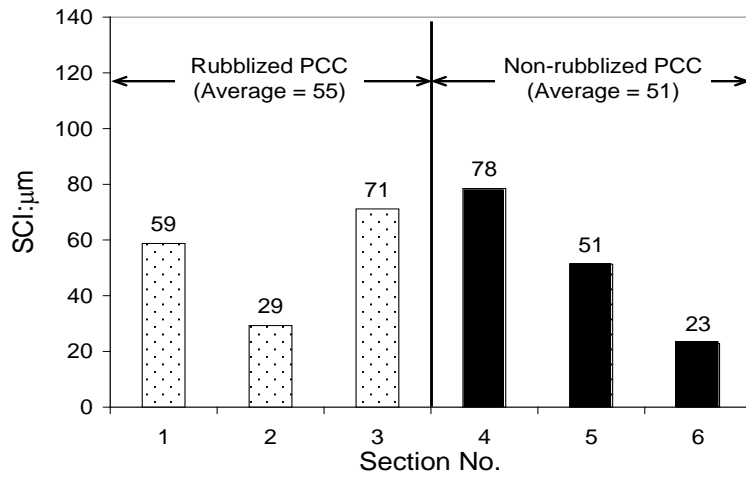
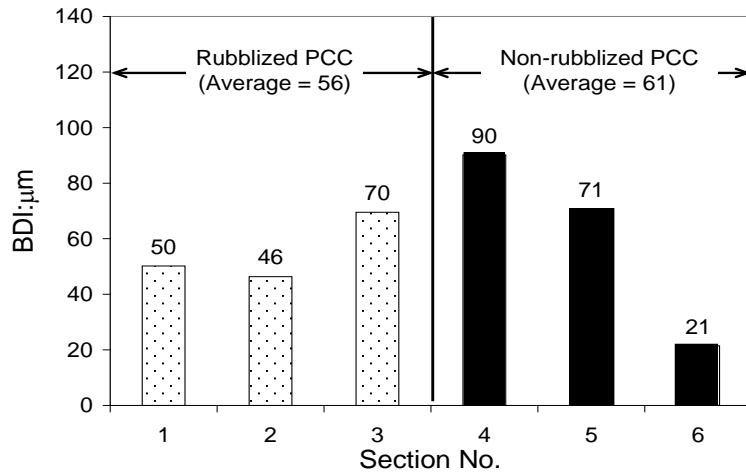
Fig. 6. SCI, BCI and BDI in test sections: (a) SCI; (b) BCI; (c) BDI

The AREA, AUPP and ISM values for test sections are displayed in Fig. 5. Similar information for SCI, BCI and BCI are displayed in Fig. 6. Overall pavement structure strength condition can be related to AREA, AUPP and ISM. SCI can provide information on changes in relative strength of the near-surface layers. BCI is a subgrade condition indicator especially in aggregate base pavements and is strongly related to the subgrade modulus. BDI is related to base layer modulus. Higher values of AREA and ISM mean higher pavement stiffnesses. On the other hand, lower values of AUPP, SCI, BCI, and BDI mean higher pavement stiffnesses.

It is observed from these figures that although there is some variation in each test section, the average values of DBPs are not significantly different between the rubblized PCC sections and the non-rubblized PCC sections. As seen in Fig. 5, both sections have similar overall pavement condition indicated from average values of AREA, AUPP and ISM. Especially, the average BDI value of 56 μm in rubblized PCC sections is slightly lower to that of 61 μm in non rubblized PCC sections as shown in Fig. 6(c). Considering that BDI is related to the strength of base layer (rubblized PCC or non-rubblized PCC layer) and lower values of BDI mean higher stiffness, this result indicates that the strength of rubblized PCC layer are comparable, or even better, to that of PCC layer without rubblization.
