Non-destructive evaluation of in-place rehabilitated concrete pavements

Reference to this paper should be made as follows: Gopalakrishnan, K., Kim, S., and Ceylan, H. (2010). "Non-Destructive Evaluation of In-Place Rehabilitated Concrete Pavements," the Journal of Civil Engineering and Management, Vol. 16, No. 4, pp. 552-560.

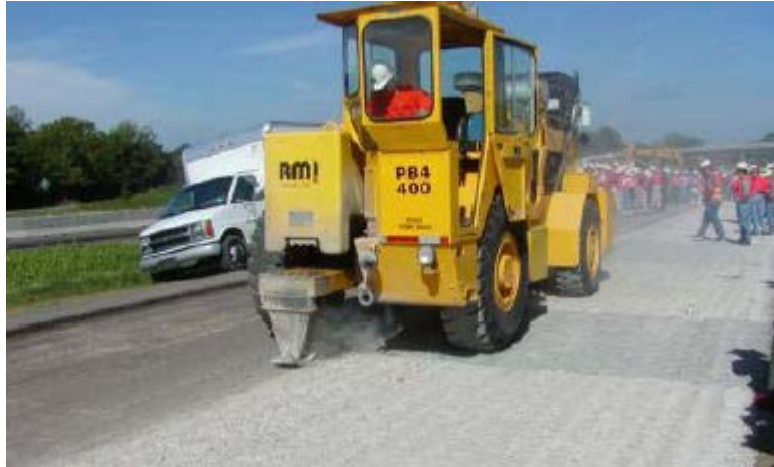
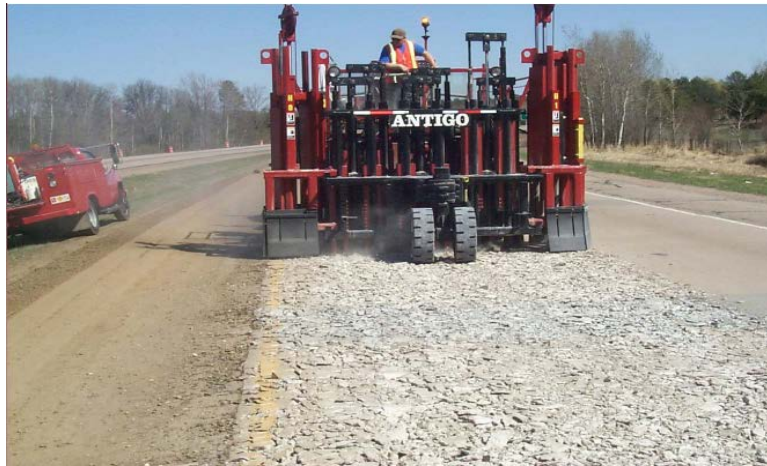
Fig. 1. Equipment in the rubblization: (a) Resonant Pavement Breaker (Resonant Machines, Inc. 2007); (b) Multi-Head Breaker (Antigo Construction, Inc. 2007)

In general, two types of equipment are used in the rubblization process: Resonant Pavement Breaker (RPB) and Multiple-Head Breaker (MHB). The rubblization procedure plays an important role in long-term performance of the pavement. The RPB shown in Fig. 1(a) uses vibrating hammers to demolish the existing pavement. This system breaks the concrete slab and destroys the bond between the concrete and the steel. It works on the principle that the frequency of a vibratory force can be varied until the resonant frequency of the body being vibrated can be determined. More details of the equipment are available at the reference (Resonant Machines, Inc. 2007).

The other common rubblizing equipment is the MHB as shown in Fig. 1(b). The equipment is of the self-contained and self-propelled type, which is capable of rubblizing the pavement over a maximum width of 4 m (13 ft.) per pass. The hammers used by this breaker are mounted laterally in pairs, with half of the hammers in the forward row and the remainder diagonally offset in the rear row. More details of this equipment are available at reference (Antigo Construction, Inc. 2007).

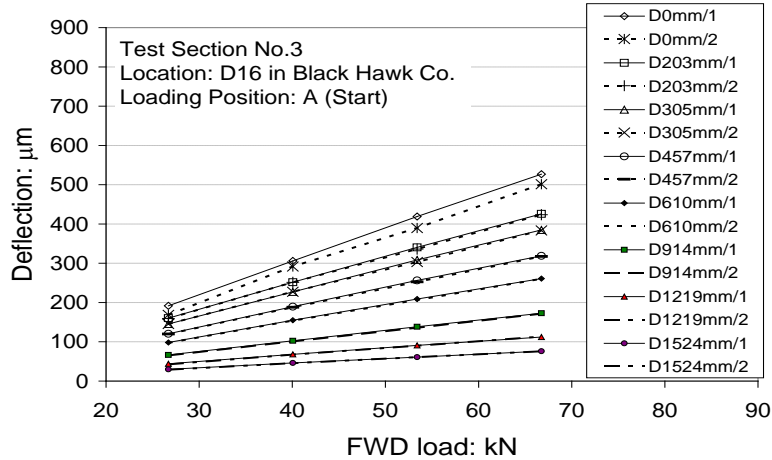
Fig. 2. FWD deflections with loads

Two-frequency FWD tests denoted as D/1 and D/2 in Fig. 2 were conducted on a single location to identify the FWD sensor measurement errors. No significant differences were observed, which confirmed that the employed FWD equipment can produce consistent results for same test material. The measured deflections on geophones were responding linearly to increasing FWD loads (see Fig. 2). This indicated that the deflections at different FWD load levels could be normalized to the deflections at one FWD load level. The measured deflections at 27, 53, and 67 kN of FWD loads were normalized to the deflections at 40 kN of FWD load in accordance with the following equation.

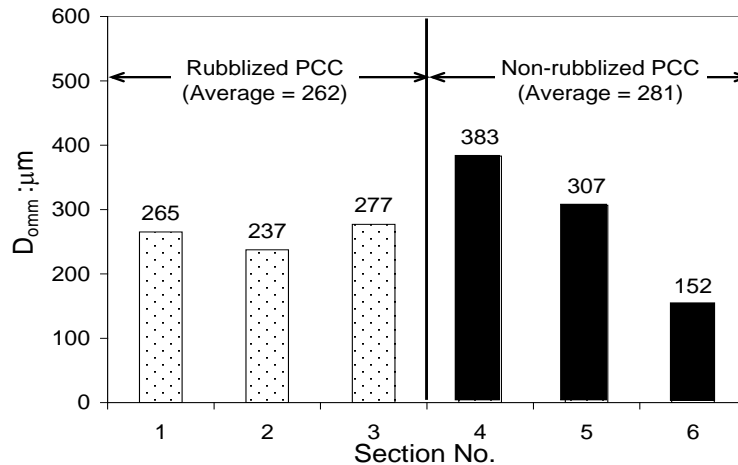
Fig. 3 presents the values of normalized deflection at D_{0mm} of FWD geophone for each test section. The D_{0mm} deflection provides an indication of the overall pavement strength. As seen in Fig. 3, the average D_{0mm} value of 262 μm in rubblized PCC sections is slightly lower than that of 281 μm in non rubblized PCC sections. This result indicates that AC overlay with rubblized PCC pavement has better or at least similar overall pavement strength to AC overlay with non-rubblized PCC pavement.

Fig. 3. FWD deflection at D_{0mm} in test sections

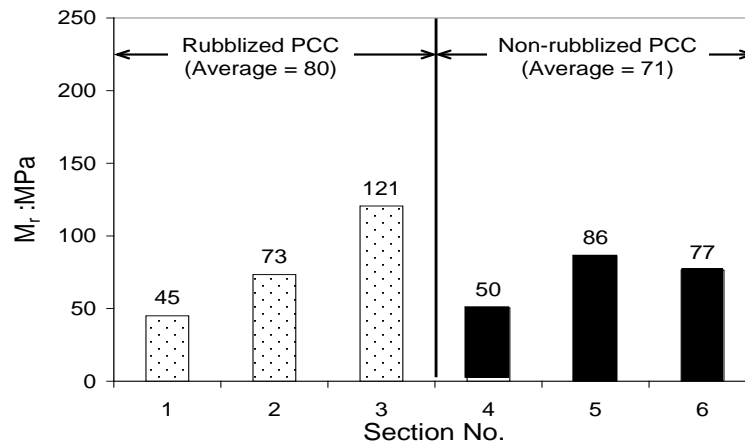
Fig. 4. DCPI and Mr in test sections: (a) DCPI; (b) Mr

The DCP measures as shown in Fig. 4 (a) has been correlated to the California Bearing Ratio (CBR, percent) which has been further correlated to the resilient modulus

CBR is the California Bearing Ratio (%), DCPI is the dynamic cone penetration index (mm/blow), and Mr is the resilient modulus (psi). As seen in Fig. 4 (b), the average Mr value of 80MPa in rubblized PCC sections is higher than that of 71 MPa in non rubblized PCC sections. However, the higher average of Mr values in rubblized PCC sections may not be significant considering higher variation within test sections. This result indicates that the rubblization could be performed on subgrade conditions similar to that of AC overlaid non-rubblized PCC pavements.

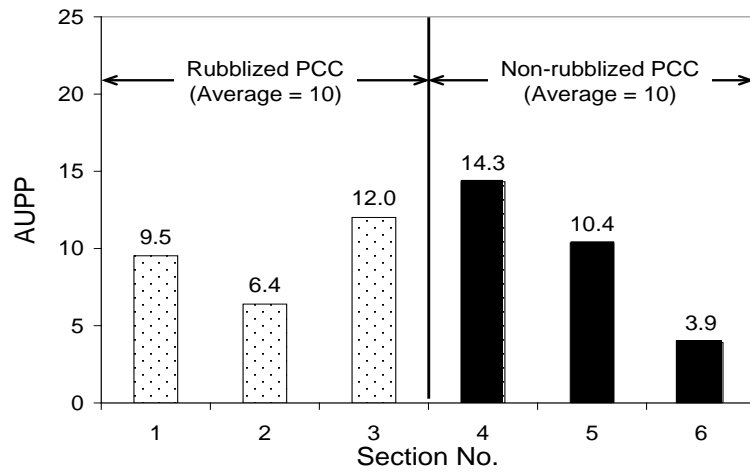
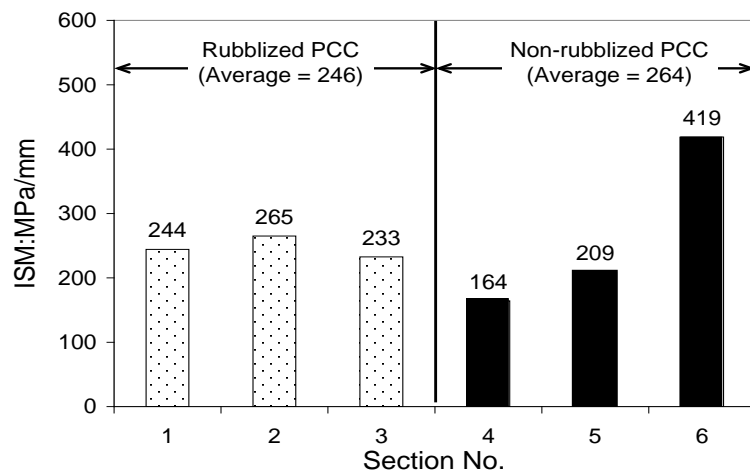
Fig. 5. AREA, AUPP and ISM in test sections: (a) AREA; (b) AUPP; (c) ISM

The AREA, AUPP and ISM values for test sections are displayed in Fig. 5. Similar information for SCI, BCI and BCI are displayed in Fig. 6. Overall pavement structure strength condition can be related to AREA, AUPP and ISM. SCI can provide information on changes in relative strength of the near-surface layers. BCI is a subgrade condition indicator especially in aggregate base pavements and is strongly related to the subgrade modulus. BDI is related to base layer modulus. Higher values of AREA and ISM mean higher pavement stiffnesses. On the other hand, lower values of AUPP, SCI, BCI, and BDI mean higher pavement stiffnesses.

It is observed from these figures that although there is some variation in each test section, the average values of DBPs are not significantly different between the rubblized PCC sections and the non-rubblized PCC sections. As seen in Fig. 5, both sections have similar overall pavement condition indicated from average values of AREA, AUPP and ISM. Especially, the average BDI value of 56 μm in rubblized PCC sections is slightly lower to that of 61 μm in non rubblized PCC sections as shown in Fig. 6(c). Considering that BDI is related to the strength of base layer (rubblized PCC or non-rubblized PCC layer) and lower values of BDI mean higher stiffness, this result indicates that the strength of rubblized PCC layer are comparable, or even better, to that of PCC layer without rubblization.

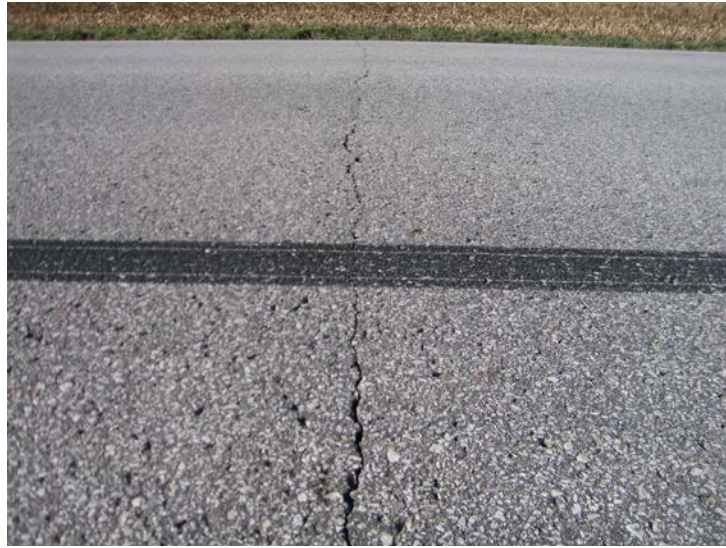
Fig. 8. Picture of low-temperature cracking on AC-overlaid rubblized PCC pavement (No. 3: D16 in Black Hawk County)

Distress survey results are summarized in Table 2. In general, no load-associated distresses, such as fatigue cracking, were found in any of the test sections as shown in Fig. 7. The predominant distresses observed in the rubblized PCC sections are low-temperature cracks as shown in Fig. 8. No reflection cracking was observed in these rubblized PCC sections. However, some of the non-rubblized PCC section, especially IA-139 in Winneshiek County (No. 6), showed high-severity reflection cracking, as shown in Fig. 9. These results indicate that the rubblized pavement sections in Iowa have better performance under structural conditions comparable to that of non-rubblized sections.

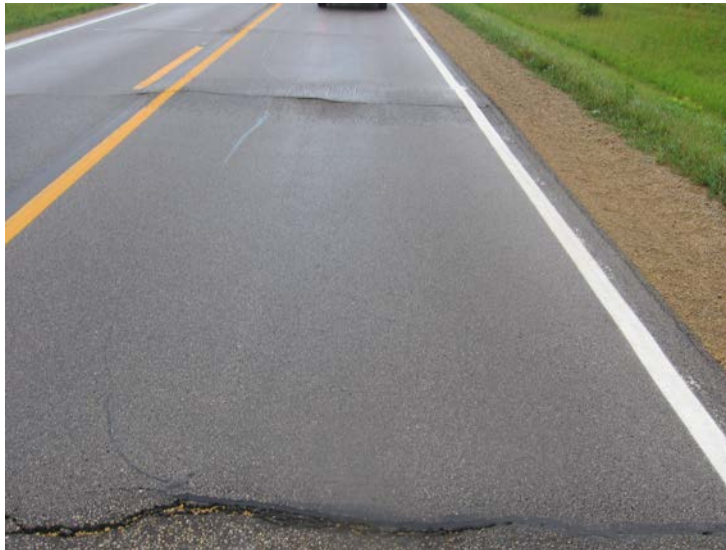
Fig. 9. Picture of reflection cracking on AC-overlaid virgin PCC pavement (No. 6: IA139 in Winneshiek County)
