# Fish Passage in a Western Iowa Stream Modified by Grade Control Structures

Mary E. Litvan  
*Iowa State University*

Clay L. Pierce  
*United States Geological Survey*

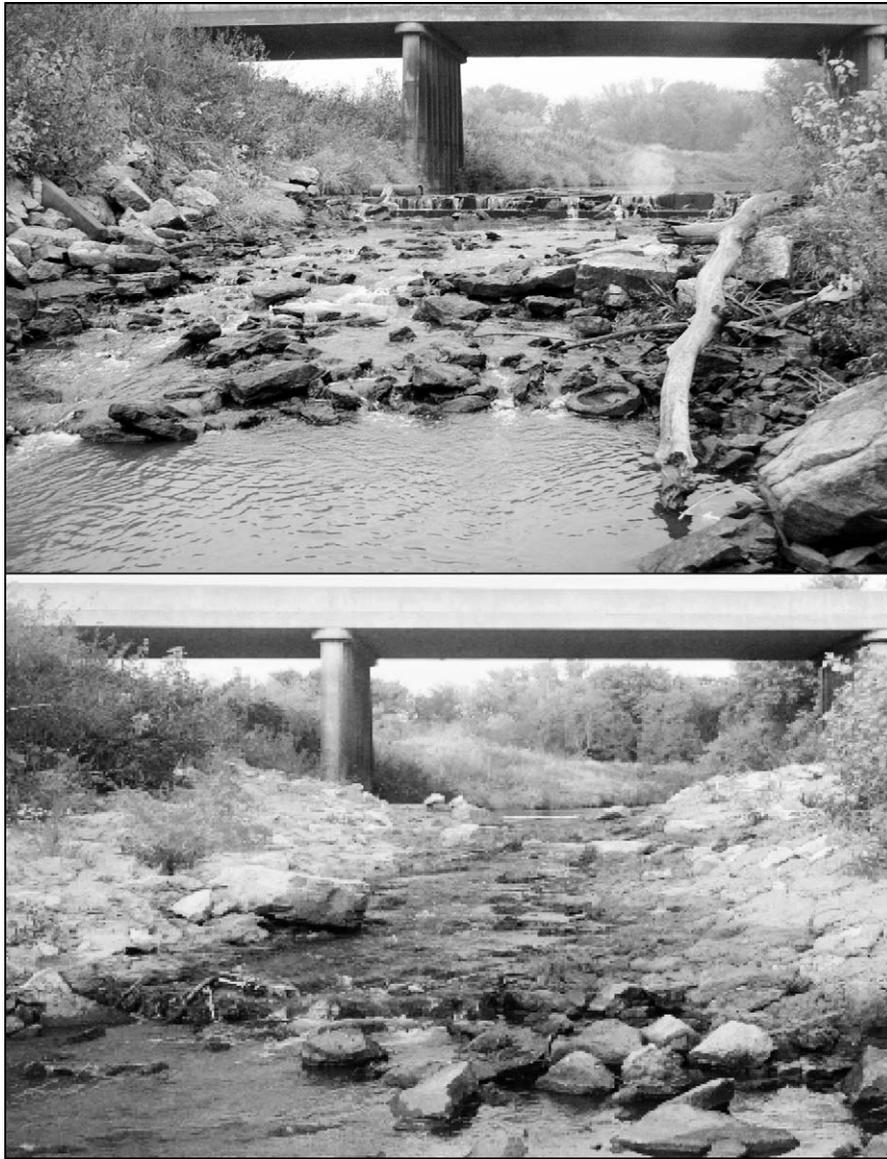
FIGURE 1.—The grade control structure at site G3 on Turkey Creek during the fall of 2004 before modification (top) and during the fall of 2005 after slope modification (bottom). From 2002 to 2004, no fish were documented as passing over this structure. After modification, channel catfish, black bullheads, and creek chub were all documented passing over this structure.

and 1958 have left 85% of the channel nonmeandering, the sinuosity ratio for a main channel being less than 1.5 (Bulkeley 1975). Turkey Creek has been described as resembling a ditch rather than a natural stream, having nearly vertical banks up to 6 m high (Harlan et al. 1987). Streambank erosion is prevalent and benthic substrates are dominated by silt and sand. Beginning in 1996, nine GCSs have been built downstream of bridges in Turkey Creek to stabilize the stream channel and halt the upstream progression of knickpoints (e.g., Figure 1).

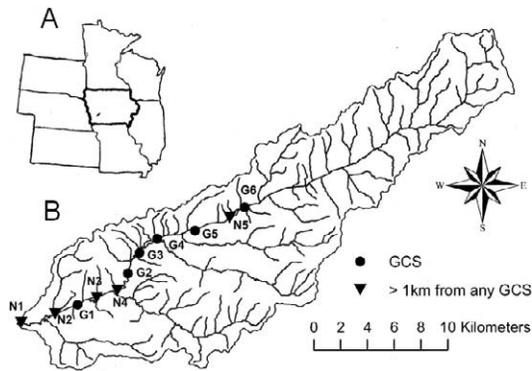
FIGURE 2.—Locations of (A) Turkey Creek and (B) the sampling sites on Turkey Creek at or 1 km from a grade control structure (GCS). Sites G1–G6 and N4 were sampled by means of passive gear and electrofishing, sites N1–N3 and N5 by electrofishing only. At least six additional stream stabilization structures (GCSs or riprap piles) are located upstream from site G6 in the main channel of Turkey Creek and its headwater tributaries.

The study area consisted of 11 sampling sites (Figure 2). Site names beginning with the letter *G* were located directly downstream from GCSs, whereas site names beginning with the letter *N* were located at least 1 km from any GCS (Table 1; Figure 2). The most downstream site (N1) was located 0.3 km upstream from the creek's confluence with the East Nishnabotna River, draining a watershed of 331 km<sup>2</sup>; the most upstream site (G6) was located 23.9 km upstream, draining a watershed of 133 km<sup>2</sup>. Within the study area, Turkey Creek ranges from a third- to fourth-order stream of approximately 3–15 m in wetted width. All sampling sites were accessed at bridge crossings; the six *G* sites were reaches immediately downstream from GCSs, whereas the five *N* sites, which were all located at least 1 km from any GCS, were accessed by bridges without GCSs. None of the bridges in this study were low-water crossings or contained structural elements that could have restricted fish passage. Stretches of stream that appeared to be affected by bridge presence were excluded from sampling reaches.

*GCS modifications and measurements.*—Six GCSs are located within the study area of Turkey Creek (Table 1; Figure 2). Structures at sites G2, G3, G4, and G6 were built in 1996 and those at G1 and G5 in 2001. All structures were originally constructed with ungrouted riprap aprons ranging from 4:1 to 10:1 in downstream slope, and all structures except one, site G2, contained a metal sheet-pile dam at the upstream face of the structure. Similar to many GCSs in western

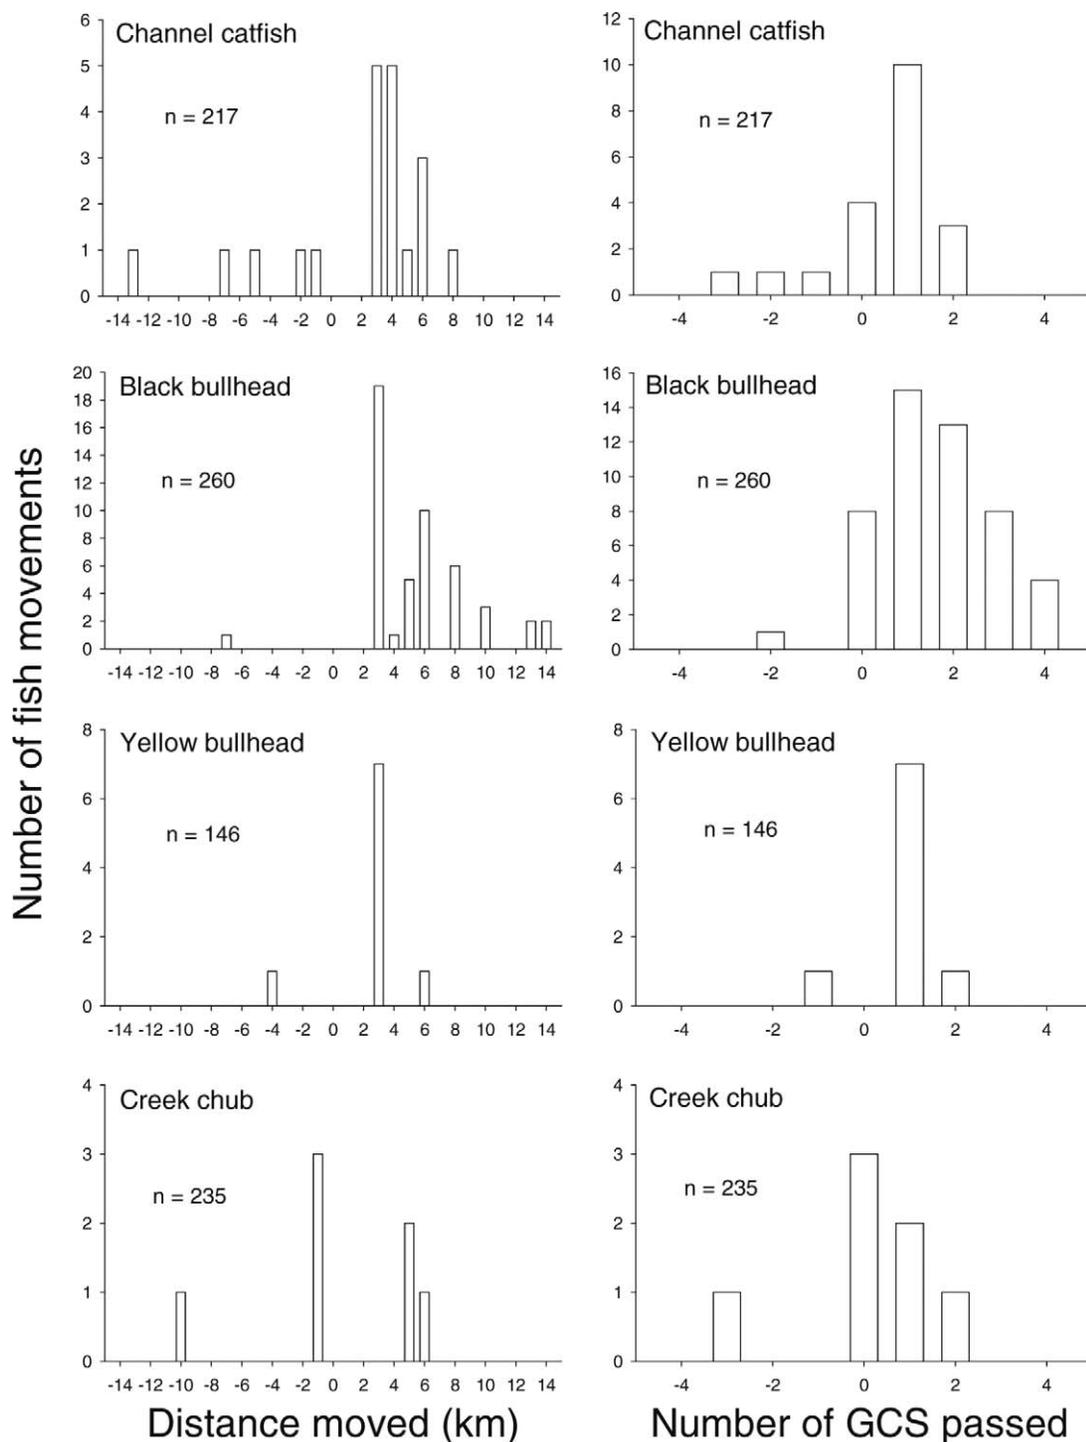
FIGURE 3.—Histograms of documented movements of marked channel catfish, black bullheads, yellow bullheads, and creek chub in Turkey Creek from May 2002 to May 2006 ( $n$  = the total number of recaptures). Downstream movements are indicated by negative values, upstream movements by positive values. These histograms show a total of 85 movements; four upstream movements of black bullheads were treated as two recorded movements because they involved the same fish moving upstream twice.

Overall, most ictalurid fish passing over GCSs were recaptured one site upstream from their original marking site, displaying movement over only one GCS (Figure 3). Channel catfish were documented moving upstream a maximum distance of 7.9 km over a maximum of two GCSs; their maximum distance downstream was 13.8 km, passing over a maximum of three GCSs (Figure 3A, B). Black bullheads were documented moving upstream a maximum distance of 13.3 km over a maximum of four GCSs and downstream a maximum 7.9 km over a maximum of two GCSs (Figure 3C, D). Yellow bullheads were documented moving upstream a maximum distance of 5.4 km over a maximum of two GCSs and downstream a maximum distance of 4.4 km over a maximum of one GCS (Figure 3E, F). Ninety-one percent of all ictalurid movements were in the upstream direction (Figure 3).

Most of the creek chub displaying movement between sites moved downstream from site G6 to N5, a distance of 1.5 km, but they did not pass over any GCS (Figure 3G, H).
