# Laboratory Investigation of Concrete Beam-End Treatments

May 2015

tech transfer summary

Concrete coatings (silanes, epoxies, etc.) for protecting prestressed concrete beam ends may help prevent premature deterioration due to moisture and chloride penetration.

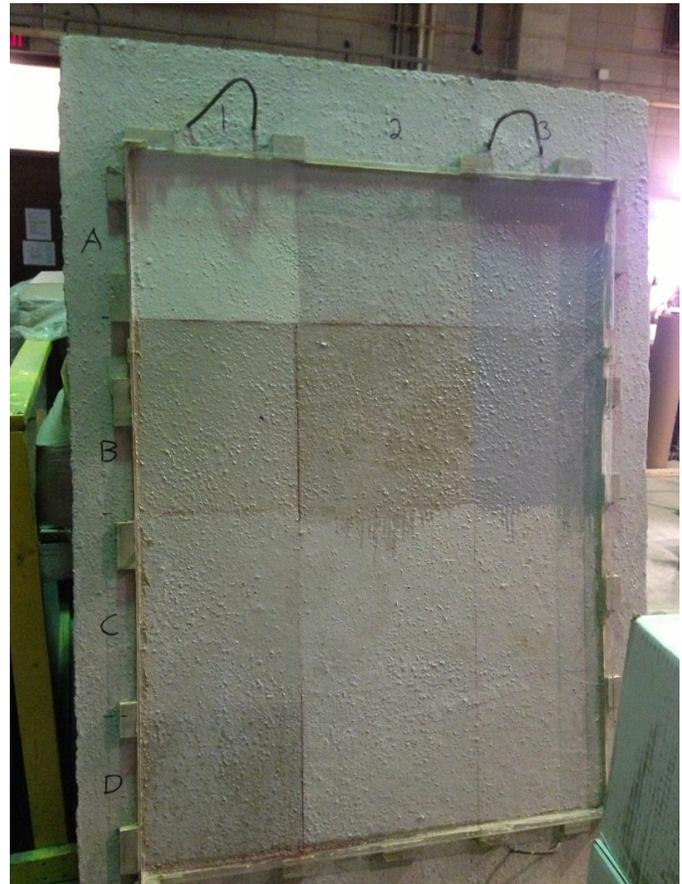
*Typical ponding slab with coating alternatives applied*

The selected products were tested in the laboratory according to AASHTO T259-80. Each product was applied to a designated square on each of three concrete ponding slabs, with each slab from a different precast facility in or near Iowa. In addition, two coats of Sikagard 62 were applied to one square, and two were left uncoated as controls.

The three slabs were submerged in a 3% chloride solution for 90 days, and samples were taken to be tested at the Iowa State University materials testing facilities. This procedure was repeated two more times.

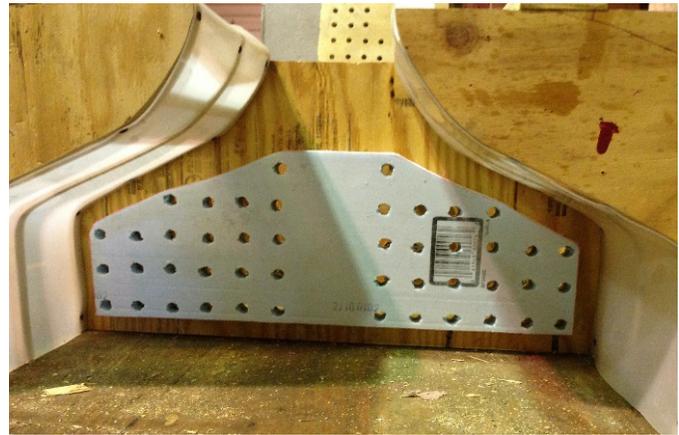
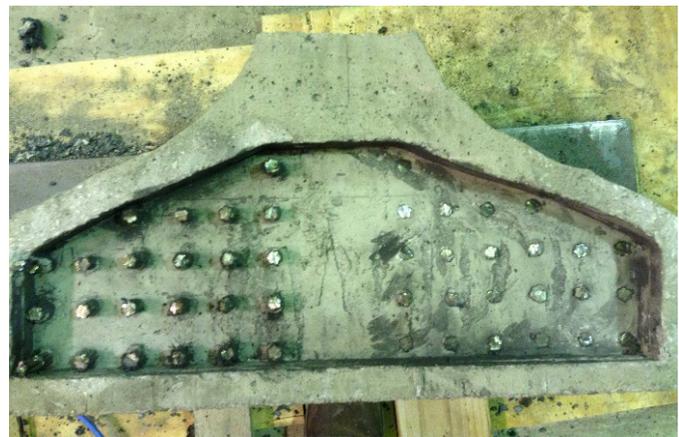
*Single blockout formed with 2 in. foam*

- Single beam-end blockout around the entire cluster of strands in the beam's bottom flange
- Double beam-end blockout around the two clusters of strands in the beam's bottom flange
- Individual blockout around each strand in the beam's bottom flange
- Drilling out the strands

All blockouts were filled with grout or similar material.

Single, double, or individual bar blockout are excellent options for separating the face of the beam end and the end of the prestressing strand. Viable alternative beam-end fabrication details include any of the blockout options: single, double, or individual strand.

Foam was found to be the best material for creating the voids. Further investigation is warranted into potential grout products, epoxy products, or both that can adequately fill voided areas without cracking.
