Laboratory Investigation of Bridge Strip Seal Joint Termination Details

tech transfer summary

February 2016

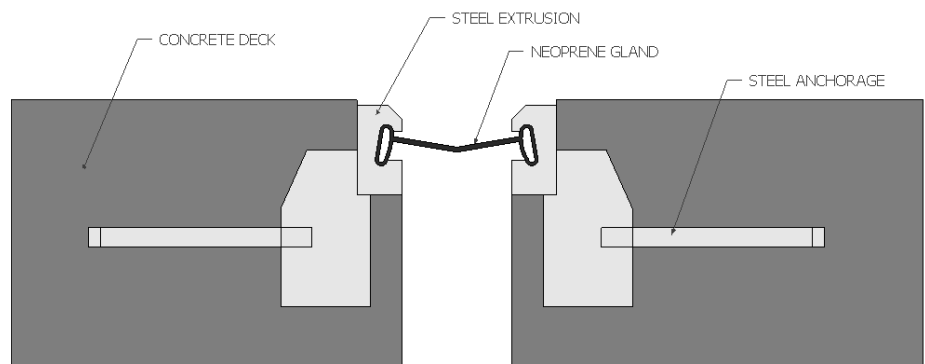
Strip seal cross-section

The strip seal system is comprised of steel extrusions that are cast in the concrete deck and a neoprene gland that fits into cavities in the extrusion. These expansion joint seals are susceptible to tears and pull outs that allow water, chlorides, and debris to infiltrate the joint, and subsequently the bearings below.

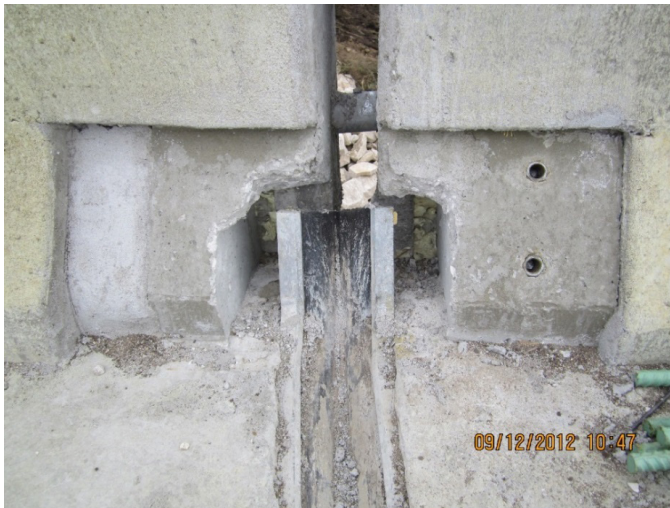
Field construction of strip seal termination turn-up at barrier rail with blockout

Field inspections have found that the poor performance of the current Iowa DOT termination detail often stems from the fact that the blockout region around the strip seal turn-up is not fabricated with the best construction methods and/or quality control practices. Often, a larger than necessary void in the barrier rail is left around and behind the strip seal turn-up during barrier rail construction, and the void is later filled by hand packing concrete into it.

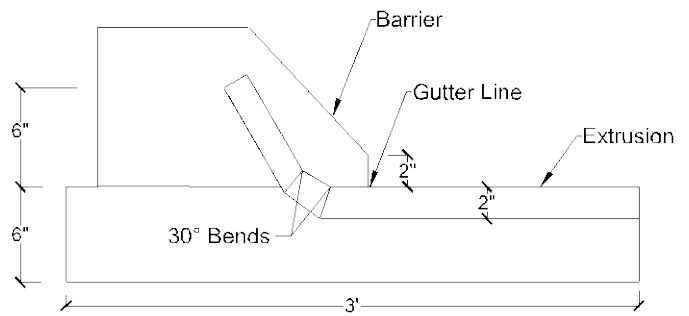
Section view of turn-up termination detail

Strip seal termination details vary from state to state. In Iowa, strip seals run transverse to the bridge deck and terminate by turning up and into the barrier rail in a two-step turn. The turn-up prevents water from flowing over top of the strip seal, where it could then reach and cause deterioration to substructure elements below.

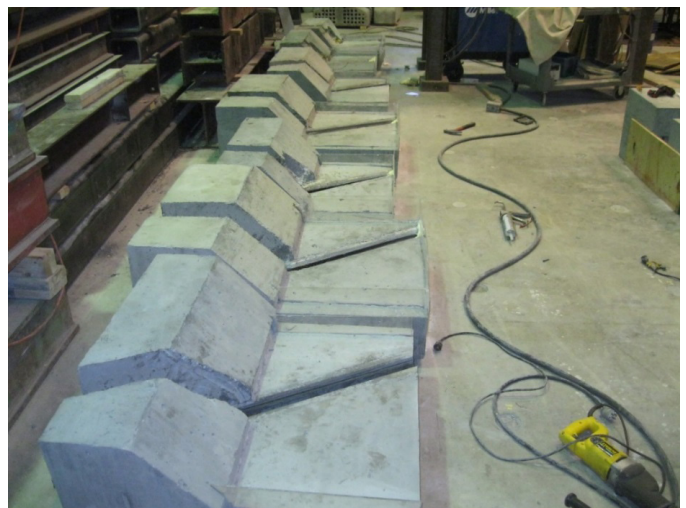
Laboratory specimens before testing

Given that the Iowa DOT experiences the most severe problems with the strip seal termination detail on skewed bridges, all laboratory specimens were constructed at a 30 degree skew. This ensured that recommendations for new or improved details were tested under the most critical circumstances.

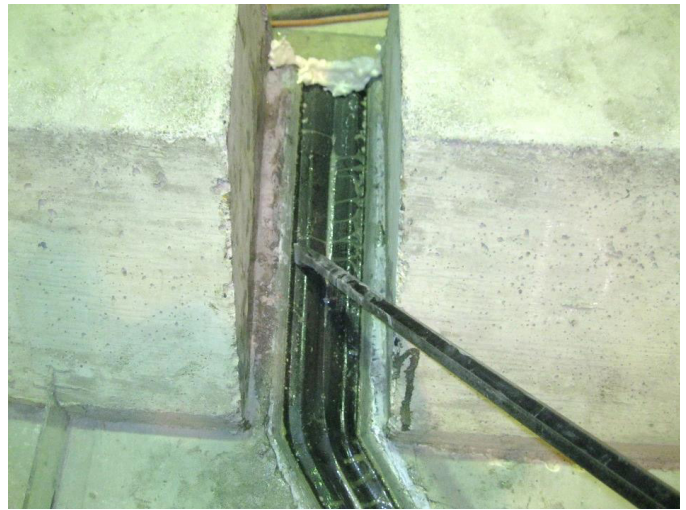
Use of a crowbar to install D.S. Brown gland

For the D.S. Brown strip seal, the gland installation between the barrier rails proved to be simple, taking a total of 10 minutes, and was achieved using a basic pry bar. Both the dogleg and straight-through of the D.S. Brown specimens passed all ponding tests.

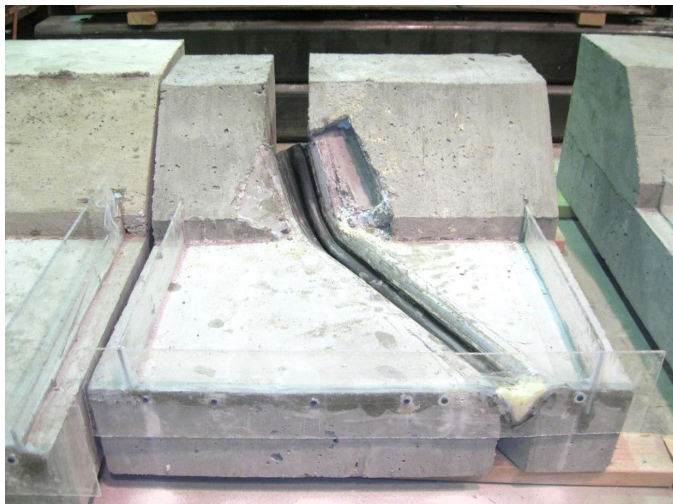
Turn-up specimen with blackout formed using blue insulation board

- If a blackout is to be utilized around the current strip seal termination turn-up, forming the blackout with blue foam board is both efficient and results in a quality product. If spray foam is utilized, the face of the metal extrusion should be scraped and scrubbed clean of all spray foam residue prior to casting the barrier rail.
