# Conclusions from the Investigation of Deterioration of Joints in Concrete Pavements

**RESEARCH PROJECT TITLE**

Investigation of Deterioration of Joints in  
Concrete Pavements

tech transfer summary

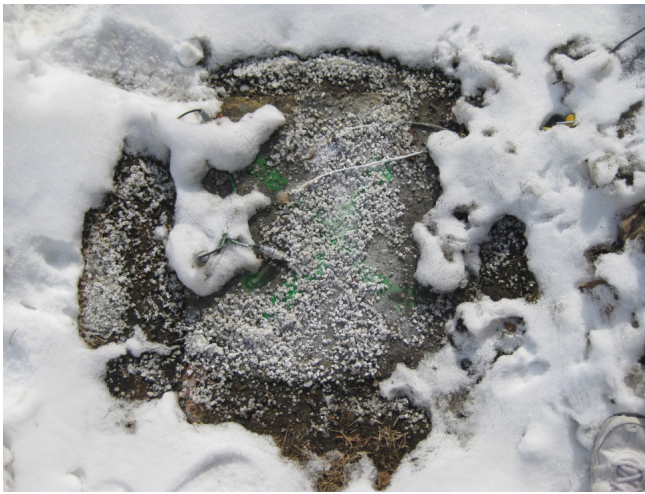
*Instrumented slab buried in the ground during a snow event, showing sodium chloride applied*

This test examined the influence of the environment on concrete internal temperature and relative humidity. An instrumented concrete slab, 20 × 20 × 8 inches, was built using a typical concrete pavement mixture containing 20 percent fly ash.

The slab was cast in early October, moist-cured for two weeks, placed in a freezer for one month, and then placed into the ground. Sodium chloride was applied to the top of the slab during snow events. Temperature data were recorded.

- The temperature at the bottom of the slab did not fluctuate as markedly as the top surface. During one of the greatest temperature swings, the difference between the top and bottom of the slab never exceeded about 8°F.
- The edge of the slab showed higher temperature differentials, likely because the soil at the edge of the slab was not thoroughly compacted and thus acted as a better conductor of heat than the concrete. This is also likely true of the interior of a sawn joint.

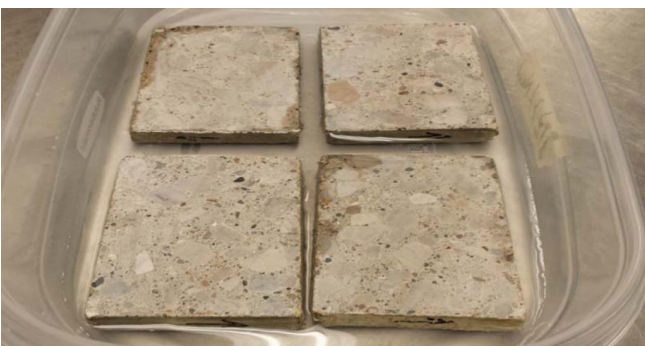
*Samples partially immersed in testing solution*

The beams were cured in a fog room for 28 days and then cut into 1/2 inch thick slices. The slices were partially immersed in either water, 3 percent sodium chloride (NaCl), or 3 percent magnesium chloride (MgCl<sub>2</sub>) at a constant 40°F for 56 days. After 56 days, the slices were cut into two halves to examine the effects of the solutions through the thickness of the samples.

- Exposure to water and NaCl above freezing temperatures results in negligible distress.
- The failure mechanism in MgCl<sub>2</sub> does not appear to be related to freezing/thawing of water, salt crystallization, or dissolution of the interfacial transition zone.
- The paste appears to expand in the presence of MgCl<sub>2</sub> and thus becomes debonded from the coarse aggregate particles that are not expanding. The mechanism of expansion is likely the formation of calcium oxychloride (Ca(OCl)<sub>2</sub>) in the paste.

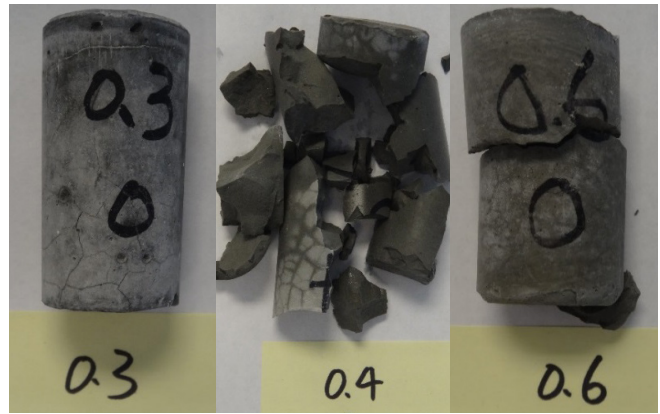
*Oven-dried paste samples with different w/cm ratios after one freeze-thaw cycle*

Paste samples were cured in sealed containers for 24 hours after mixing while being continually rotated. Samples were kept in sealed bottles for 7 days at 75°F before a cyclic freeze-thaw test. The lids were then removed, and the oven-dried samples were kept in an oven at 122°F until constant mass was achieved.

Samples were then sent for mercury intrusion porosimetry testing. Paste samples prepared from the same mixtures were also subjected to freeze-thaw cycles following the same preparation and curing procedures. The dried samples were placed in a freezer at 0°F (18°C) for 12 hours and thawed to 70°F (21°C).

- Increasing the w/cm ratio increases the total porosity and pore sizes of the hardened cement paste. Notably, the peak pore sizes in the lower w/cm ratio mixtures were within the range considered to be problematic based on the mixtures' abilities to allow water to evaporate.
- The high w/cm mixture had similar peaks in the fine zone but had a far larger peak on the coarse side, likely meaning that water is able to enter and leave the system readily, which allows the system to dry out enough to avoid freezing-related distress. This does not justify choosing mixtures with high w/cm ratios but does mean that systems with a w/cm ratio of about 0.4 have to be protected by other means.

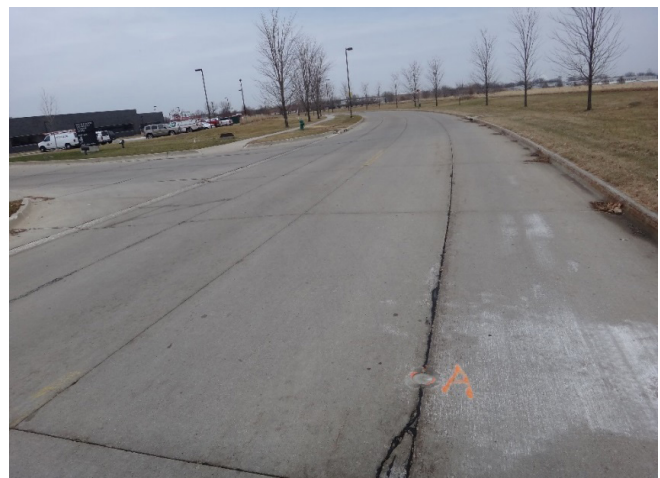
*Joint distress on a city street in Ames, Iowa*

This test examined the relationship between pavement performance and the permeability of subsurface layers. Field tests were conducted on a city street in Ames, Iowa, which had been paved in 1997 in one day using a full-width slipform paver. Joint sealing details and the extent of the pavement's distress were mapped.

Five cores were extracted over two years, with cores from a sound joint and a distressed joint sent for petrographic examination. Field borehole permeameter tests were also conducted. The influence of freezing on the moist base material's permeability was then evaluated in the laboratory.

- The results of the field borehole permeameter tests indicate that a low-permeability subsurface layer may correlate with joint deterioration under freezing conditions.
- The laboratory falling head permeability tests show that permeability decreases as moisture content increases and that freezing of the moist base material significantly reduces permeability.

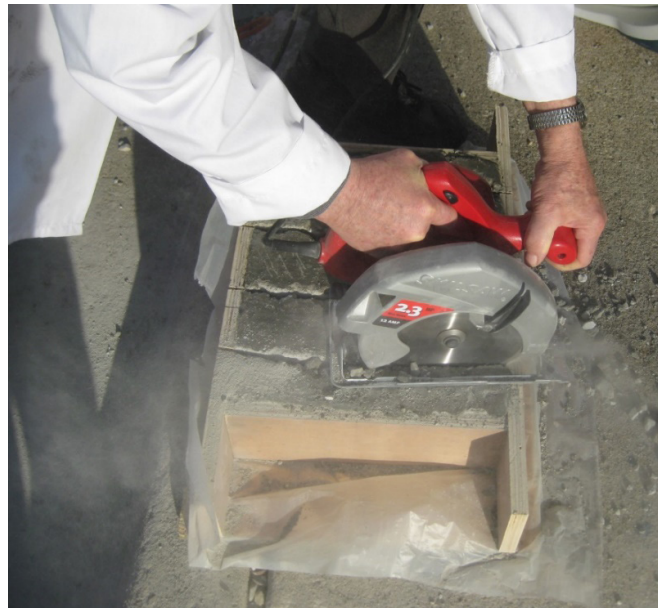
*Saw cutting a test slab using poor practices*

This test assessed whether sawing practice influences joint damage. A 12 × 18 × 4 inch slab was cast outdoors using a standard paving mixture. A handheld saw fitted with a diamond blade was used to dry-cut joints in the slab starting too early, causing extreme raveling. The operator was asked to push hard on the blade and to induce a curve to mimic poor practice.

After the slab hardened and gained strength, a full-depth section was cut perpendicular to the hand-sawn joints to observe the concrete condition at the bottom of the cuts.

- Under an optical microscope, the only evidence of joint-related damage due to sawing was a small piece of aggregate cracked at the tip of one of the cuts.
