Performance of Six Vegetative Treatment Systems for Controlling Runoff from Open Beef Feedlots in Iowa

An ASABE Meeting Presentation

Paper Number: 097054

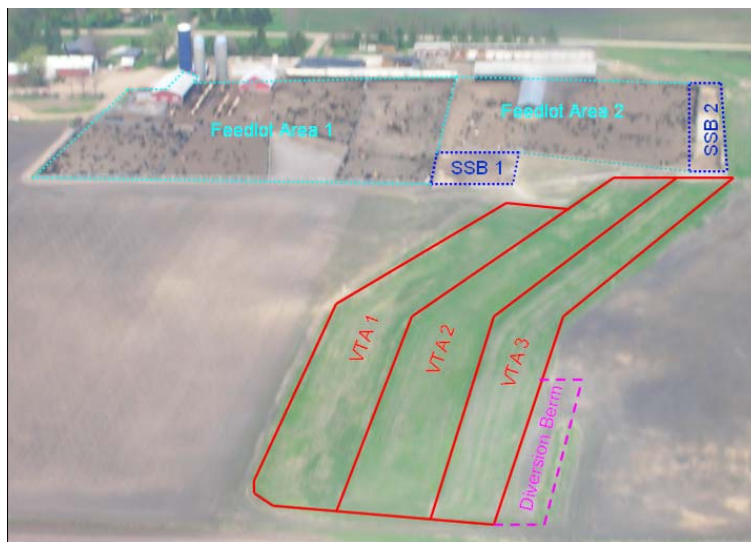
Figure 2. Layout of Central Iowa 1 and the VTS used to control and treat runoff generated by the facility.

Central Iowa 1 was 4.2-ha earthen open beef feedlot with a permitted capacity of 1,500 cattle located in central Iowa. The VTS at this site consisted of two solid settling basins, a vegetative treatment area (VTA) divided into three channels, a containment berm located at the southeast corner of the VTA, and a vegetated waterway (located on the eastern edge of the VTA). The VTS was divided into two portions, the pilot and the non-pilot system. The western lot (labeled Feedlot Area 1 in Figure 2) was the pilot portion of the feedlot. This was a 3.09-ha earthen feedlot area permitted for 1,000 head of cattle. Runoff effluent drained into a solid settling basin (labeled SSB 1) designed to hold 4,289 m³ of effluent. Effluent captured in the settling basin was then released onto the two western channels of the VTA (labeled VTA 1 and VTA 2). These two VTAs were operated in parallel, i.e., effluent was released onto both VTAs (VTA 1 and VTA 2) at the same time; both channels received similar effluent loadings. Each of these VTAs was 24 m wide with an average length of 311 m, giving a VTA to feedlot area ratio of 0.5:1. During the winter of 2007 and the spring of 2008, the producer converted a portion, 1.01-ha, of the pilot system open feedlot area into a confinement building (hoop structure) to house cattle. This reduced the remaining pen area which contributed feedlot runoff to the pilot system, from 3.08-ha to 2.06-ha and resulted in an increased VTA to feedlot area ratio of 0.7:1. Also, during 2008 three earthen berms were constructed within each of the VTAs. These berms helped slow the flow of water through the VTAs, redistribute effluent over the width of the VTAs, and provide some effluent storage within the VTAs. A final berm, prior to the outlet from the pilot VTA, was added in mid-June 2008.

Initial treatment of feedlot runoff occurred in solid settling basins. The downstream end of the settling basin was surrounded by concrete walls, while earthen berms were used for the settling basin sidewalls. The settling basin has a maximum depth of 1.2 m with 223 m² of concreted area. The remainder of the SSB bottom was constructed with a compacted earth bottom. The settling basin was designed with a porous dam outlet; the outlet was constructed on the downstream end of the settling basin out of vertical pieces of 2" x 4" lumber spaced 1.9 cm apart. After flowing through the porous dam outlets the effluent entered two 20-cm diameter pipe outlets which directed flow to VTA 1 and VTA 2. During the summer of 2007, a V-notch weir and knife-gate were added behind the porous dam outlet of the pilot system settling basin in an attempt to improve solids retention in the SSB. The knife-gate provided the producer with more control over when, how much, and at what rate effluent was released from the settling basin onto the VTA. In addition to the porous dam outlets, each settling basin was constructed with an emergency overflow weir on the downstream wall of the settling basin. The overflow weir was rectangular in shape, 46 cm long, and 15 cm below the top of the downstream end wall.

The effluent in the settling basin was released onto concrete pads which direct the effluent into a concrete level spreader at the upper end of each VTA. The level spreaders were the width of the VTA, 3 m long, and 0.15 m deep. The spreaders encourage uniform application of the settling basin effluent over the width of the VTA. The three VTA channels were constructed parallel to each other and “stair step” down in elevation with VTA 1 being the highest and VTA 3 the lowest. This design minimized the amount of cut-and-fill required during construction of the VTAs. The VTAs were designed to have a 0.5% slope along the length and to be level across its width. Geotextile flow spreaders were located at 61 m intervals down the length of each VTA channel to help maintain uniform flow distribution. These geotextile spreaders constantly required maintenance, i.e., the spreader needed to be restrung to maintain tension. As mentioned, during the summer of 2008 the producer added three earthen flow spreaders to each VTA. These earthen spreaders were installed to increase effluent retention time in the VTA and to improve flow distribution over the VTA. After installation of the earthen spreaders geotextile spreader were no longer maintained.

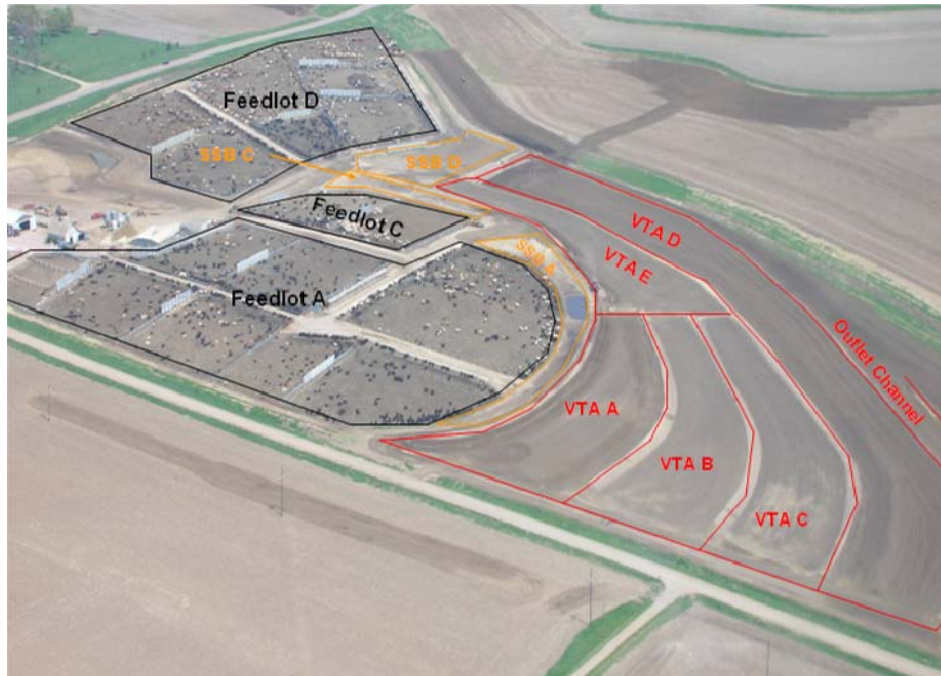
Figure 4. Diagram of the VTS's located on Northwest Iowa 1.

Northwest Iowa 1 had three stand alone VTA systems receiving runoff from a feedlot area of 6.88 ha. The feedlot runoff control system for this 3,400 head open beef cattle feedlot consisted of three solids settling basins, five vegetative treatment areas, and one outlet channel. The five VTAs ran parallel to each other and were “stair stepped” down a hill, with the first VTA constructed at the highest elevation. All the VTAs were surrounded by 0.9 m high berms to prevent transfer of effluent from one VTA to another, were level along their width, and were sloped (5%) along their length.

The pilot system portion of the feedlot (feedlot D) was approximately 2.91-ha of earthen feedlot that contained up to 1,400 head of cattle. Feedlot runoff was collected in a 1.2 m deep SSB having a volume of 3,710 m³. The SSB was designed to store runoff from a 25-year, 24-hour storm. A 15 cm SSB outlet pipe discharged water onto a 1.4 m wide concrete level spreader which was level across the top width of the VTA. A ball valve was added in the spring of 2007 to control the release of effluent from the SSB to the VTA. This effluent was released onto a VTA that was 479 m long by 35 m wide, giving a VTA to feedlot area ratio of 0.57 to 1. Again any effluent released from this VTA received further treatment as it flowed through the outlet channel. The VTA was initially planted with brome and reed canary grasses. Over the monitoring period, the brome grass took over becoming the dominate species.

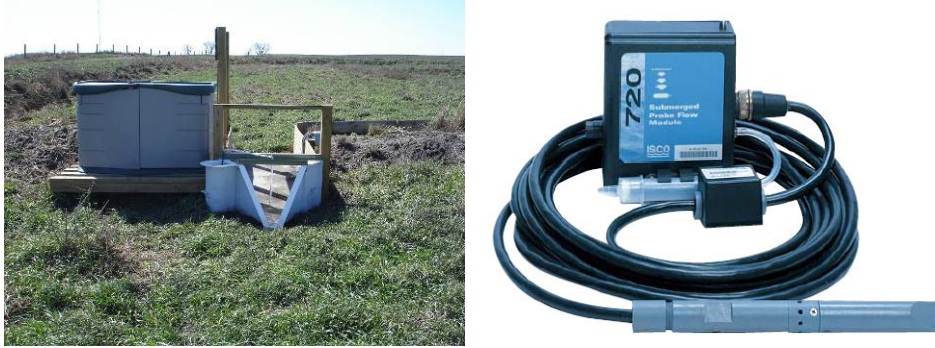
Figure 10. 0.46m outlet flume from a VTA (left) and the 720 submerged probe and module.

At locations where a pipe outlet was not installed as part of the system design, a 0.46 m (1.5 foot) H-flume in conjunction with an ISCO 720 submerged probe (Teledyne ISCO, Lincoln, NE) was used to monitor flow. These locations included the VTA outlets at Central Iowa 1,

Central Iowa 2, Northwest Iowa 1, Southwest Iowa 1, and the solid settling basin outlet at Northwest Iowa 2. A picture showing an outlet flume is provided in Figure 10. The ISCO 720 probe, also shown in Figure 10, used a differential pressure transducer to measure the level of water above the sensor. The ISCO 720 probe was placed in the stilling well of the H-flume. Flow rate was then calculated by the ISCO 6712 using a stage-flow relationship for the H-flume.

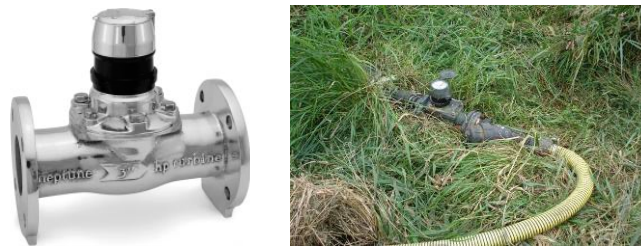
Figure 11. Neptune flow meter with Tricon/E3 encoder (left) and Neptune flow meter as installed to measure flow from the VIB into the VTA.

Effluent from the VIB was collected in a sump and then pumped onto the VTA. The pumped volume was measured continuously using a Neptune 5 cm (2-inch) turbine flow meter (Neptune, Tallassee, AL). Flow based samples were again collected using the ISCO 6712 automated sampler. The Neptune turbine meter was interfaced with the automated sampler using an ISCO 780 smart 4-20 Module (Teledyne ISCO, Lincoln, NE). The ISCO 6712 sampler had the capacity to interpret analog data from flow meters that output a 4-20 milliamp signal. The 780 Module allowed the flow signal to pace the sampler. The Neptune turbine flow meter, shown in Figure 11, was designed for full pipe flow and was capable of measuring a flow rate up to 756 liters per minute. The Tricon/E3 encoder (Neptune, Tallassee, AL) was attached to a register that will output an analog 4-20 milliamp signal. This signal was sent to the ISCO 780 4-20 milliamp module. Photos of the turbine meter and encoder are shown in Figure 11.
