# Performance of Six Vegetative Treatment Systems for Controlling Runoff from Open Beef Feedlots in Iowa

This is an ASABE Meeting Presentation, Paper No. [097054](#).

**Written for presentation at the  
2009 ASABE Annual International Meeting  
Sponsored by ASABE  
Grand Sierra Resort and Casino  
Reno, Nevada  
June 21 – June 24, 2009**

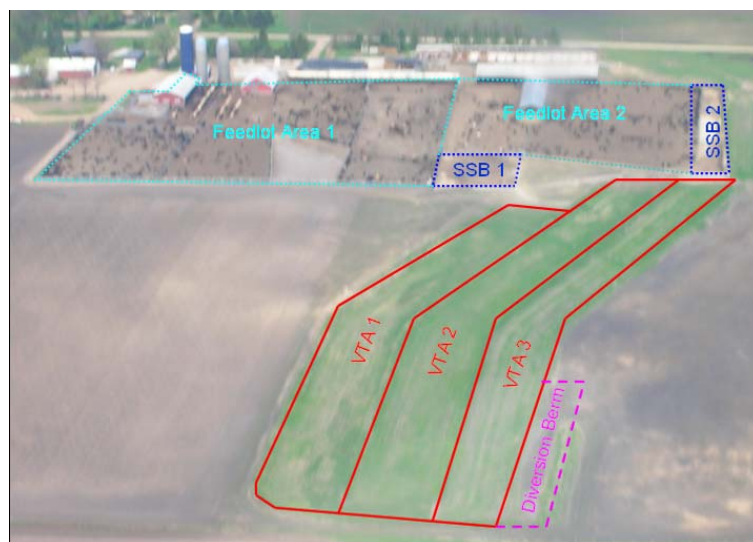
**Figure 2. Layout of Central Iowa 1 and the VTS used to control and treat runoff generated by the facility.**

Central Iowa 1 was 4.2-ha earthen open beef feedlot with a permitted capacity of 1,500 cattle located in central Iowa. The VTS at this site consisted of two solid settling basins, a vegetative treatment area (VTA) divided into three channels, a containment berm located at the southeast corner of the VTA, and a vegetated waterway (located on the eastern edge of the VTA). The VTS was divided into two portions, the pilot and the non-pilot system. The western lot (labeled Feedlot Area 1 in Figure 2) was the pilot portion of the feedlot. This was a 3.09-ha earthen feedlot area permitted for 1,000 head of cattle. Runoff effluent drained into a solid settling basin (labeled SSB 1) designed to hold 4,289 m<sup>3</sup> of effluent. Effluent captured in the settling basin was then released onto the two western channels of the VTA (labeled VTA 1 and VTA 2). These two VTAs were operated in parallel, i.e., effluent was released onto both VTAs (VTA 1 and VTA 2) at the same time; both channels received similar effluent loadings. Each of these VTAs was 24 m wide with an average length of 311 m, giving a VTA to feedlot area ratio of 0.5:1. During the winter of 2007 and the spring of 2008, the producer converted a portion, 1.01-ha, of the pilot system open feedlot area into a confinement building (hoop structure) to house cattle. This reduced the remaining pen area which contributed feedlot runoff to the pilot system, from 3.08-ha to 2.06-ha and resulted in an increased VTA to feedlot area ratio of 0.7:1. Also, during 2008 three earthen berms were constructed within each of the VTAs. These berms helped slow the flow of water through the VTAs, redistribute effluent over the width of the VTAs, and provide some effluent storage within the VTAs. A final berm, prior to the outlet from the pilot VTA, was added in mid-June 2008.

Initial treatment of feedlot runoff occurred in solid settling basins. The downstream end of the settling basin was surrounded by concrete walls, while earthen berms were used for the settling basin sidewalls. The settling basin has a maximum depth of 1.2 m with 223 m<sup>2</sup> of concreted area. The remainder of the SSB bottom was constructed with a compacted earth bottom. The settling basin was designed with a porous dam outlet; the outlet was constructed on the downstream end of the settling basin out of vertical pieces of 2" x 4" lumber spaced 1.9 cm apart. After flowing through the porous dam outlets the effluent entered two 20-cm diameter pipe outlets which directed flow to VTA 1 and VTA 2. During the summer of 2007, a V-notch weir and knife-gate were added behind the porous dam outlet of the pilot system settling basin in an attempt to improve solids retention in the SSB. The knife-gate provided the producer with more control over when, how much, and at what rate effluent was released from the settling basin onto the VTA. In addition to the porous dam outlets, each settling basin was constructed with an emergency overflow weir on the downstream wall of the settling basin. The overflow weir was rectangular in shape, 46 cm long, and 15 cm below the top of the downstream end wall.

The effluent in the settling basin was released onto concrete pads which direct the effluent into a concrete level spreader at the upper end of each VTA. The level spreaders were the width of the VTA, 3 m long, and 0.15 m deep. The spreaders encourage uniform application of the settling basin effluent over the width of the VTA. The three VTA channels were constructed parallel to each other and “stair step” down in elevation with VTA 1 being the highest and VTA 3 the lowest. This design minimized the amount of cut-and-fill required during construction of the VTAs. The VTAs were designed to have a 0.5% slope along the length and to be level across its width. Geotextile flow spreaders were located at 61 m intervals down the length of each VTA channel to help maintain uniform flow distribution. These geotextile spreaders constantly required maintenance, i.e., the spreader needed to be restrung to maintain tension. As mentioned, during the summer of 2008 the producer added three earthen flow spreaders to each VTA. These earthen spreaders were installed to increase effluent retention time in the VTA and to improve flow distribution over the VTA. After installation of the earthen spreaders geotextile spreader were no longer maintained.

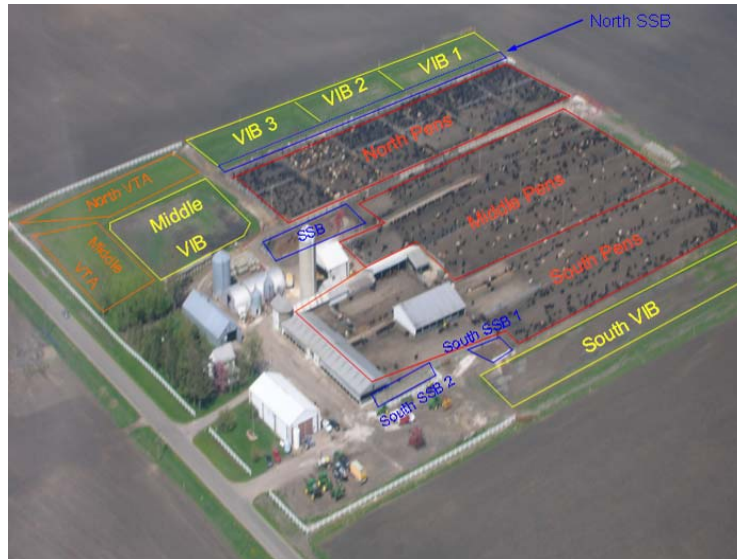
**Figure 3. Diagram of the VTS's for Central Iowa 2.**

Central Iowa 2 had three VTSs for handling runoff from the 3.24-ha earthen/concrete feedlot and was permitted for 2,500 head of cattle. A map showing the feedlot and the different system treatment components is shown in Figure 3. This location used three VTSs to treat feedlot runoff. These are referred to as the South, Middle, and North systems. The Middle system was the pilot VTS at this location, and consisted of a SSB, the Middle VIB, and the Middle VTA. The North VTS consisted of a long, narrow SSB, three VIBs (VIB 1, VIB 2, and VIB 3), and the North VTA. The South system consisted of two SSBs (South SSB 1 and South SSB 2), the South VIB, and crop land across the road which served as a land application area for any effluent released from the South VIB.

The pilot system controlled runoff from 1.07-ha of feedlot. This portion of the feedlot consisted of three pens, two of which were earthen and a third which was approximately half earthen and half concrete. The feedlot runoff drained into a 61 cm deep concrete SSB with a volume of 51 m<sup>3</sup>. The outlet from the settling basin was a 30.5 cm PVC pipe that releases effluent into the VIB. Prior to reaching the outlet pipe the effluent flowed through a porous dam which slowed the flow. In 2006, to reduce the amount of solids leaving the basin, the producer placed a “fence” of round bales in the settling basin to further slow and to filter the flow. During 2007, the round bale filter was not used, but a gate valve was installed at the settling basin outlet to provide the operator with more control over when, how much, and at what rate effluent was released to the VIB. Due to poorer solid-liquid separation during 2007, the producer decided to use the round bale filter along with the gate valve in 2008.

Wet conditions in the VIB made it difficult to establish and maintain vegetation in this treatment component. This 0.32 ha VIB was designed with 1.2 m berms surrounding it. The VIB provided storage for the 25-year, 24-hour storm within the VTS. The VIB had 10 cm (4 inch) diameter perforated tiles installed approximately 1.2 m below the soil surface. These tiles were spaced 6 m apart. A perimeter tile was installed around the VIB to intercept outside groundwater flow and prevent it from entering the VIB system. Flow from the VIB tile lines is collected in a concrete sump and is then pumped onto a 0.2 ha VTA. A gated pipe is used to spread VIB effluent evenly across the top width of the VTA. Flow then proceeded down the length of the VTA via gravity drainage. Both the VIB and VTA are planted with reed canary grass and brome grass.

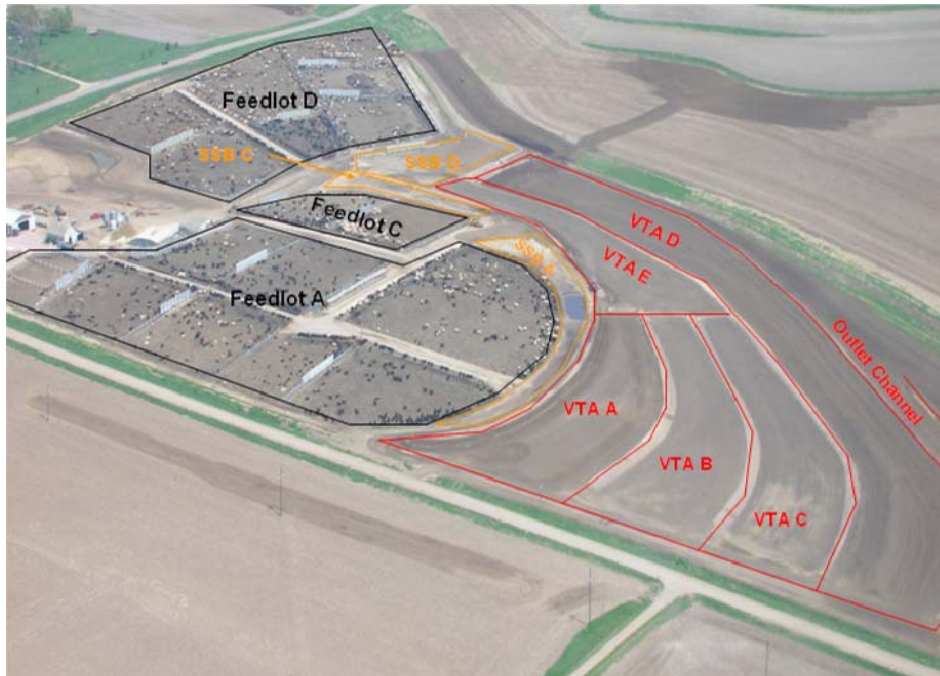
**Figure 4. Diagram of the VTS's located on Northwest Iowa 1.**

Northwest Iowa 1 had three stand alone VTA systems receiving runoff from a feedlot area of 6.88 ha. The feedlot runoff control system for this 3,400 head open beef cattle feedlot consisted of three solids settling basins, five vegetative treatment areas, and one outlet channel. The five VTAs ran parallel to each other and were “stair stepped” down a hill, with the first VTA constructed at the highest elevation. All the VTAs were surrounded by 0.9 m high berms to prevent transfer of effluent from one VTA to another, were level along their width, and were sloped (5%) along their length.

The pilot system portion of the feedlot (feedlot D) was approximately 2.91-ha of earthen feedlot that contained up to 1,400 head of cattle. Feedlot runoff was collected in a 1.2 m deep SSB having a volume of 3,710 m<sup>3</sup>. The SSB was designed to store runoff from a 25-year, 24-hour storm. A 15 cm SSB outlet pipe discharged water onto a 1.4 m wide concrete level spreader which was level across the top width of the VTA. A ball valve was added in the spring of 2007 to control the release of effluent from the SSB to the VTA. This effluent was released onto a VTA that was 479 m long by 35 m wide, giving a VTA to feedlot area ratio of 0.57 to 1. Again any effluent released from this VTA received further treatment as it flowed through the outlet channel. The VTA was initially planted with brome and reed canary grasses. Over the monitoring period, the brome grass took over becoming the dominate species.

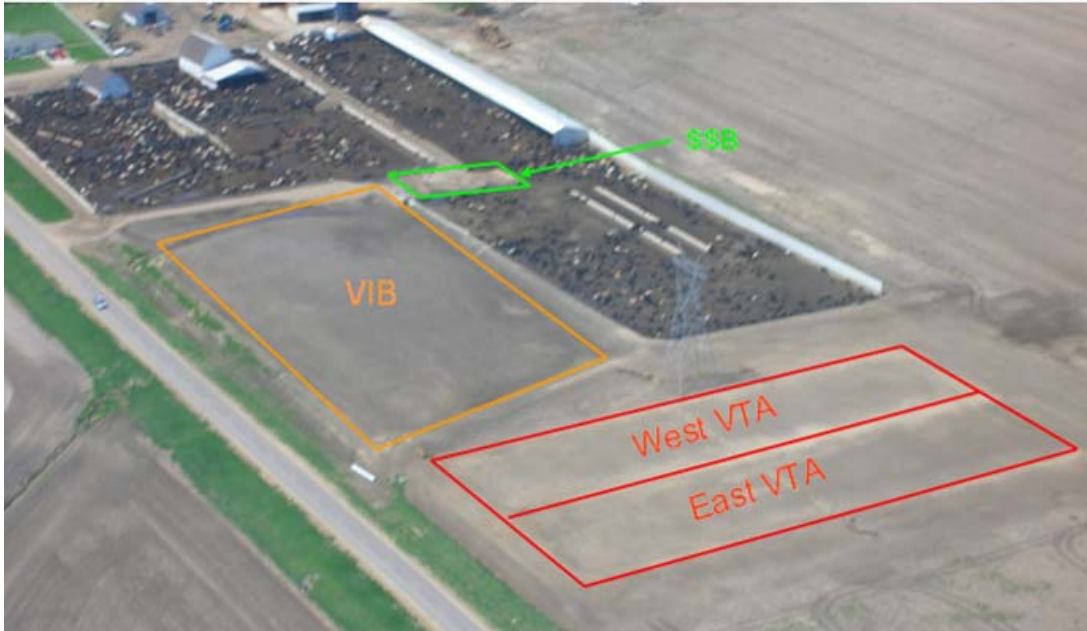
**Figure 5. Diagram of the VTA system at Northwest Iowa 2.**

Northwest IA 2 had a VIB-VTA system designed to control runoff from a 2.96-ha concrete feedlot; a picture of this facility is shown in Figure 5. A concrete settling basin of 101 m<sup>3</sup> capacity collected the runoff from the feedlot. The SSB was 0.6 m deep and has a V-notch weir at the outlet. The effluent flowing through the V-notch weir then flowed into a concrete channel and through an H-flume for measurement. In 2008, a series of stop-blocks was added to control when an SSB release would occur. The stop-blocks were constructed from 5 cm diameter PVC pipe and stacked at the SSB outlet. The stop-blocks were then removed, from the top down, to dewater the SSB from the top down.

Effluent from the settling basin was released into a 1.01-ha VIB. The VIB had 15 cm diameter perforated tiles installed 1.2 m deep and spaced 4.6 m apart. The VIB was built 0.9 m deep in the ground, and allowed storage of the 25-year, 24-hour storm runoff with an additional 0.3 m of freeboard before a VIB overflow would occur. Wet conditions in the VIB again made it difficult to maintain vegetation. Flow from the tile lines was collected in a sump and pumped onto each of the VTAs. A gated pipe was used to spread flow evenly cross the top width of the VTA. The 0.28 ha VTA was divided into two, 27 m wide channels. At a given time, effluent was pumped onto only one of the VTA channels. The channel receiving effluent was switched

manually by the producer by switching a set valves. Topographically, the VTA was at higher elevation than the VIB, as a result any effluent reaching the bottom of the VTA was routed back into the VIB. A surface inlet was used to capture this effluent at the bottom of the VTA. It was then routed through a 15 cm pipe that flowed via gravity back into the VIB. Thus, any release from the VTA was recycled back into the VIB, and not released from the overall VTS.

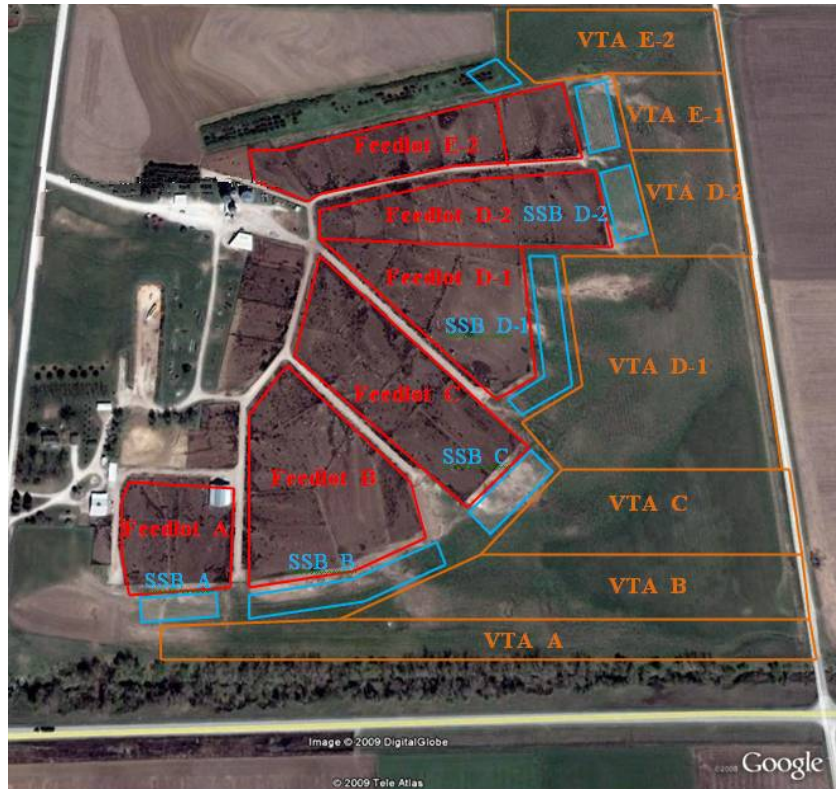
Figure 7. Diagram of the VTA system at Southwest Iowa 2.

Southwest Iowa 2 was a 20.2-ha earthen feedlot that used seven VTSs to control feedlot runoff. Each VTS consisted of an SSB and a VTA. A diagram of the VTSs at this site is shown in Figure 7. The pilot system at this location was feedlot C, SSB C, and VTA C. The feedlot area for the pilot system is 3.08 ha. Runoff from this area drained into a solid settling basin designed to hold the 25-year, 24-hour storm. The outlet of this settling basin was a perforated PVC pipe surrounded by a porous dam. The pipe ran from the settling basin to a gated pipe at the top of the VTA. A gate valve was installed in the PVC pipe to provide the producer with control of when effluent would be applied onto the VTA. The pilot VTA had an area of 3.5-ha, giving a VTA to feedlot area ratio of 1.1. This VTA was constructed with small ridges along the length of the VTAs. These ridges slowed the flow of effluent through the system and provided more time for infiltration to occur. A pipe outlet was located at the bottom of the VTA. A gate valve was installed at this outlet. This gate valve was closed between November 1<sup>st</sup> and April 1<sup>st</sup> to prevent outflow from snowmelt; between April 1<sup>st</sup> and November 1<sup>st</sup> the gate valve was left open so that outflow from the VTA could be monitored.

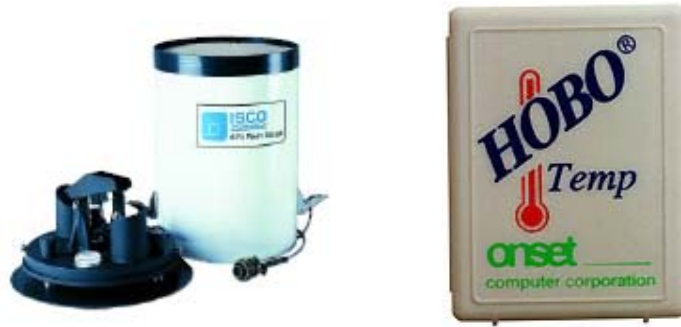
**Figure 8. ISCO 674 tipping bucket rain gauge (Teledyne ISCO, Lincoln, NE) (left) and Hobo temperature logger (Onset, Bourne, MA) (right).**

Precipitation depth and intensity were measured using and ISCO 674 tipping bucket rain gauge (Teledyne ISCO, Lincoln, NE). A standard passive rain gauge was also installed at all the sites as a back-up and for use during cold weather conditions. Temperature was measured at the sites hourly using Hobo temperature loggers (Onset, Bourne, MA). The ISCO rain gauge and the Onset temperature logger are shown in Figure 8.

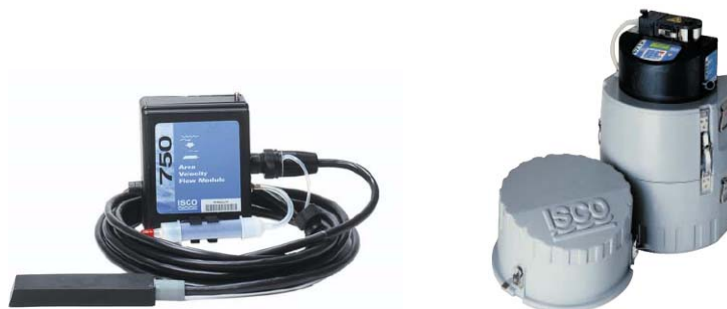
**Figure 9. ISCO 750 low profile area velocity sensor and module (left) and ISCO 6712 portable sampler (right)**

Pipe outlets were used at the SSBs at Central Iowa 1, Central Iowa 2, Northwest Iowa 1, Southwest Iowa 1, and Southwest Iowa 2. Additionally, pipe outlets were used in the tile line at Southwest Iowa 1, and the VTA outlets at Southwest Iowa 2 and Northwest Iowa 2. At these locations an ISCO 750 low profile area-velocity sensor (Teledyne ISCO, Lincoln, NE), shown in Figure 9, was used to measure flow. The ISCO 750 low profile area velocity sensor used Doppler technology to measure the average velocity in a full or partially flowing pipe. An integral pressure transducer measured the depth of water flow in the pipe. The depth, along with the diameter of the pipe, allowed calculation of the flow area. Flow rate was calculated by the ISCO 6712 sampler as the product of velocity and flow area by the ISCO 6712 sampler. The ISCO 6712 sampler also maintained a cumulative flow volume and collected samples based on the measured volume.

The ISCO 6712 automated sampler was a portable sampler used to collect flow or time based samples. It was powered with a twelve-volt deep cycle marine battery recharged with a solar panel. The sampler had the versatility to integrate a large range of modular sensors with various flow measurement devices. The sampler was programmed with four different programs at one time. A specific program was then selected based on current site and predicted weather conditions to collect samples according to the required situation.

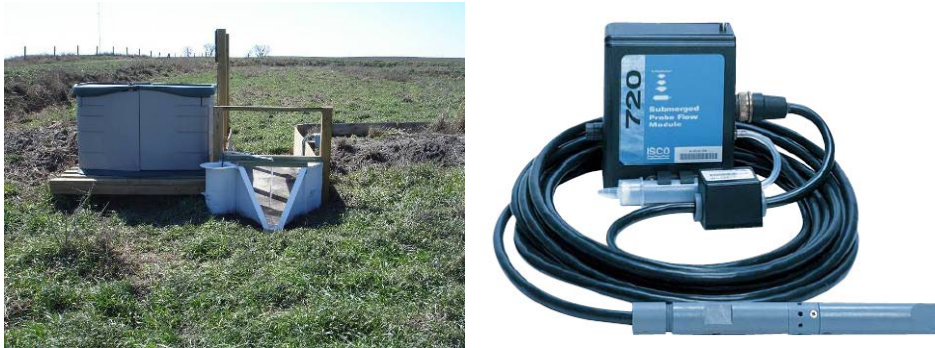
**Figure 10. 0.46m outlet flume from a VTA (left) and the 720 submerged probe and module.**

At locations where a pipe outlet was not installed as part of the system design, a 0.46 m (1.5 foot) H-flume in conjunction with an ISCO 720 submerged probe (Teledyne ISCO, Lincoln, NE) was used to monitor flow. These locations included the VTA outlets at Central Iowa 1,

Central Iowa 2, Northwest Iowa 1, Southwest Iowa 1, and the solid settling basin outlet at Northwest Iowa 2. A picture showing an outlet flume is provided in Figure 10. The ISCO 720 probe, also shown in Figure 10, used a differential pressure transducer to measure the level of water above the sensor. The ISCO 720 probe was placed in the stilling well of the H-flume. Flow rate was then calculated by the ISCO 6712 using a stage-flow relationship for the H-flume.

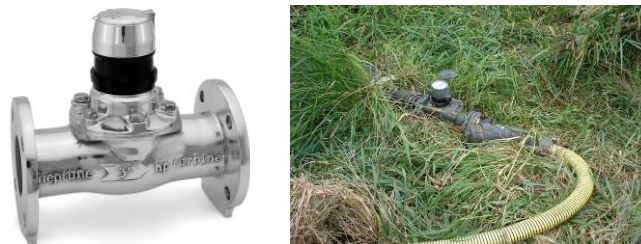
**Figure 11. Neptune flow meter with Tricon/E3 encoder (left) and Neptune flow meter as installed to measure flow from the VIB into the VTA.**

Effluent from the VIB was collected in a sump and then pumped onto the VTA. The pumped volume was measured continuously using a Neptune 5 cm (2-inch) turbine flow meter (Neptune, Tallassee, AL). Flow based samples were again collected using the ISCO 6712 automated sampler. The Neptune turbine meter was interfaced with the automated sampler using an ISCO 780 smart 4-20 Module (Teledyne ISCO, Lincoln, NE). The ISCO 6712 sampler had the capacity to interpret analog data from flow meters that output a 4-20 milliamp signal. The 780 Module allowed the flow signal to pace the sampler. The Neptune turbine flow meter, shown in Figure 11, was designed for full pipe flow and was capable of measuring a flow rate up to 756 liters per minute. The Tricon/E3 encoder (Neptune, Tallassee, AL) was attached to a register that will output an analog 4-20 milliamp signal. This signal was sent to the ISCO 780 4-20 milliamp module. Photos of the turbine meter and encoder are shown in Figure 11.

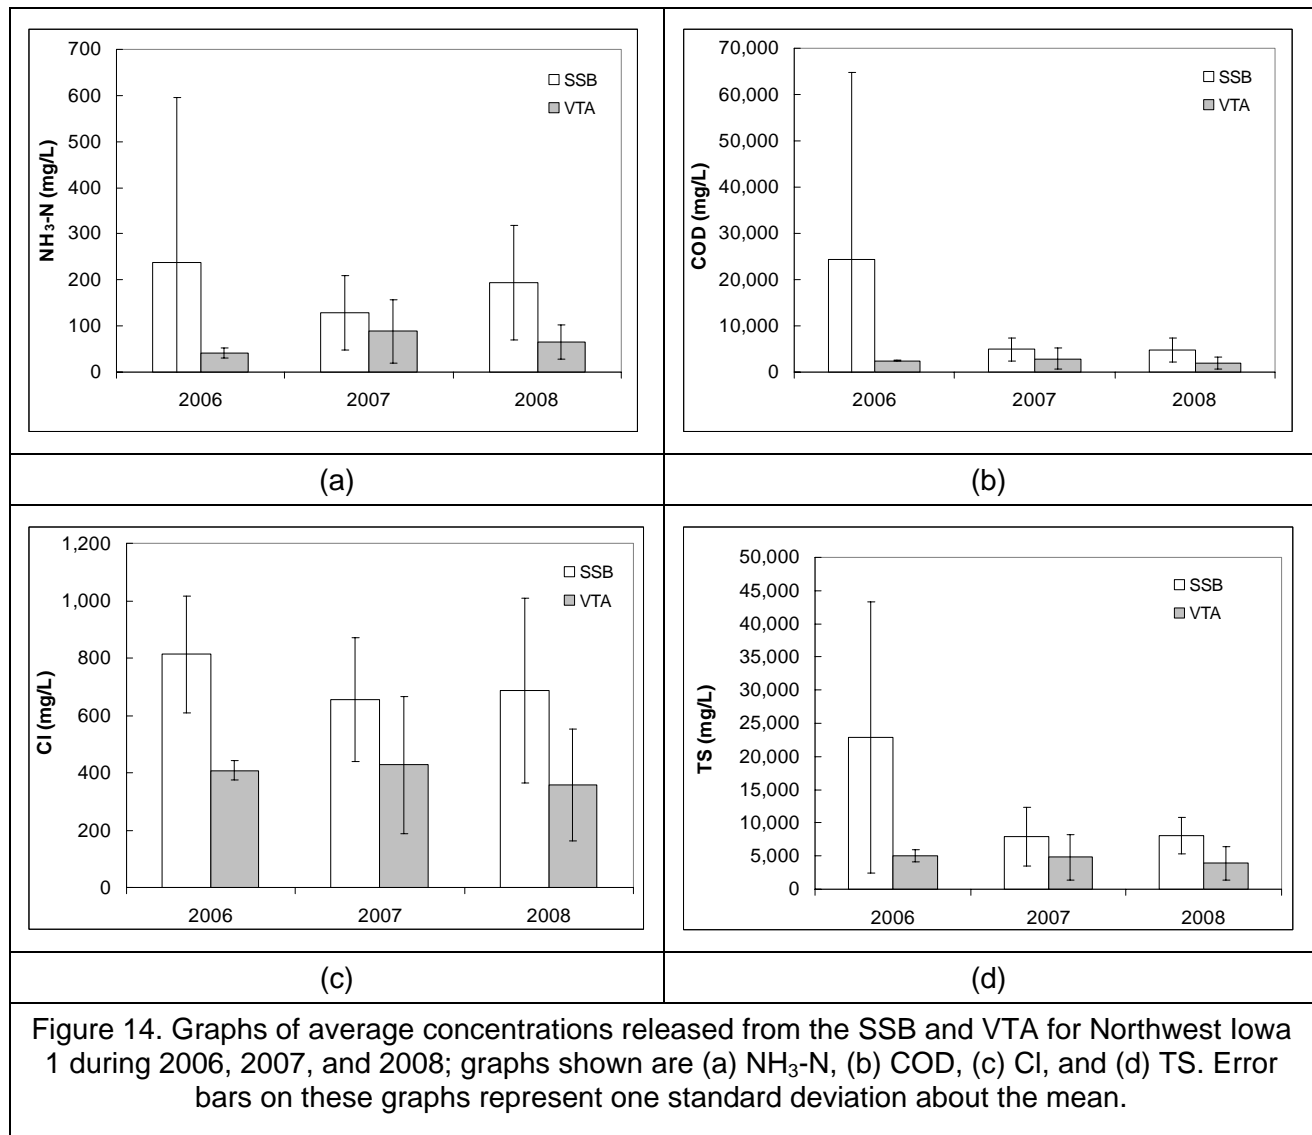
The average concentrations of effluent released from the solid settling basin tells a similar story to what we saw at the previous sites. Concentrations of COD and TS were substantially higher in 2006 than in 2007 and 2008 after a valve was installed at the settling basin outlet. This again seems to indicate that increasing the retention time in the settling basin increases the separation of solids and organic material. At this site, the longer retention time had little effect on ammonia-nitrogen and chloride concentrations. At this location, effluent concentrations released from the VTA have been relatively stable for all four parameters.

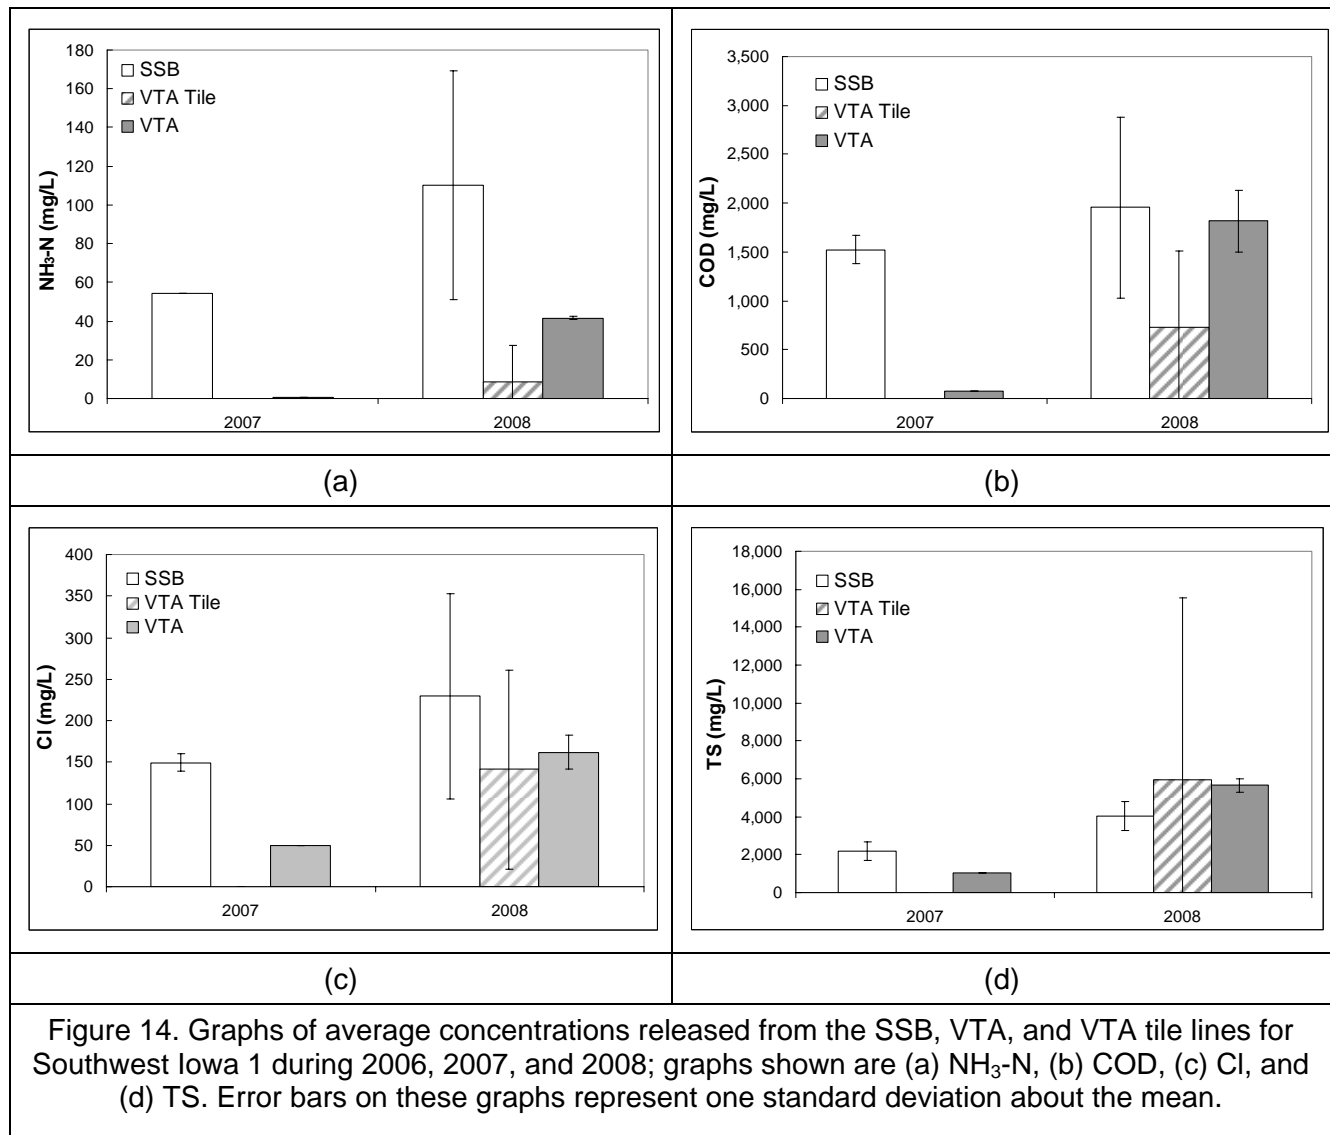
For Southwest Iowa 1 the results from 2007 only represent one month of monitoring data; the first real chance to examine how this system was performing was in 2008. To date, concentration reductions have been lower than at other sites. Only half of the VTAs had vegetation established going into the 2008 monitoring year and this may have contributed to the lower nutrient removal efficiencies. Also of note is the high variability in the tile line concentrations, especially as compared to the other sampling locations. This variability would seem to indicate that the concentration spiked after effluent was applied to the VTA but would then return to pre-application levels.

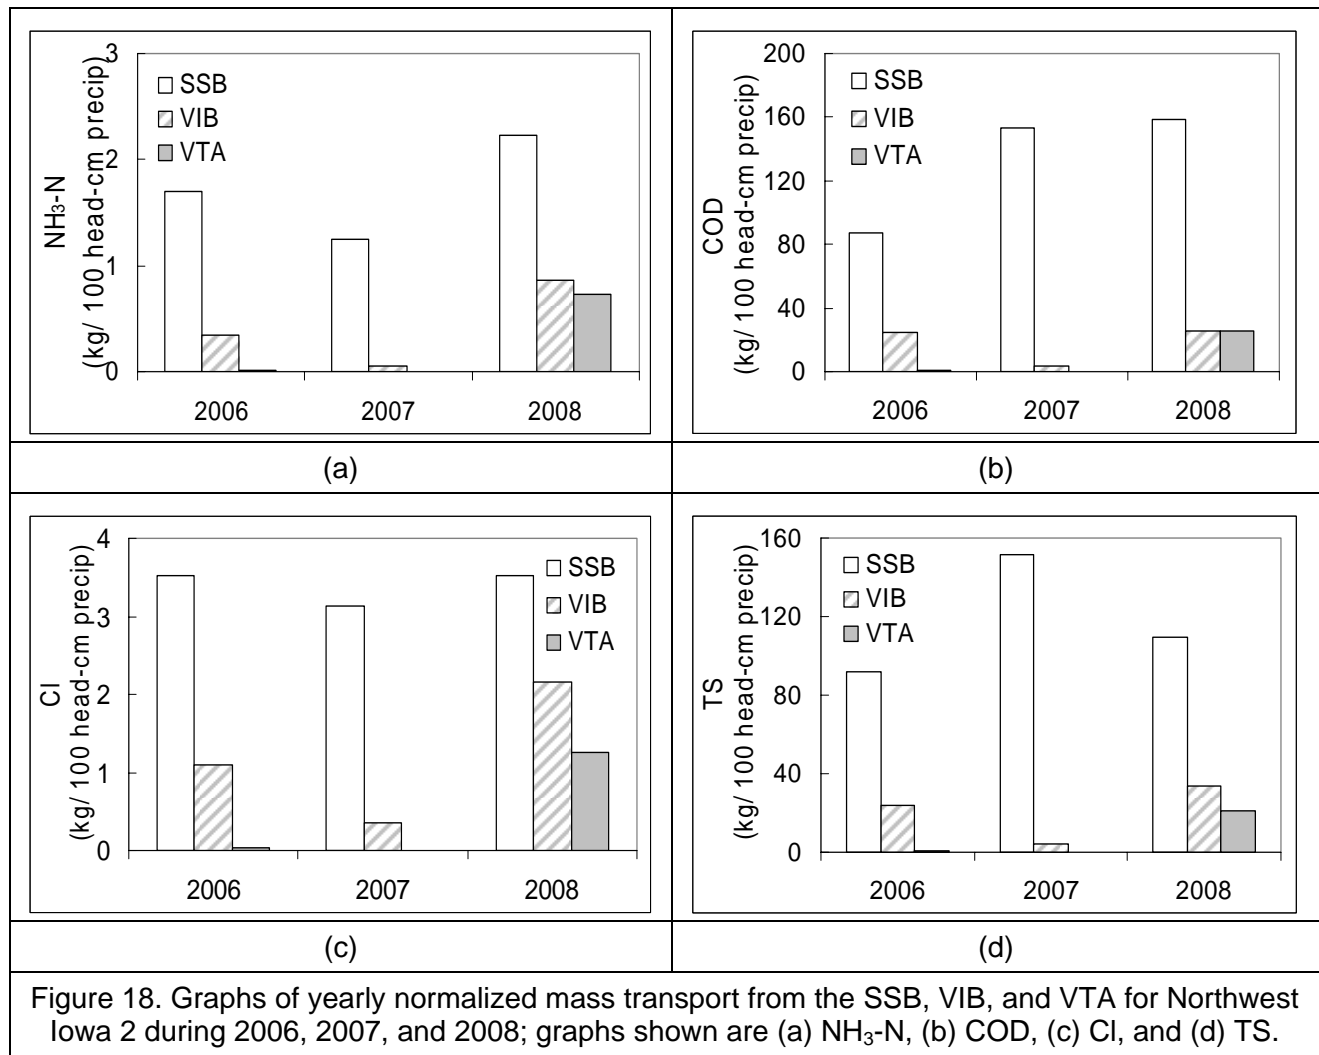
Figure 18. Graphs of yearly normalized mass transport from the SSB, VIB, and VTA for Northwest Iowa 2 during 2006, 2007, and 2008; graphs shown are (a) NH<sub>3</sub>-N, (b) COD, (c) Cl, and (d) TS.

Performance of the VTS at Northwest Iowa 2 has been relatively consistent over the three years with little to no release from the VTA during the first two years of monitoring. In 2008 the producer applied effluent to the VTA at a faster rate than in previous years. This resulted in effluent release from the VTA which was recycled back into the VIB. During this time period the producer had the outlet from his VIB opened. It is believed that this effluent was then pumped out to the top of the VTA and applied again where a large percentage of it again reached the outlet of the VTA. This recycling of effluent in the system causes the mass transport number for the VTA and VIB to be larger in 2008 than the otherwise would have been. Also, it appears the transport of total solids from the SSB was reduced in 2008. This in part can be attributed to the producer installing stop-blocks at the SSB outlet to improve settling and solids retention within the basin; however, this concentration reduction appears to have had no effect on the transport of ammonia, chemical oxygen demand, or chloride.

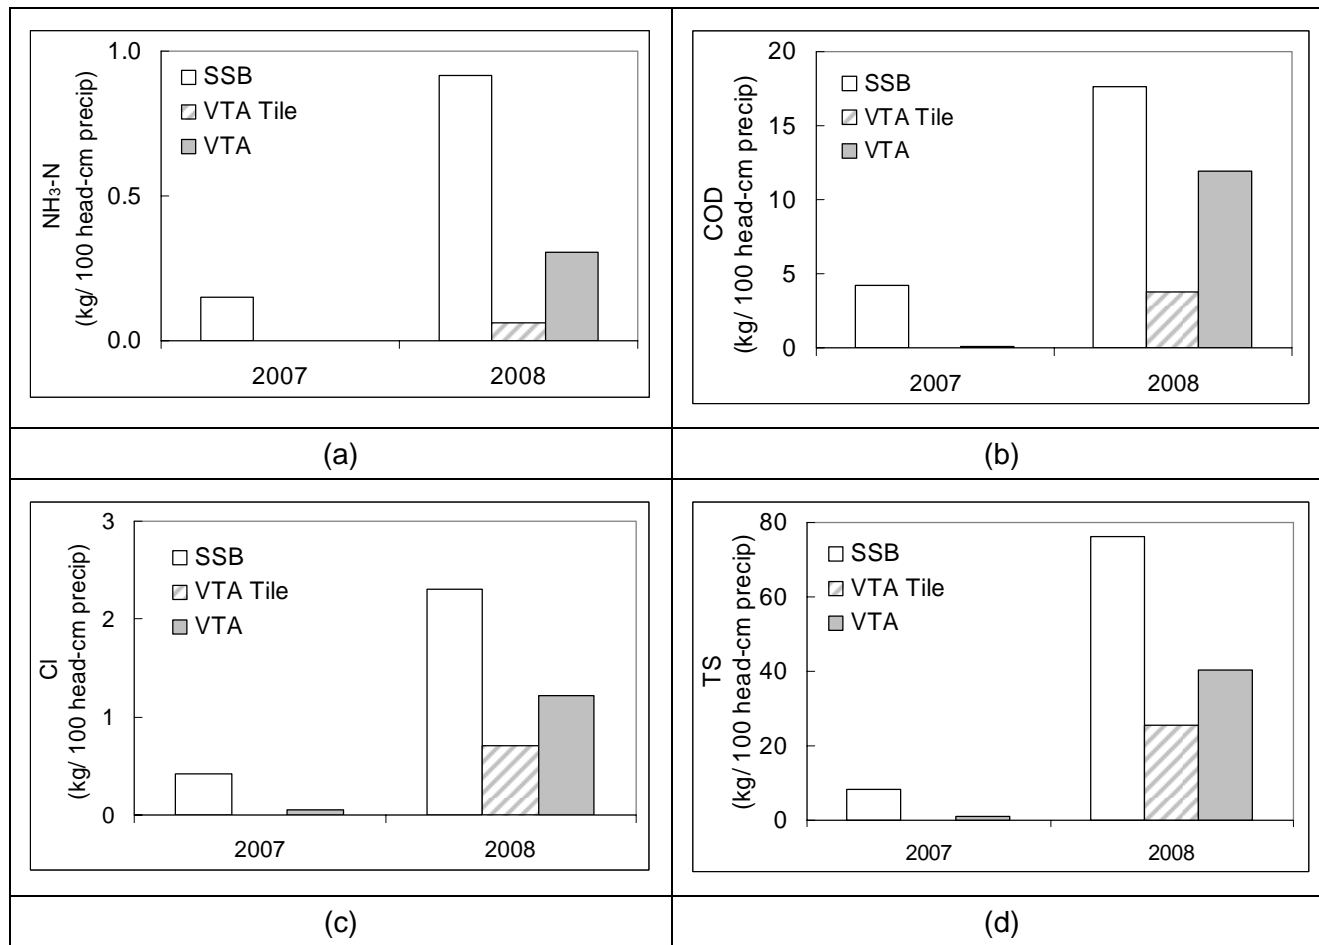
Figure 19. Graphs of yearly normalized mass transport from the SSB, VTA, and VTA Tile for SW IA 1 during 2006, 2007, and 2008; graphs shown are (a) NH<sub>3</sub>-N, (b) COD, (c) Cl, and (d) TS.

Southwest Iowa 1 was only monitored for from September through December in 2007, so it is hard to make year-to-year comparison with so little data in 2007. In 2008 this site experienced some setbacks in operation of the system; specifically breaches in both the berms surround the settling basin and the VTA. Transport from these events was estimated as described above. These events caused a substantial volume of the overall system release. One other item of note is that mass transport in the tile lines account for about ¼ of the total transport of these contaminants from the system. Although not shown, approximately 80% of all nitrate lost from this system was in the tile lines.
