HIGH FREQUENCY LONGITUDINAL AND SHEAR WAVE  
INSPECTION OF GAS TURBINE CERAMICS

Thomas Derkacs  
Thompson-Ramo-Wooldridge  
Cleveland, Ohio 44117

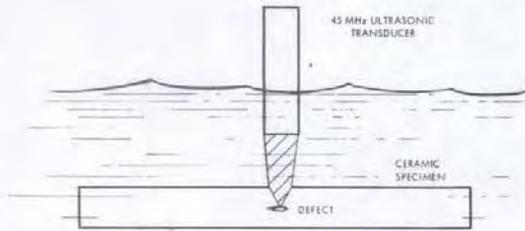
Figure 1. Pulse-echo longitudinal wave inspection is performed at 25 to 45 MHz using a focused ultrasonic transducer immersed in water. C-scan recordings are made of the results. This technique is more sensitive to defects oriented parallel to the surface that is normal to the transducer.

The basic technique developed employs an ultrasonic system operating in the pulse-echo mode at 25 to 45 MHz with a focused ultrasonic transducer. Figure 1 shows the arrangement for longitudinal wave inspection. The specimen and transducer are immersed in water with the transducer normal to the specimen surface. The transducer is scanned across the specimen and a C-scan recording is made of the results. We have found that for a 6.4 mm (0.25 inch) thick billet, scans are required at three focal planes to provide complete coverage. Because of the beam orientation, the strongest response is from a defect oriented parallel to the specimen surfaces. This, of course, is not usually the defect orientation of greatest interest. Figure 2 shows the arrangement for shear wave inspection. The same equipment is used, but the transducer is tilted at an angle (11° for hot pressed silicon nitride) in the direction of the scan. This results in a shorter ultrasonic wavelength for a given frequency and pro-

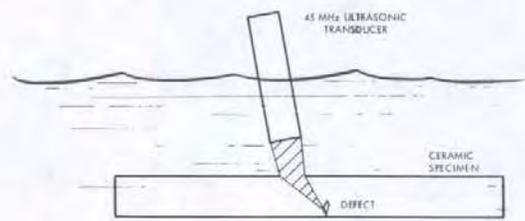
Figure 2. Pulse-echo shear wave inspection is performed using the same equipment, but with the transducer tilted at an angle of about  $11^\circ$  to the surface. This technique is more sensitive to defects oriented normal to the surface.

vides a beam in the specimen at about a 45 degree angle to the surface. This technique is more sensitive than the longitudinal wave technique and is better applicable to detecting defects which are oriented perpendicular to the specimen surfaces.

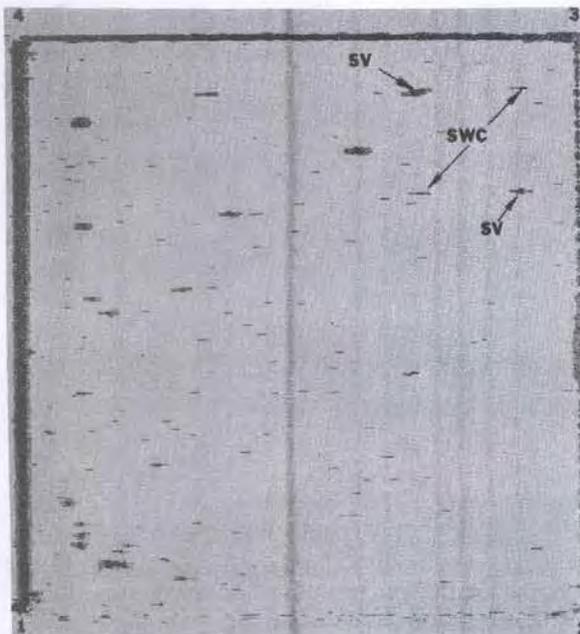
Figure 3. Typical C-scan recording of inspection results for a billet of Cerralloy 147A hot pressed silicon nitride showing seeded low density (SV) and high density (SWC)  $125 \mu\text{m}$  (0.005 inch) defects as well as numerous natural defects.

The following figures illustrate some of the capabilities of these techniques. The first group of six illustrate some of the work done on the NAVAIR sponsored program. Figure 3 shows a typical C-scan recording of a billet of Ceralloy 147A, hot pressed silicon nitride. This billet contained four seeded defects forming a 25 mm (1 inch) square near corner No. 3. Two of these defects, located on one diagonal, were 125  $\mu\text{m}$  (0.005 inch) diameter simulated voids (SV) consisting of aluminum oxide inclusions. The other two were 125  $\mu\text{m}$  (0.005 inch) diameter tungsten carbide inclusions (SWC). In addition to these seeded defects, a number of natural defects were detected in the billet. Figure 4 is a composite sketch showing each defect detected in the billet as a dot. The layout of four-point bend specimens is shown with specimen numbers on the outside of each specimen and the height of the ultrasonic pulse from the defect in cm on the inside. The pulse heights were obtained with the beam focused on the defect and are referenced to 4.0 cm for the reference simulated void. Figure 5 shows how each specimen was cut from the billet in order to place the defect near the tensile surface during testing. The 6.4 x 3.2 x 31.8 mm (1/4 x 1-1/4 inch) specimens were cut with the billet thickness as the 6.4 mm (1/4 inch) dimension and with the defect 380  $\mu\text{m}$  (0.015 inches) below the tensile surface.

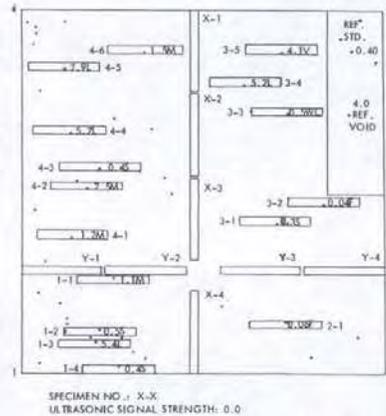
Figure 4. Sketch showing the defects detected in the billet of Cerralloy 147A, the four-point-bend specimens cut from the billet, and the ultrasonic signal strength of the defects located in the specimens.

Figures 6, 7 and 8 show fracture surfaces for specimens that initiated fracture at the ultrasonically detected defects. Figure 6 shows a 25  $\mu\text{m}$  (0.005 inch) tungsten carbide inclusion. The size and material of both these seeded defects were verified by electron microprobe analysis. The portion of the billet containing the other two seeded defects was saved for use as a reference standard as shown in Fig. 4.

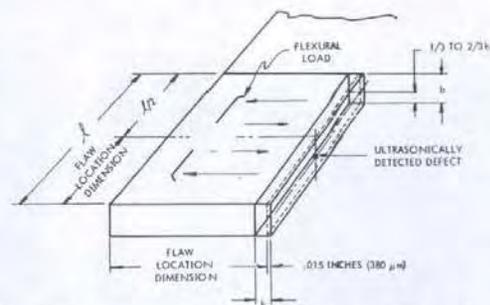
Figure 5. Sketch showing the method by which four-point-bend specimens were cut from the billet of Cerralloy 147A with ultrasonically detected defect located near the tensile surface.

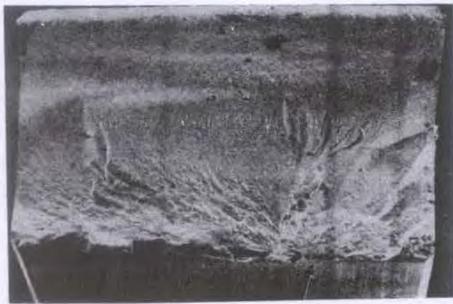
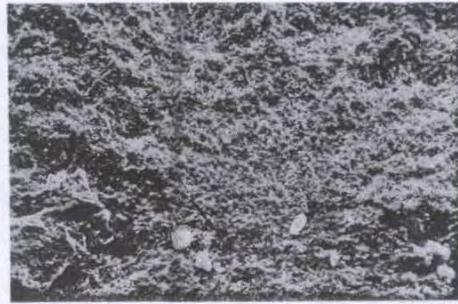
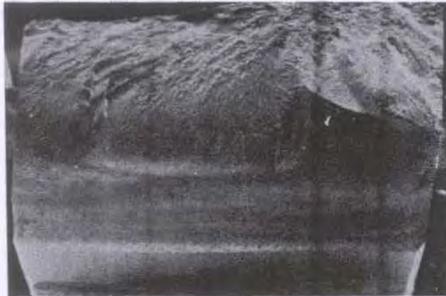
Figure 6. Fracture surfaces of specimen 1-4, showing fracture origin at ultrasonically detected 25  $\mu\text{m}$  (0.001 inch) void.

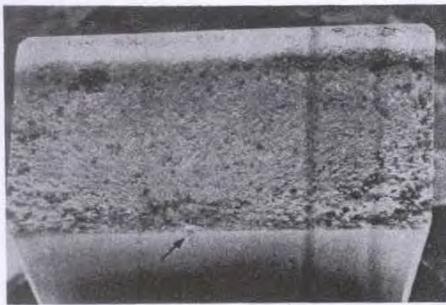
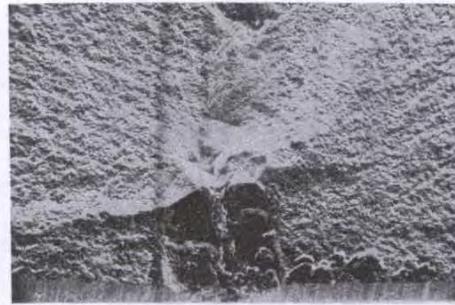
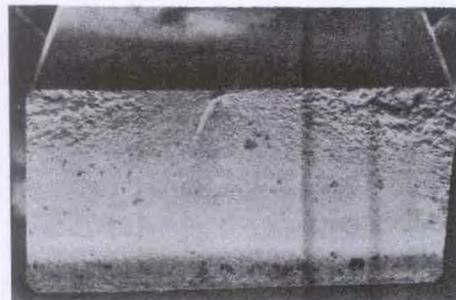
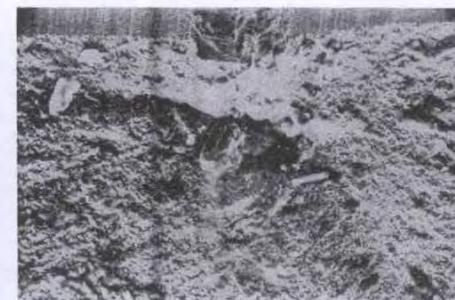
Figure 7. Fracture surfaces of specimen 3-5, showing fracture origin at seeded 125  $\mu\text{m}$  (0.005 inch) simulated void (aluminum oxide inclusion).

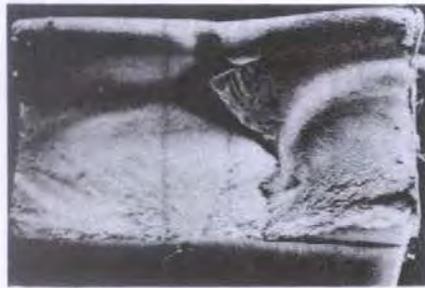
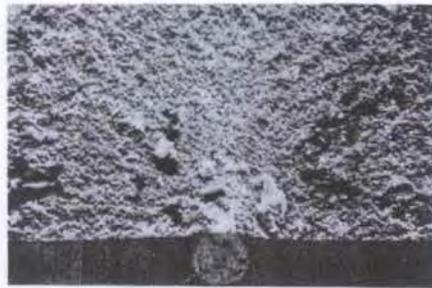
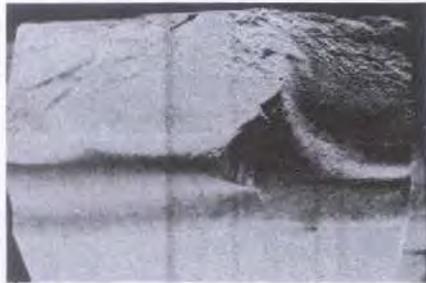
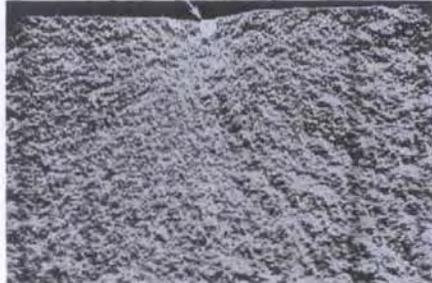
WC Seeded Defect

Figure 8. Fracture surfaces of specimen 3-3, showing fracture origin at seeded 125  $\mu\text{m}$  (0.005 inch) high density (tungsten carbide) inclusion.

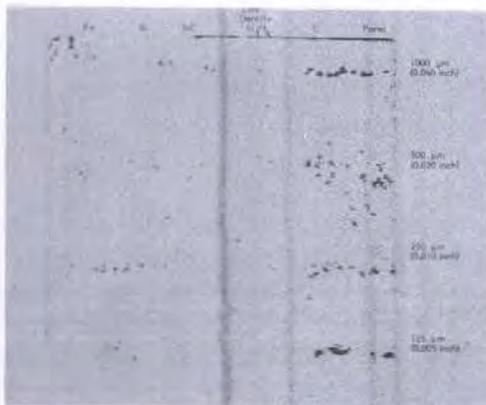
Figure 9. C-scan recording of 45 MHz longitudinal wave inspection results for Airesearch seeded billet of NC-350 reaction bonded silicon nitride.

Item 1 is almost complete and items 2 and 3 are in progress. Figures 9 through 12 show some of the results for item 1. Figure 9 shows the C-scan recording of the 45 MHz longitudinal wave inspection of a billet of NC-350, reaction bonded silicon nitride. The billet was seeded with Fe, Si, SiC, low density  $\text{Si}_3\text{N}_4$ , C and pores in sizes ranging from 125 to 1000  $\mu\text{m}$  (0.005 to 0.040 inches) as shown in the margins. Figure 10 shows the corresponding shear wave inspection results. Not only are the defect indications larger in Fig. 10, but there are a number of defect indications in Fig. 10 which do not appear in Fig. 9. This shows the superior sensitivity of the shear wave techniques. Although there are some blank areas where seeded defects are supposed to be, particularly for the low density  $\text{Si}_3\text{N}_4$  and the smallest size of Si and SiC, there is no way of knowing whether the defects are actually present until the billet is cut up.

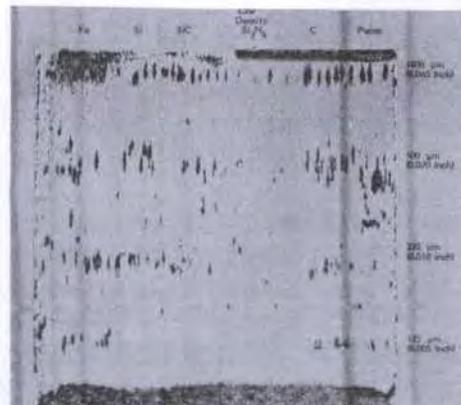
Figure 10. C-scan recording of 45 MHz shear wave inspection results for Airesearch seeded billet of NC-350, showing superior sensitivity of shear wave technique.

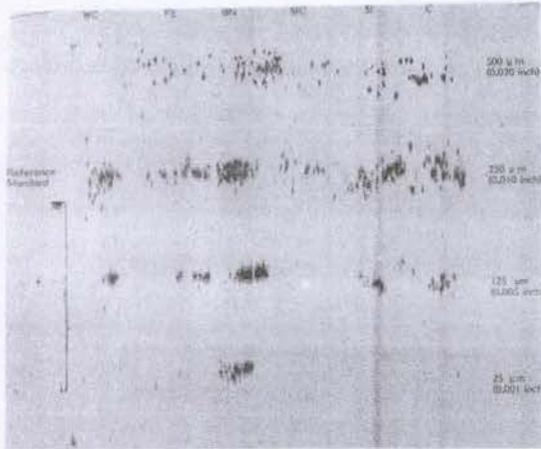
Figure 11. C-scan recording of 45 MHz longitudinal wave inspection results for Airesearch seeded billet of NC-132 hot pressed nitride.

Figures 11 and 12 show C-scans of 45 MHz longitudinal and shear wave inspections of a seeded billet of NC-132, hot pressed silicon nitride. In this case the seeded defects are WC, Fe, BN, SiC, Si and C in sizes ranging from 25 to 500  $\mu\text{m}$  (0.001 to 0.020 inches). Once again the shear wave inspection shows more defects than the longitudinal wave inspection. Although the actual defect sizes have yet to be verified by metallurgical evaluation, Fig. 12 offers additional evidence of the ability of high frequency ultrasonics to detect defects at least down to 25  $\mu\text{m}$  (0.001 inches) in size in hot pressed silicon nitride.

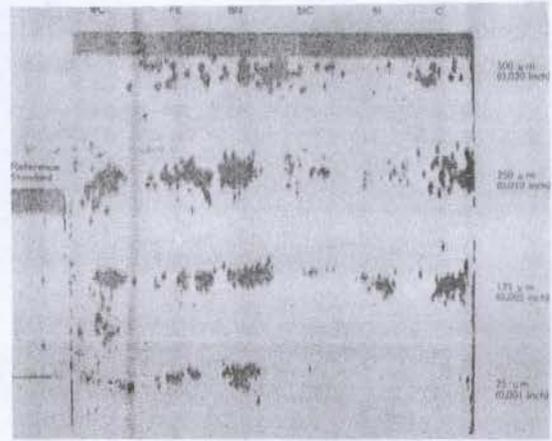
Figure 12. C-scan recording of 45 MHz shear wave inspection results for Airesearch seeded billet of NC-132, showing superior sensitivity of shear wave technique.
