ADVANCED MAGNETIC METHODS OF FLAW DETECTION

John R. Barton
Southwest Research Institute
San Antonio, Texas

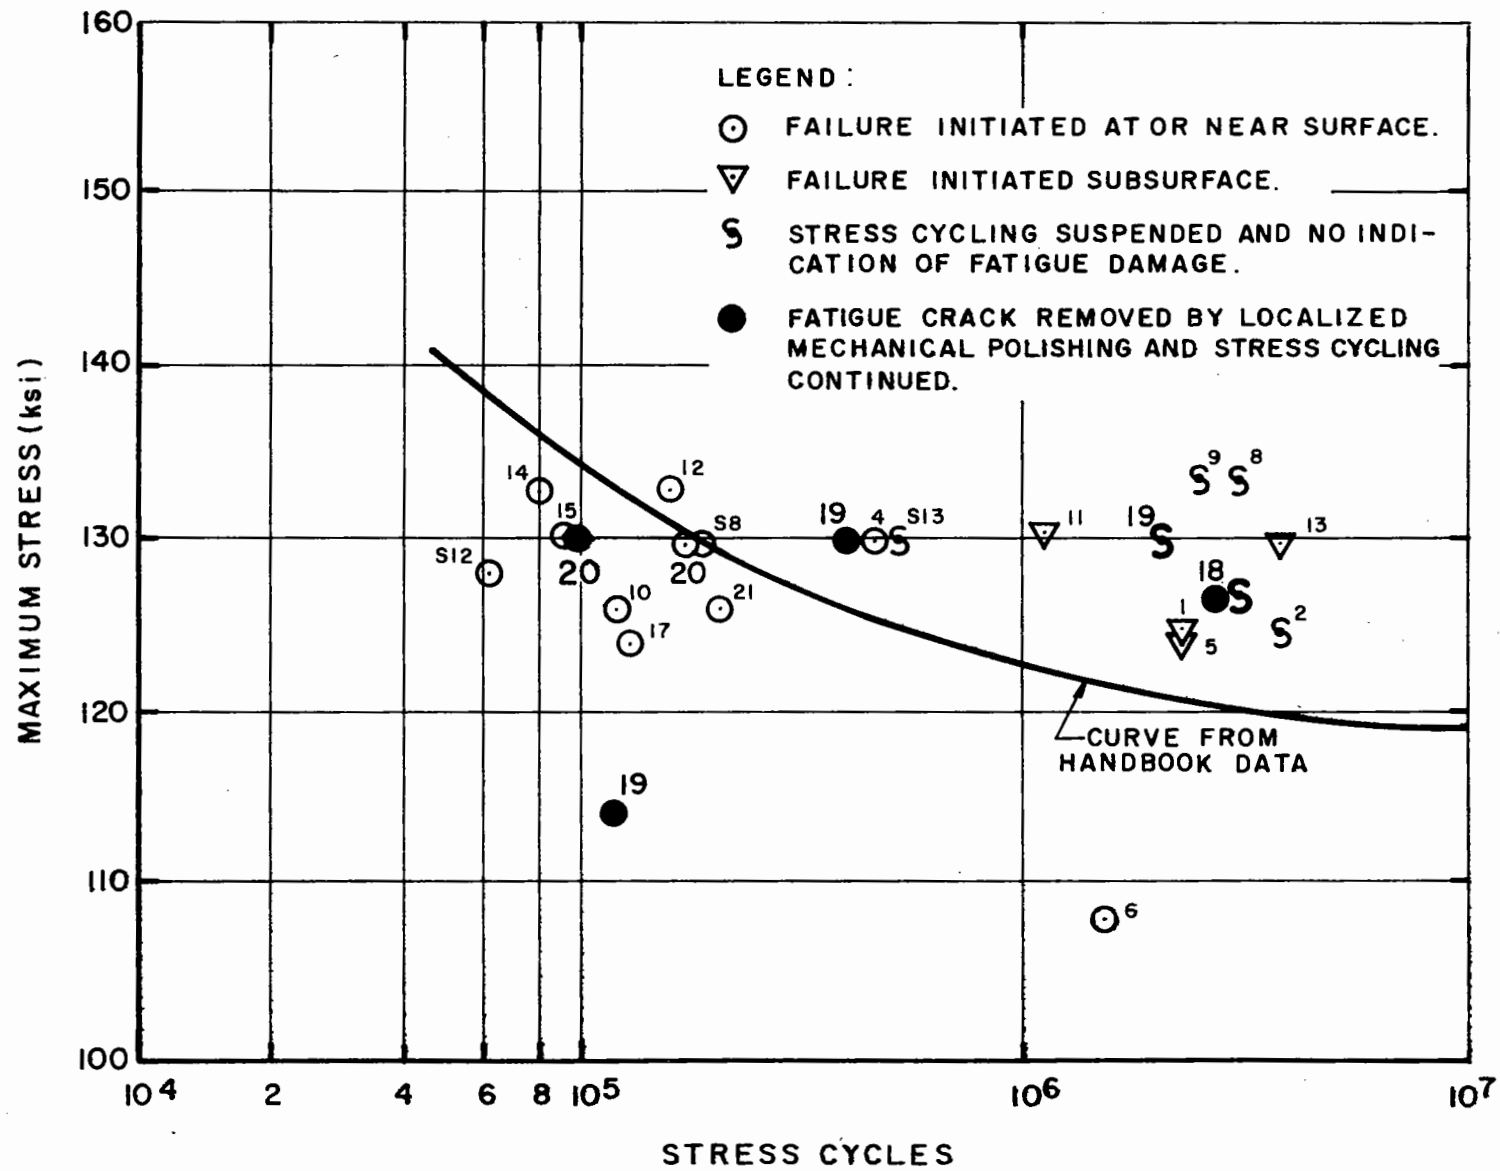
Fig. 7. S-N diagram on specimens.

I am going rather rapidly over this information because I think the main thing is to show the quantitative relationship. Figure 7 is an S/N diagram of a large number of these specimens. The points seem to be rather scattered, but statistically we find that our data points fit the handbook S/N curve fairly well as shown in Fig. 8. Usually, the specimen is not cycled to fracture. We take it to where a fatigue crack of approximately 0.010 to 0.015 inch in length has developed and then we polish out the crack to see where the next crack will initiate in the

In Specimen #20, Fig. 7 and Fig. 9C, the crack initiated at 68,100 cycles, and we plotted it at the 10^5 cycle point on the S/N curve, at which it would have fractured. The crack was removed and the specimen subsequently fractured at 180,000 cycles.

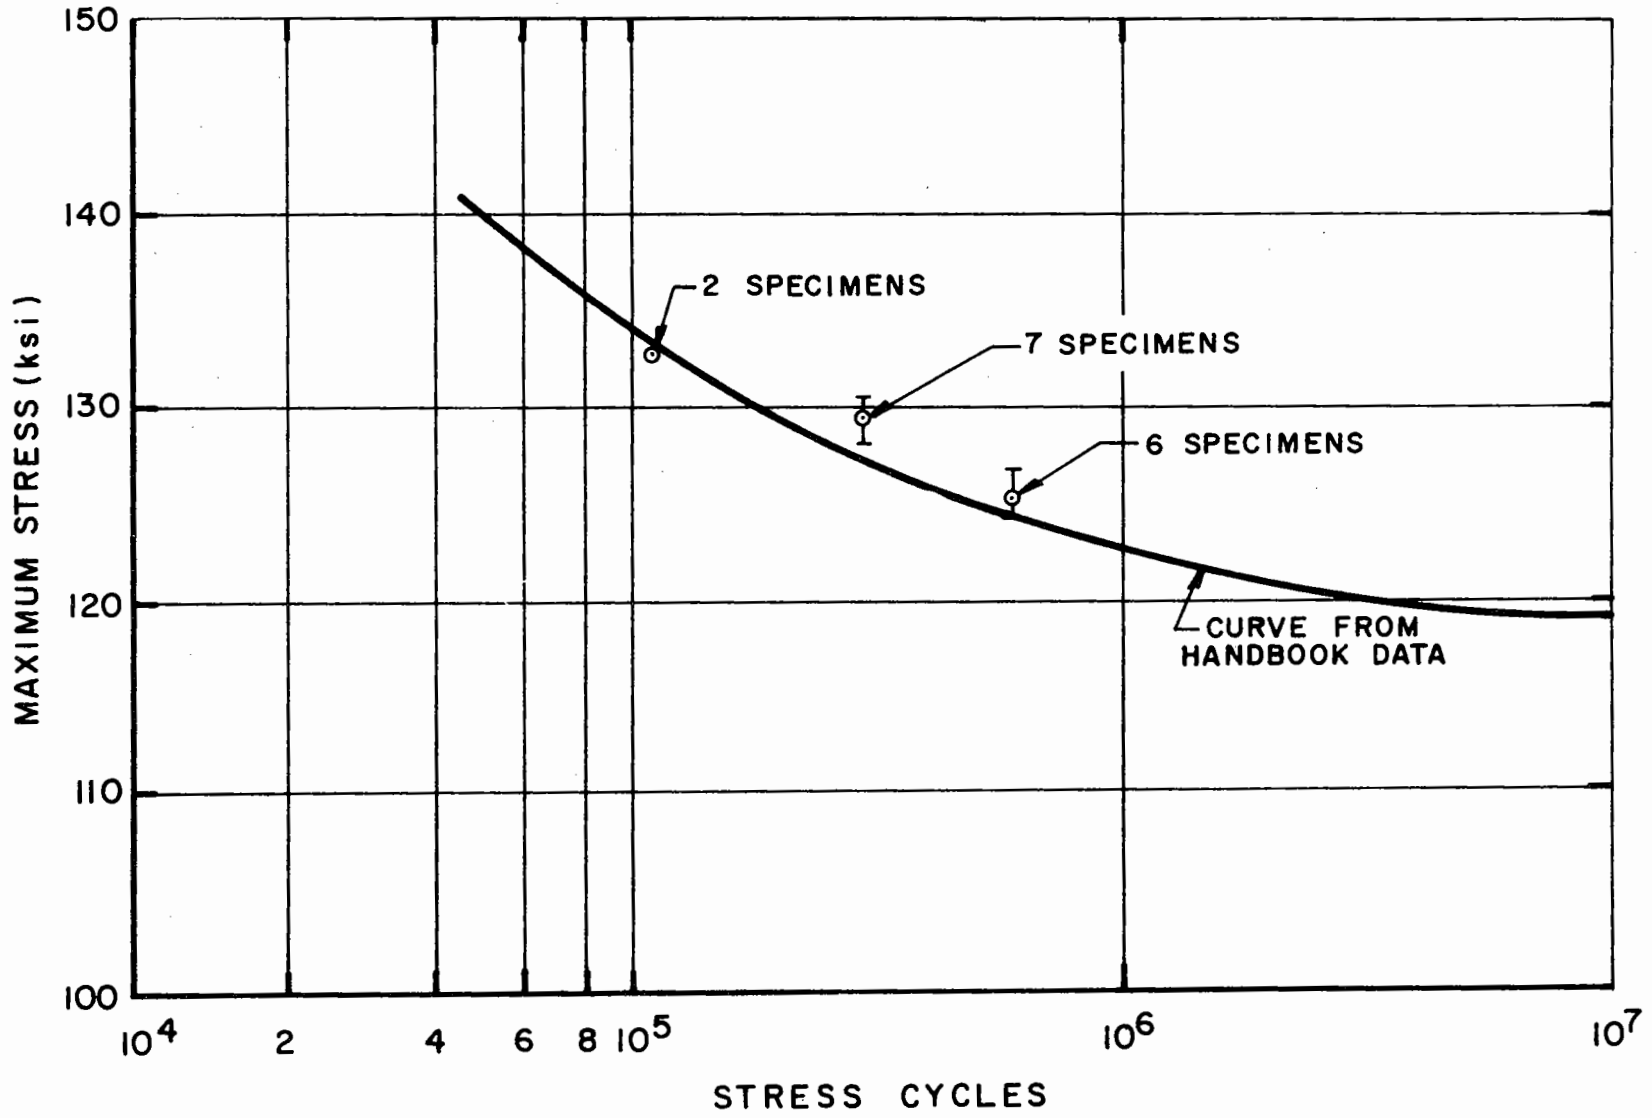
Fig. 8. Statistical comparison with handbook curve.

specimen. The vertical coordinate is the section stress at the inclusion-crack location and the horizontal coordinate includes the actual cycles plus the estimated cycles to fracture (usually 30,000 to 60,000 depending on crack length).

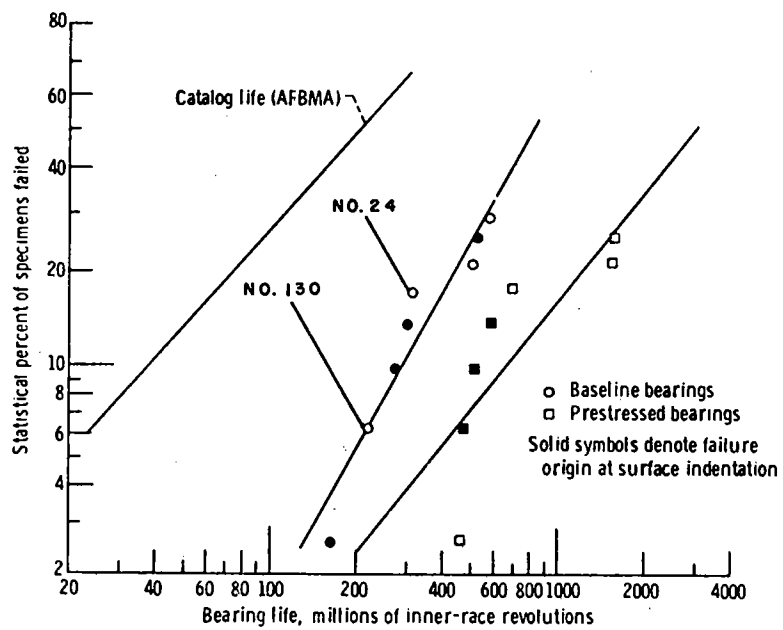
Fig. 19. Results of fatigue tests with 207-size ball bearings tested at a radial load of 5860 newtons (1320 lb) and a shaft speed of 2750 rpm with a super-refined naphthenic mineral oil.

In Fig. 19 Weibull plots are presented from a NASA report generated around some other data, but still based on these same bearings.

Only 54 of the 103 bearings were tested, and they were divided into two groups of 27 each. One group was subjected to a limited-time over-stress run prior to endurance testing; the other group was used to establish a baseline. These bearings were all better than the catalog-rated average life as seen in Fig. 19.

The catalog life data, I have been told, were generated some years ago and are not really of much use anymore since most bearings greatly exceed this life today. First we consider the Weibull plot on the baseline bearings. The only two failures that correlated with the magnetic perturbation signatures were specimens #130 and #24. The people at NASA Lewis were quite disappointed. They expected, I would presume, that all failures would be located at inclusion signatures. However, this was not the case and the basis of why this did not happen will be presented later.

On the Weibull plots, the solid symbols denote failure originating at a surface indentation. These are probably caused by debris in the oil or from some source; particles become interposed between the balls and the race, and what is known as an indentation is produced when the ball rolls over such particles. Indentations are very detrimental and cause many bearings to fail. If we eliminate from the baseline plot specimens which failed from indentations, only four points are left to define the Weibull plot and, accordingly, the statistical confidence is not high. Even so, with the statistics as they are, the important factor observed is that the first two failures obtained were specimens #130 and #24 at 6 percent life and 16 percent. These were, in fact, the only early failures in the whole group of bearings, and the early failures are the ones you would like to eliminate.
