## ULTRASONIC IMAGING ANALYSIS OF COMPONENT INTEGRITY

M.C. Tsao, R.H. Grills and R.P. Simpson

NDT Technology Development  
General Dynamics/Electric Boat Division  
Groton, CT

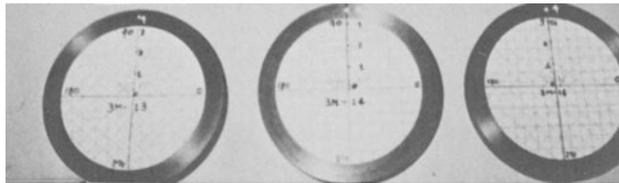
Figure 4(a).- Photo of composite flywheels

displaying the distributions of the signal amplitudes, the pattern of the color images can be correlated with the integrity of the component. Figure 4(a) shows the photo of three composite flywheels designed to store excessive kinetic energy for automotive vehicles during braking. The flywheel has three parts: the disk, the retaining ring and an aluminum hub glued at the

center of one side of the disk. The disk is made of multiple layers of fiber plies mixed with epoxy resins. The disk is then shrink-fit with a retaining ring made of wound plies of graphite fibers mixed with epoxy resins. Figure 4(b) shows the ultrasonic image of the interior structure pattern of the flywheel. The blue and green colors represent the high amplitudes of the ultrasonic signals echoed from the bottom surface of the flywheel, and in turn, they represent the good bonding characteristics of the structure. Around the ring-edge and ring-disk interface areas, only a small portion of the transducer is encountered over the tested area, and hence on these areas, the signal amplitudes are small. Small signal amplitudes are represented by red and pink colors. Aside from the ring-edge and ring-disk interface areas, the red and pink colors represent areas where microvoids are concentrated through the disk thickness such that the ultrasonic signals are attenuated by the clustered microvoids. The flywheel was then spin tested up to 35000 RPM to evaluate the structure integrity at these speeds. In one case, as shown in Figure 4(c), the aluminum hub was separated from the disk and a band of fiber ply was torn from the disk top surface. Figure 4(d) shows the
