Ultrasonic Detection of Surface Flaws in Gas Turbine Ceramics

Thomas Derkacs
Thompson-Ramo-Wooldrige

Derkacs, Thomas and Matay, I. M., "Ultrasonic Detection of Surface Flaws in Gas Turbine Ceramics" (1980). *Proceedings of the DARPA/AFML Review of Progress in Quantitative NDE, July 1978–September 1979*. 101.
http://lib.dr.iastate.edu/cnde_yellowjackets_1979/101

This paper presents the results of a program sponsored by NADC for NASC to develop an ultrasonic surface wave technique for detection of small flaws, $<100\ \mu\text{m}>$ ($<0.004\ \text{inch}>$), in gas turbine quality ceramics. A 45 MHz ultrasonic surface wave inspection technique is described, which employs immersion scanning and C-scan recording. Inspection results are presented using this technique on specimens of hot pressed Silicon nitride and silicon carbide, from two sources each, and reaction bonded silicon nitride. Results are also presented of four-point-bend tests and scanning electron micrography, which were used to identify defect sizes and types and to correlate flexural strength with inspection results. The flexural strength is shown to correlate, at least qualitatively, with the extent of ultrasonic resp

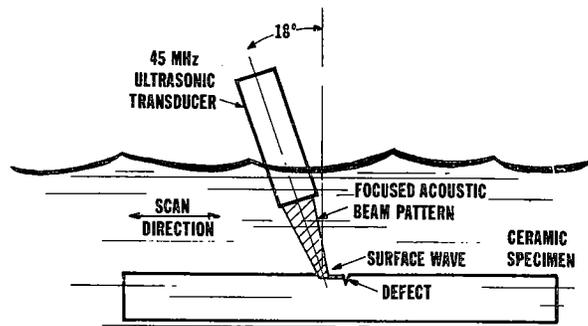
Fig. 1 Immersion 45 MHz Ultrasonic Surface Wave Technique.

Ultrasonic surface wave inspection at conventional frequencies is normally a manual, contact operation in which no provision is made to automatically correlate defects with their locations in the part. This is necessary because immersion testing is not usually possible. A surface wave traveling on a part submerged in water radiates energy into the water and quickly dissipates. The method used in this program to overcome this limitation is illustrated in Fig. 1. The transducer used was an Aerotech Laboratories 45 MHz alpha transducer with a focal length of 1.8 inches in water and a beam spot size at half-amplitude of .023 inches ($580 \mu\text{m}$). The transducer and part were submerged in water and the transducer was tilted at an angle to the entry surface of about 18° in order to generate surface waves in the specimen by mode conversion. The water path was set so that the beam was focused in the material a short distance past the point of entry. This provides the shortest possible path length and therefore the minimum possible loss in a reflected pulse from a surface defect. The ultrasonic defect gate was set to encompass only the transducer focal point, so that as the

transducer was scanned over the part a defect indication was recorded only when the beam was focused on the defect.

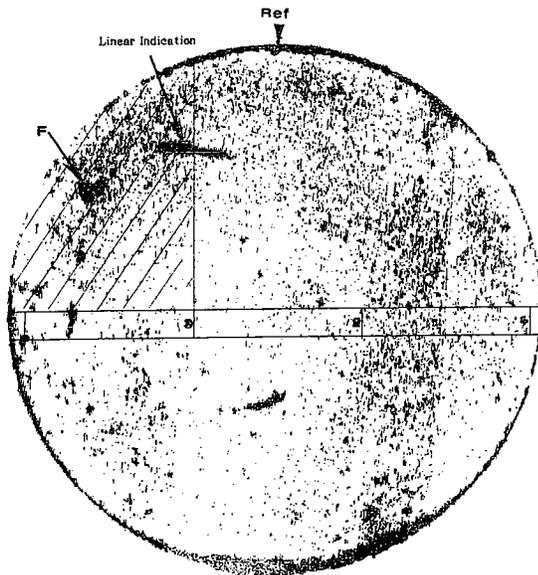
Fig. 2 Machined (Shaded) Area Overlaid on C-Scan Recording of 45 MHz, 18° Surface Wave Inspection of Top Surface of Billet of NC-350 RBSN.

Initial evaluations were performed to demonstrate that the technique does indeed generate surface waves. A simple test was to make a recognizable mark, such as a number or letter, on the surface of a ceramic specimen with a grease pencil. Then when the part was inspected, the mark showed up as a defect indication. This technique points out the importance of cleanliness. Any air bubble or dust particle on the part surface shows up as a defect indication. We adopted the policy of individually checking significant defect indications by brushing the surface to make sure the "defect" could not be removed. A more sophisticated technique for ensuring the presence of surface waves was to inspect a billet to locate surface flaws and then to machine off a thin layer and re-inspect the part. Figures 2 and 3 show an example of this technique. Figure

2 shows a C-scan recording of a 45 MHz ultrasonic surface wave inspection of a 7 1/2 inch (19 cm) diameter billet of NC-350 reaction bonded silicon nitride (RBSN). After inspection the billet was cut to remove the three numbered specimens and the left hand side was machined to remove 0.0006 inches (15 μ m) in the shaded area. The machining was done to split the linear indication in that portion of the billet. The grinding was perpendicular to the cut edge. Figure 3 shows the same portion of the billet after machining. The linear indication was removed in the machined area while remaining in the unmachined area. It is apparently less than 0.0006 inches (15 μ m) deep. The defect indication labelled F was reduced in size but not removed. This defect is apparently greater than 0.0006 inches (15 μ m) deep. The inspection technique was also found to be sensitive to machining damage. Figure 4 shows a scan of the same part made parallel to the cut edge and therefore perpendicular to the machining direction. In this case the entire machined area appears defective. This is a significant fact, since it is known that flexural strength specimens ground parallel to their major axis are stronger than those ground perpendicular to their major axis. Figures 3 and 4 indicate that the surface wave technique is sensitive to this difference in grinding direction and therefore to strength.

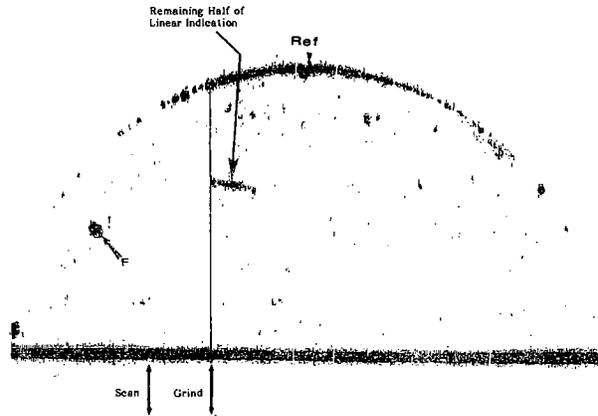
Fig. 3 C-Scan Recording of 45 MHz, 18° Surface Wave Inspection of Top Surface of Segment of Billet of NC-350 RBSN Containing Machined Area (Scan Parallel to Grinding Direction).

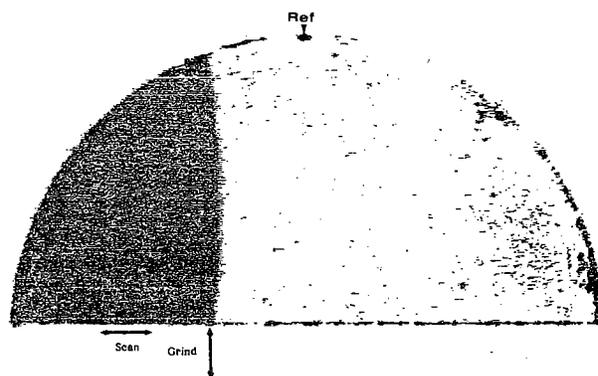
Fig. 4 C-Scan Recording of 45 MHz, 18° Surface Wave Inspection of Top Surface of Segment of Billet of NC-350 RBSN Containing Machined Area (Scan Perpendicular to Grinding Direction).

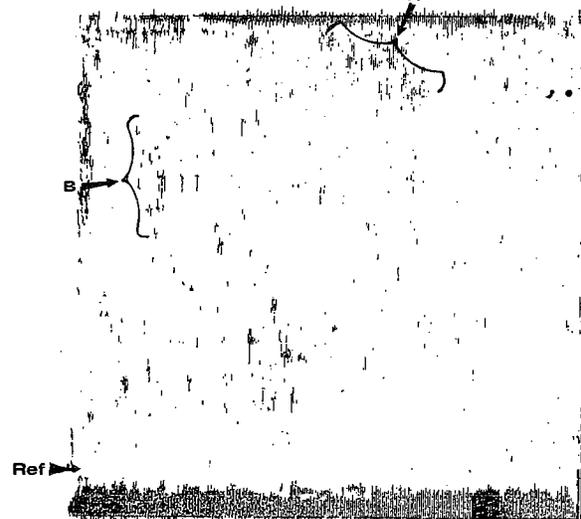
Fig. 5 C-Scan Recording of 45 MHz, 18° Surface Wave Inspection of Billet of Ceralloy 147A Hot Pressed Silicon Nitride (notch up).

Figures 5, 6 and 7 show another billet that was used to verify the presence of surface waves. This is a billet of Ceralloy 147A hot pressed silicon nitride (HPSN) which was received in the as-pressed condition and then was machined to remove a total of about 0.040 inches (1000 μ m) to provide smooth surfaces on both sides. The areas of heavy concentrations of indications in Fig. 5 correspond to the areas shown in the photomicrographs (7X) of Fig. 6 which contain surface ridges left by the pressing operation. After machining these ridges away, the indications in areas A and B disappeared. The billet of Ceralloy 147A HPSN was inspected by both shear and surface waves before machining and by surface waves after machining. A comparison of the before and after surface wave inspections shows no significant correlation in indications. This is to be expected given the amount of material removed. A comparison of the shear wave

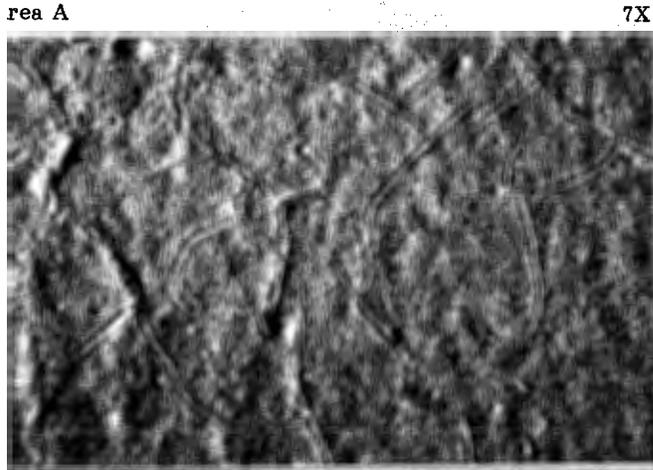
Area A 7X
Area B 7X
Fig. 6 Photomicrographs Showing Surface Condition of Two Typical Areas of As-Pressed Billet of Ceralloy 147A HPSN Where Large Numbers of Surface Wave Indications Were Detected.

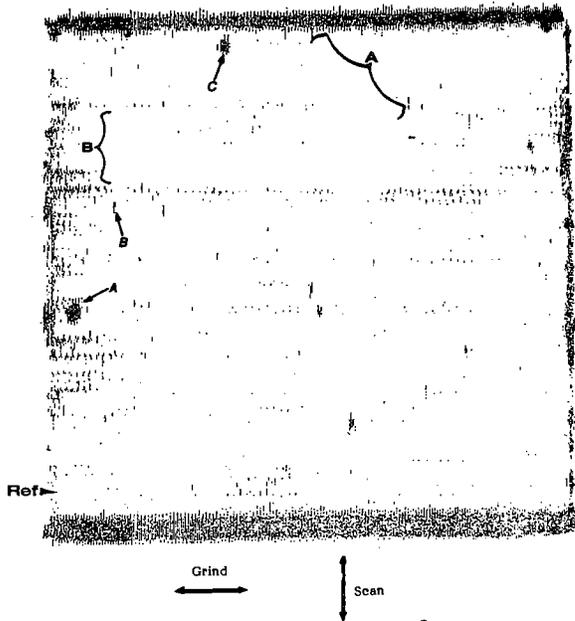
Fig. 7 C-Scan Recording of 45 MHz, 18° Surface Wave Inspection of Top Surface of Billet of Ceralloy 147A HPSN After Machining (Scan Perpendicular to Grinding Direction).

results before machining and the surface wave inspections after machining show a number of corresponding indications. The defects labelled A, B and C in Fig. 7, for example, correspond to defect indications in the corresponding shear wave scan.

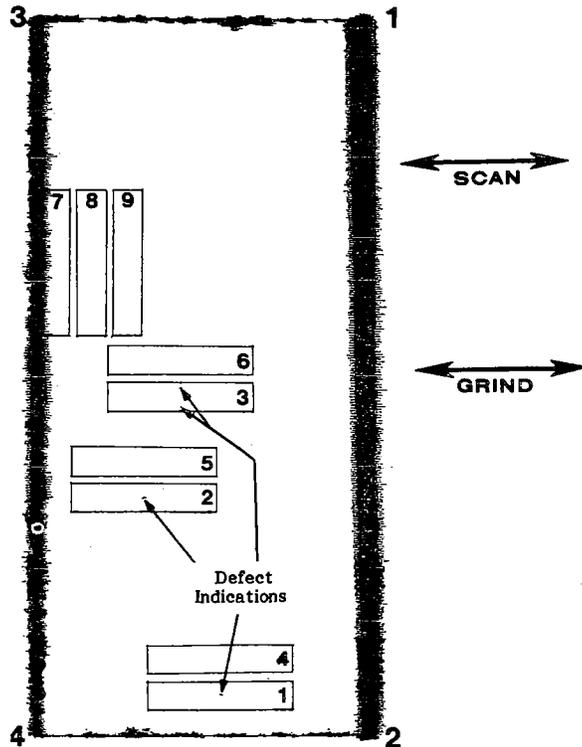
Fig. 8 C-Scan Recording of 45 MHz Ultrasonic Surface Wave Inspection of Bottom of Billet of NC-132 HPSN (Scan Parallel to Grinding Direction).

Billets of NC-132 and Ceralloy 147A HPSN, NC-350 RBSN, NC-230 and Ceralloy 146 hot pressed silicon carbide (HPSiC) and boron doped sintered SiC were inspected using the surface wave technique. In each case inspections were made on both major surfaces both parallel and perpendicular to the grinding direction. Fig. 7 is the result of a scan made perpendicular to the grinding direction in the billet of Ceralloy 147A HPSN. In this case the sensitivity was reduced so only the most severe grinding damage was detected, thereby allowing the individual defects to also be seen. Figures 8 and 9 show the inspection results for one surface of the billet of NC-132 HPSN. The rectangles in these figures represent four-point-bend specimens machined from this billet. Figure 8 shows a defect-free billet except for very tiny indications in specimens 1, 2 and 3. Figure 9 shows a scan of the same surface perpendicular to the grinding damage. Figure 10 shows the nine bend specimens after machining. This scan was made parallel to the major axis so as to be sensitive to strength controlling defects. The contrast between grinding directions is readily apparent. Similar results were obtained for the other materials tested.

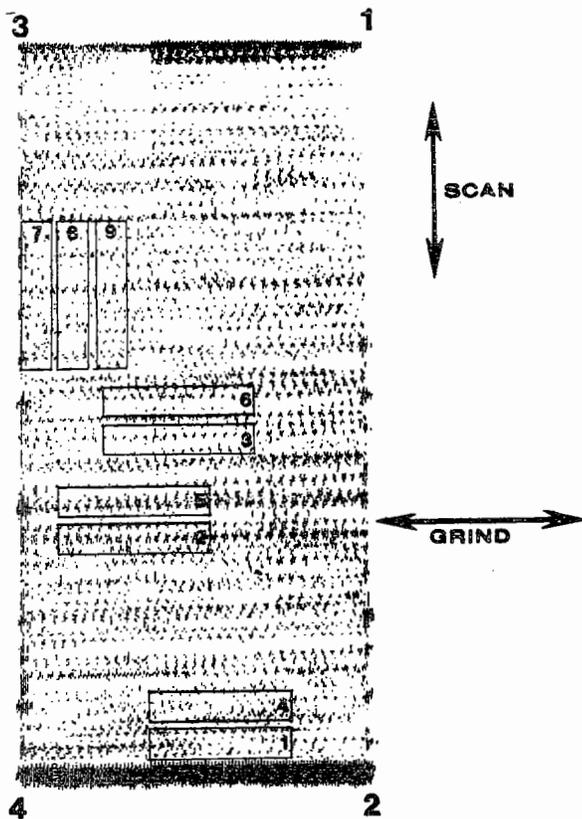
Fig. 9 C-Scan Recording of 45 MHz Ultrasonic Surface Wave Inspection of Bottom Surface of Billet of NC-132 HPSN (Scan Perpendicular to Grinding Direction).

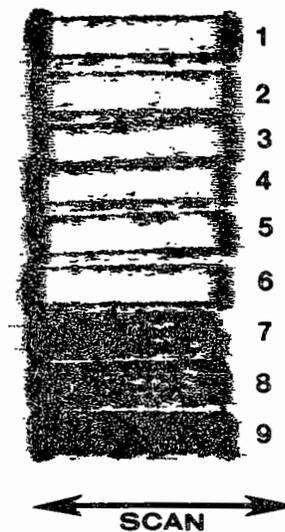
Fig. 10 C-Scan Recording of 45 MHz Ultrasonic Surface Wave Inspection of Tensile Surfaces of NC-132 HPSN Four-Point-Bend Specimens.

parallel to the major axis on all surfaces except the tensile surface, which was left as inspected. The specimens were also chamfered 0.005 inches (125 μm) at 45° on the edges. One specimen of each material machined parallel to the major axis was given a 1 kg Vicker's indentation and one specimen of each machined perpendicular to the major axis was given a 50 kg Vicker's indentation. With the quality of surfaces involved (all billets had originally been machined with a 320 grit diamond wheel) only the 50 kg Vicker's could be resolved ultrasonically.

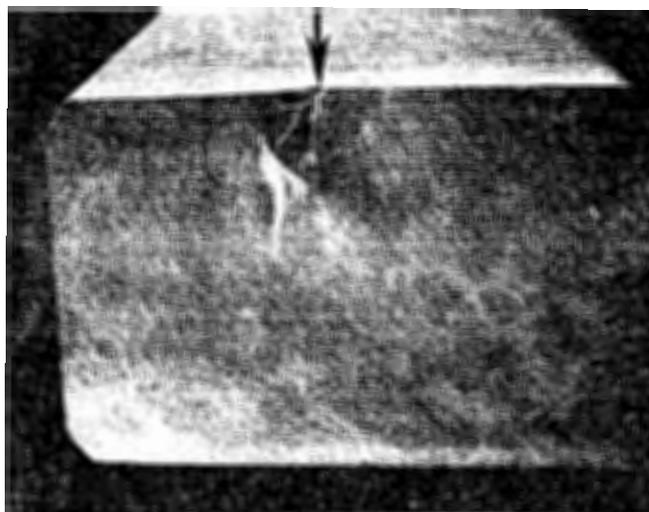
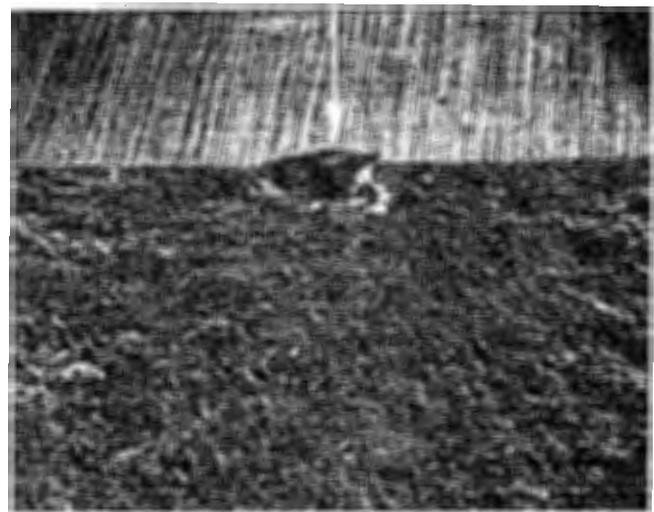
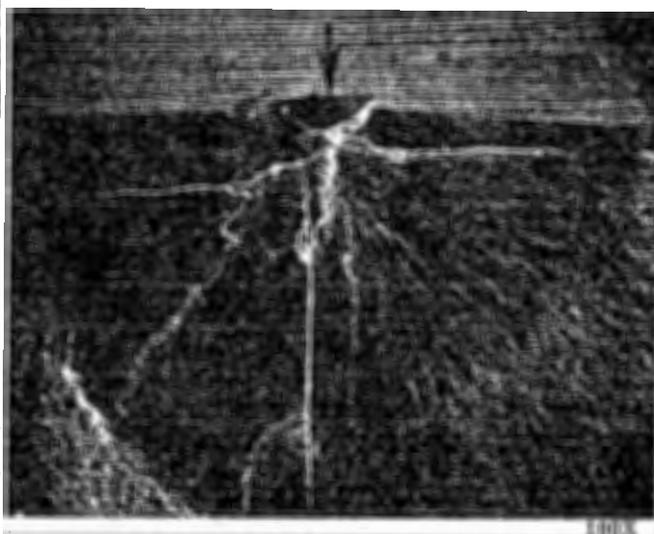
Fig. 11 Fracture Surface of Ceralloy 147A Specimen No. 2 Showing Ultrasonically Detected Surface Pit at Fracture Origin.

Fig. 12 Fracture Surface of Ceralloy 147A HPSN Specimen No. 9 Showing Fracture Origin at 50 kg Vicker's Indentation.

The four-point-bend tests along with SEM fractography provided data on material strength, fracture origin location with respect to indication location and the nature and size of fracture origins. From this data it was possible to correlate a number of strength limiting defects with their ultrasonic responses. Figures 11 through 16 show some typical ultrasonically detected fracture origins. Figure 11 shows a surface pit in specimen #2 of Ceralloy 147A HPSN. It is about 0.0072" (180 μm) across and 0.0030" (75 μm) deep. Figure 12 shows a typical 50 kg Vicker's indentation; a pit about the same size as in the previous specimen with a crack extending over 0.020 inches (500 μm) deep in the part. Figure 13 shows the 1 kg Vicker's indentation in the same material, an approximately 0.002 inch (60 μm) deep crack. Figure 14 shows a 0.020 inch (500 μm) wide by 0.012 inch (300 μm) deep area of very large grains in specimen #3 of Ceralloy 147A HPSN. Figure 15 shows a flake-like inclusion about 0.0004" (10 μm) thick and 0.0028" (70 μm) wide located 0.0008" (20 μm) below the surface. This is defect A in Fig. 7. Figure 15 shows the smallest defect correlated with an ultrasonic indication, a 0.0006" (16 μm) wide by 0.0008" (20 μm) deep area of large grains at the surface in specimen #1 of NC-132 HPSN (see Fig. 8 for the indication). A defect of about this same size was the largest one found at a fracture origin that could not be correlated with an ultrasonic indication. This suggests that this size defect may not have a high probability of being detected.

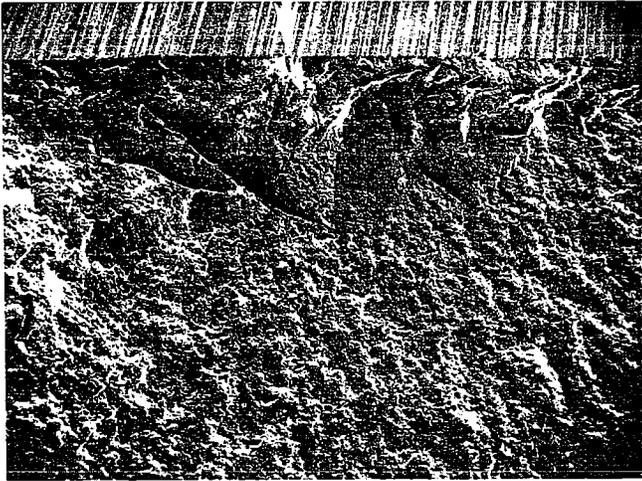
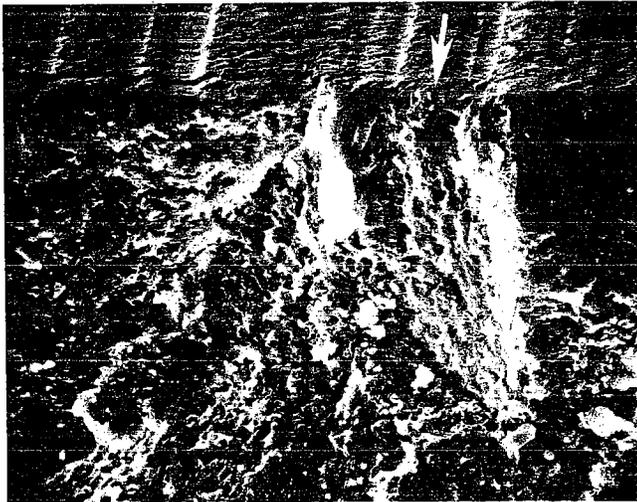
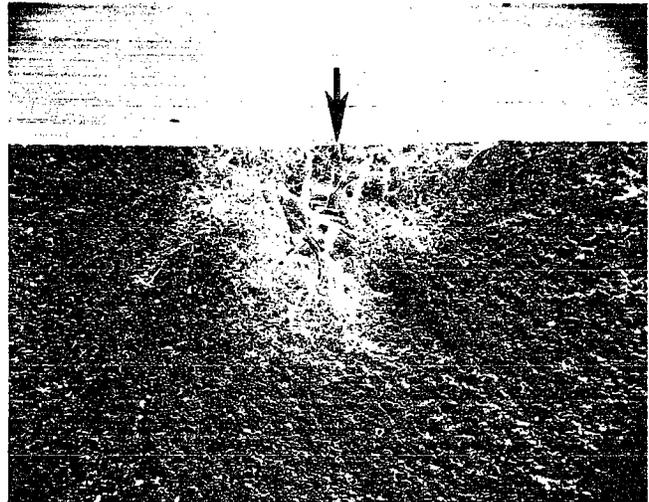
Fig. 13 Fracture Surface of Ceralloy 147A HPSN Specimen No. 6 Showing Fracture Origin at 1 kg Vicker's Indentation.

Fig. 14 Fracture Surface of Ceralloy 147A HPSN Specimen No.3 Showing Ultrasonically Detected Fracture Origin.

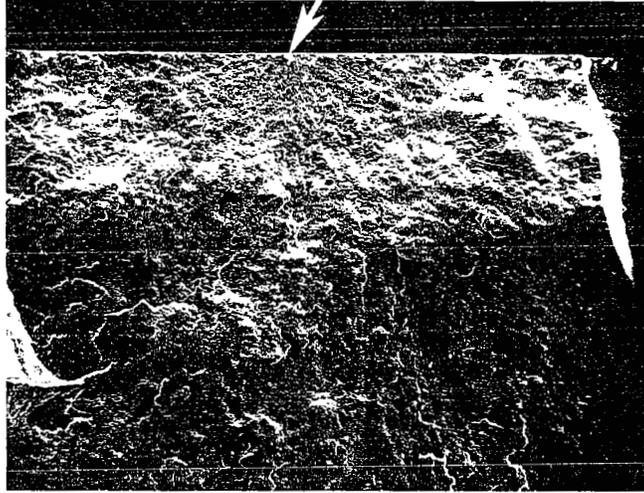
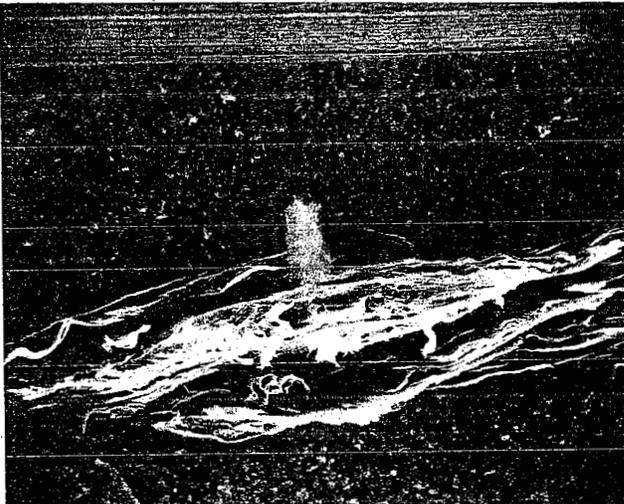
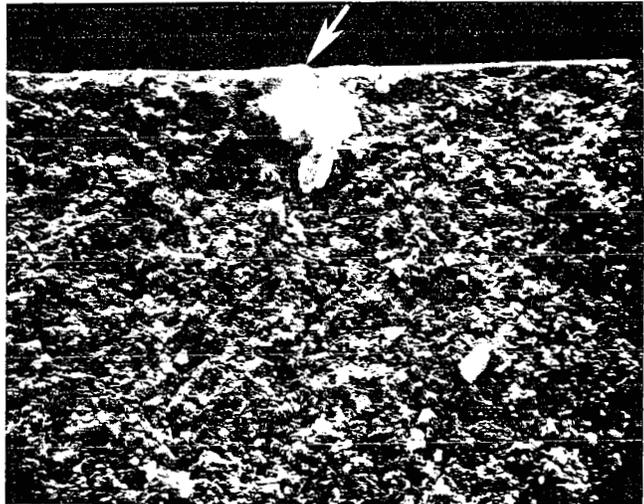
Fig. 15 Fracture Surface of Ceralloy 147A HPSN Specimen No. 4 Showing Ultrasonically Detected Fracture Origin.

Fig. 16 Fracture Surface of NC-132 HPSN Specimen No. 1 Showing Ultrasonically Detected Fracture Origin.

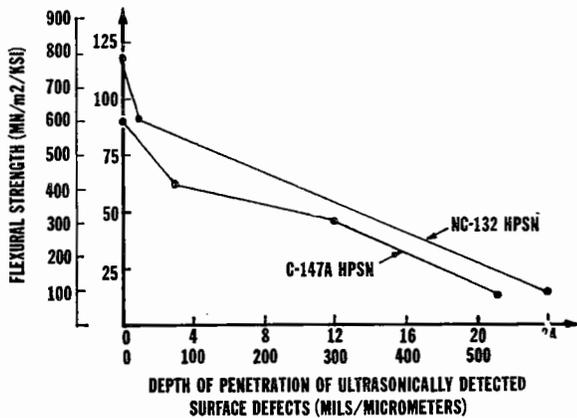
Fig. 17 Flexural Strength as a Function of the Depth of Penetration of Ultrasonically Detected Surface Defects.

Based on the strength measurements and SEM analysis, a graph was made of strength versus defect size for the two types of HPSN. This is shown in Fig. 17. The largest defects on the graph are 50 kg Vicker's indentations. The zero defect size is defect free material ground parallel to the major specimen axis. The points in between are ultrasonically detected defects. A graph was also made based on measured strengths parallel and perpendicular to grinding. This is shown in Fig. 18 for two types of HPSN and two types of HPSiC. The ultrasonic response is designated light damage (below a certain threshold) or heavy damage (above a certain threshold). Although the correlation shown in this graph is only qualitative, these results indicate that by assigning a numerical value to the magnitude of ultrasonic response, it may be possible to measure the material strength associated with a given surface finish.

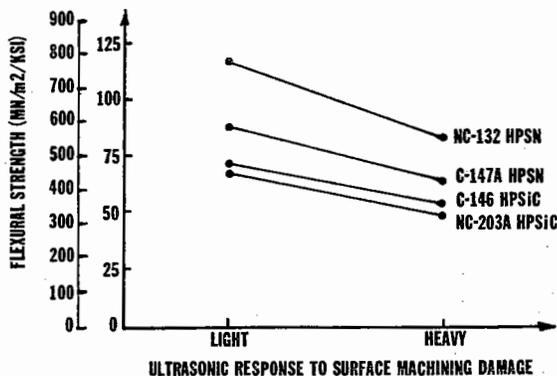
Fig. 18 Flexural Strength as a Function of Ultrasonically Detected Surface Damage in HPSN and HPSiC.
