ACOUSTIC MICROSCOPY OF CERAMICS*

L. W. Kessler, D. E. Yuhas and C. L. Vorres
Sonoscan Inc.
530 E. Green Street
Bensenville, Illinois

ABSTRACT

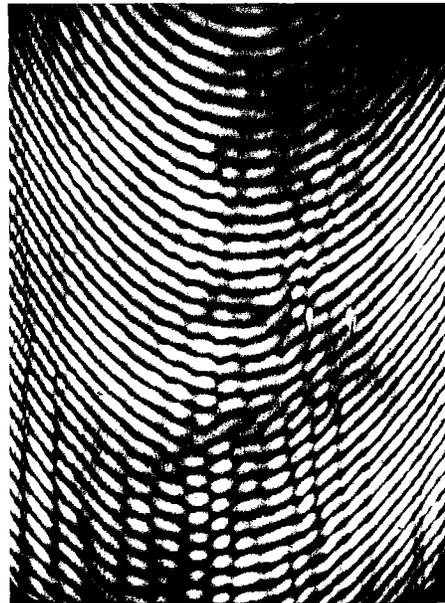
Fig. 17 - Acoustic interferograms of a typical (left) and a suspiciously flawed (right) cylindrical tensile test bar shown in Fig. 16.

In addition to flat and test samples, the SLAM can be adapted for use on complex geometries. Work has already been performed on turbine blades, tubes and other odd shaped components. In each of these cases, it is up to the investigator to select and optimize an entrance and exit port for the ultrasonic energy. Curved samples will necessarily cause corresponding curvatures to the interference fringes. For example, preliminary experiments have been performed on cylindrical ceramic test bars that are going to be subjected to tensile strength testing. The material is silicon nitride and a photograph of the sample is shown in Fig. 16. An interferogram of a good zone as compared with a suspicious zone is shown in Fig. 17 and it is evident that the differences are clearly distinguishable even though the fringes are curved.
