Investigation of Deterioration of Joints in Concrete Pavements: Field Study of Penetrating Sealers

tech transfer summary

March 2016

Federal Highway Administration
Transportation Pooled Fund TPF-5(224)
(InTrans Project 09-361)

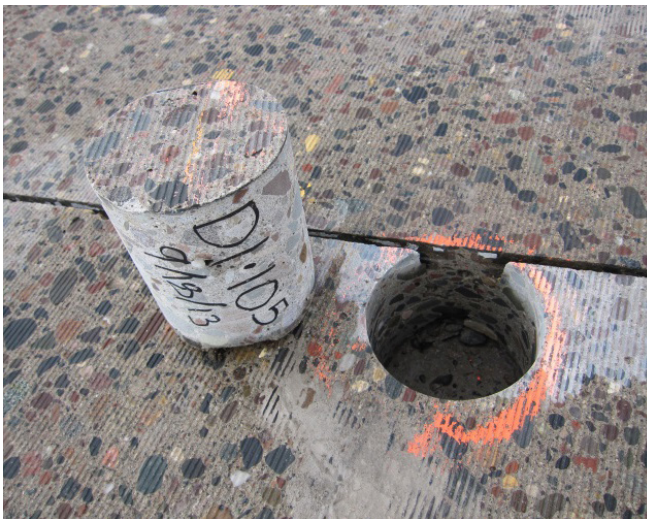
Sample core retrieved in 2013 showing the relationship to Joint 105 Cell 9

Cores were retrieved from pavements to assess the before condition. Six-inch cores were extracted immediately adjacent to the selected joints. All cores were extracted from the approach side of each joint, with respect to traffic. Cores were positioned so the edge of the expansion joint just intersected the perimeter of the core. Five cores were taken from different joints in each cell, with one joint to serve as the control and the other four to have different sealers applied.

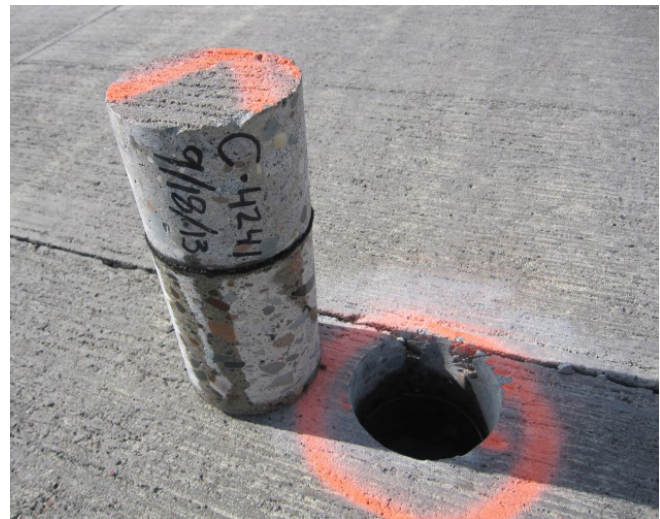
Sample core retrieved in 2013 showing the relationship to Joint 4241 Cell 505 with its fabric bond-breaker

In contrast to the 23 year old pavement, the initial concentration in the horizontal direction of Cell 505 is the same as that found in the vertical direction, suggesting the dilution evident in the older pavements does not take place in Cell 505. The joints in Cell 505 were not sealed with silicone or hot pour asphalt, and the concrete overlay was placed over a separation fabric. The lack of sealing permits free entry of salt solution and debris from the wear surface into the joint.

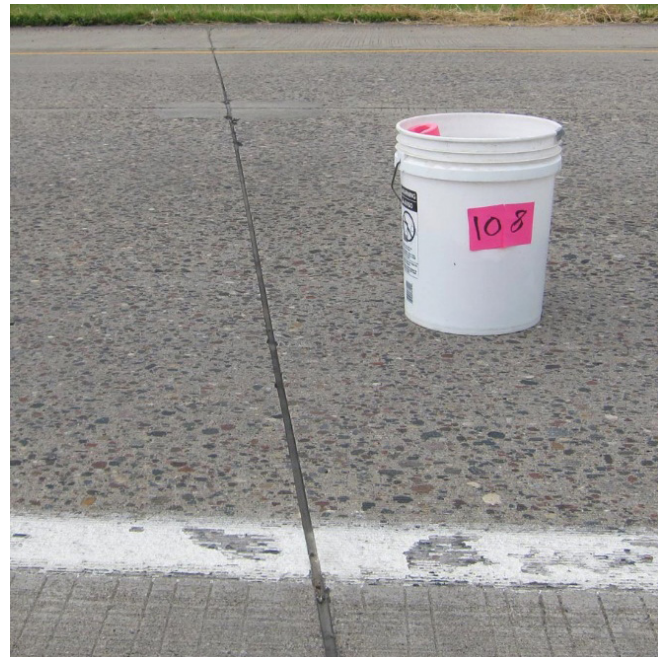
Sample core retrieved in 2013 showing the relationship to Joint 4241 Cell 505 with its fabric bond-breaker
