## SINGLE MODE LAMB WAVE INSPECTION OF COMPOSITE LAMINATES

Peter B. Nagy and Laszlo Adler

David Mih and William Sheppard

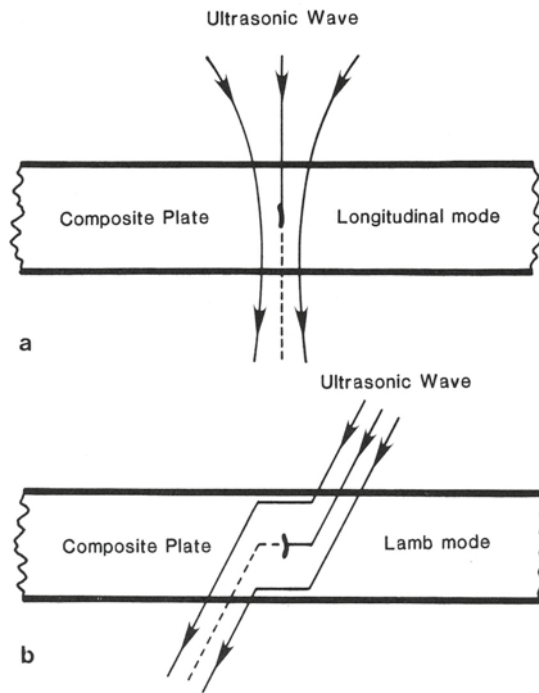
Fig. 1. Schematic diagrams of ultrasonic inspection at normal (a) and oblique (b) incidence.

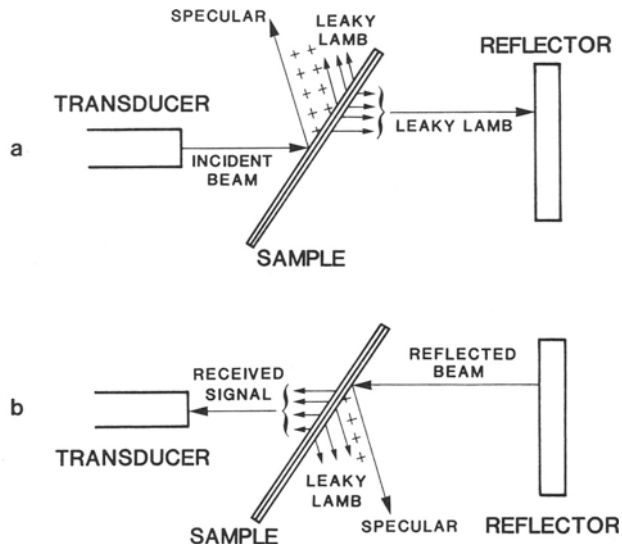
Fig. 2. Schematic diagram of the Lamb wave inspection technique.

Fig. 2 shows the schematic diagram of the Lamb wave inspection technique. A detailed description of this method can be found in Ref. 1. The transmitted signal is greatly amplified at certain frequencies where dispersive Lamb modes are phase-matched to the incident wave at that particular angle of incidence. We can obtain a Lamb wave C-scan of the composite plate by moving the transducer parallel to the reflector and using narrow-band, e.g. tone-burst, ultrasonic inspection tuned to the frequency of the most sensitive mode at that particular angle of incidence.

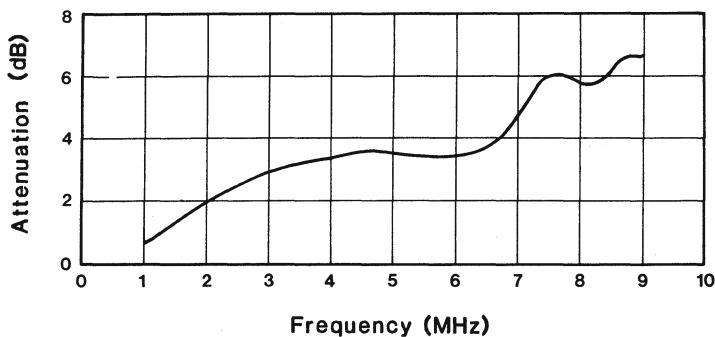
Fig. 3. Ultrasonic attenuation spectrum in a composite plate of approximately 0.2% porosity (sample #ACL 6804).

It is well known that gross porosity in the order of 0.5 - 5% can be readily detected by ultrasonic attenuation measurements. Within certain limits due to the uncertain nature of the aspect ratio of the usually elongated pores, quantitative assessment of the porosity volume fraction is feasible, too [4]. Detection problems start when the volume fraction drops to 0.1% or below and the resulting ultrasonic contrast of 1 - 2 dB cannot be distinguished anymore from the inherent background noise. Fig. 3 shows the ultrasonic attenuation spectrum in a composite plate including clusters of weak porosity in the order of 0.2% volume fraction (the inherent attenuation of the porosity free sample was accounted for in the measurement).

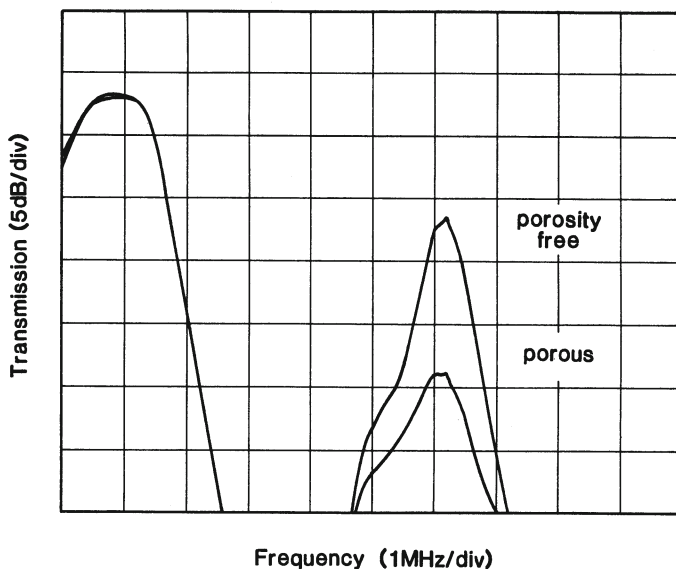
Fig. 4. Transmission spectra through porosity-free and porous parts of a composite plate (sample #ACL 6804).

Fig. 4 demonstrates the substantial improvement offered by the Lamb wave inspection technique. At 22° angle of incidence corresponding to approximately 4000 m/s phase velocity, the strongest mode is generated at 6 MHz. This mode is attenuated by as much as 12 dB, i.e. roughly four times more than the normally incident longitudinal wave, by the same weak porosity. This enhancement can be taken advantage of in order to push the detection threshold well below 0.1%.

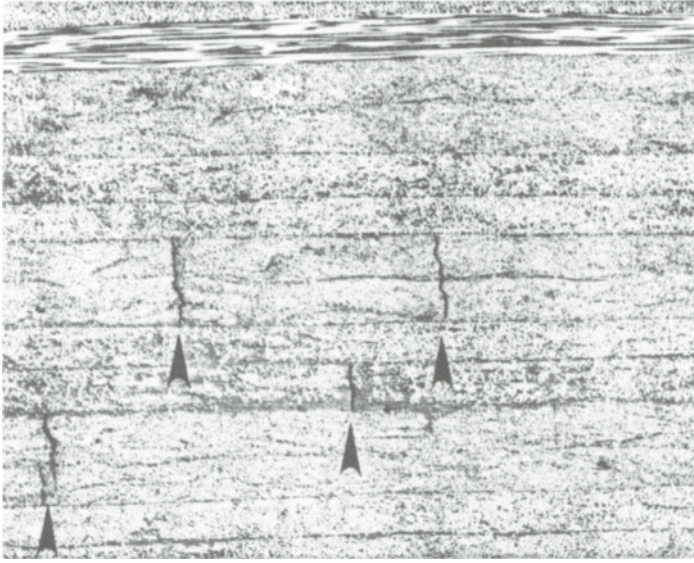
Fig. 5. One- and two-ply transverse cracks in a composite plate (sample #AMD 1530, x 50 magnification).

mainly limited by the inherent inhomogeneity of the composite plate which causes about 1 dB uncertainty in the transmitted signal. As an example, Fig. 5 shows a cluster of one- and two-ply cracks in a fiber reinforced composite plate.

In order to identify the source of the additional peaks in Fig. 9(b), we carried out the same experiment on a similar, but crack-free reference plate. As is shown in Fig. 9(c), the ripple of the background was roughly 1 - 2 dB, a fairly low value regarding the inevitable measuring uncertainties and sample inhomogeneities. According to these results, the additional peaks of Fig. 9(b) must have been caused by smaller cracks. The presence of these smaller cracks, which eluded detection on the normal incidence C-scan, was confirmed by subsequent destructive inspection. Because of the reduced lateral resolution, it is not always possible to correspond a certain peak to a single crack. Actually, many of these additional peaks represent a bunch of small cracks close to each other, as was shown in Fig. 5, too.

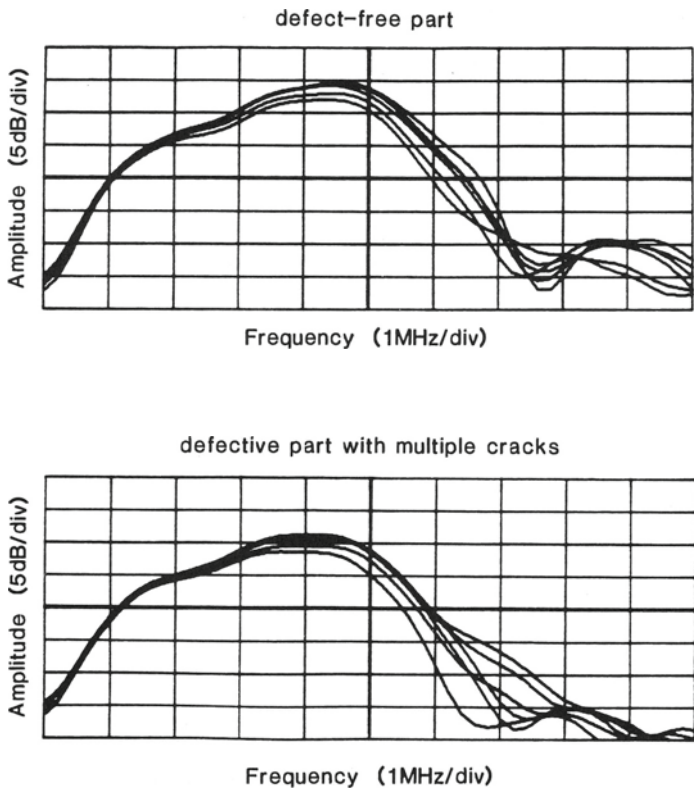
Fig. 6. Ultrasonic transmission spectra at normal incidence through defect-free and defective parts (sample #AMD 1642).

The ultrasonic contrast produced by such clusters of transverse cracks at normal incidence is in the order of 1 - 3 dB, i.e. barely detectable. Fig. 6 demonstrates this low detectability through examples of transmission spectra at defect-free and defective parts. The scatter of the defect-free spectra is approximately 3 dB at 5 MHz, while the average contrast produced by these multiple cracks is roughly 3 - 5 dB. Fig. 7 shows the ultrasonic transmission spectra of the same defect-free and defective parts at 20° angle of incidence. The principal Lamb mode of 4 MHz is attenuated by as much as 20 dB, approximately five times more than at normal incidence.

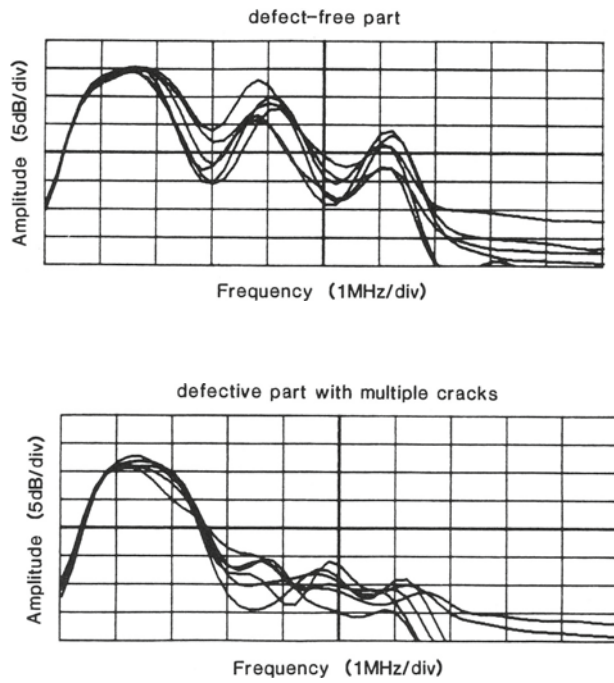
Fig. 7. Ultrasonic transmission spectra at 20° angle of incidence thru the same defect-free and defective parts as in Fig. 6.

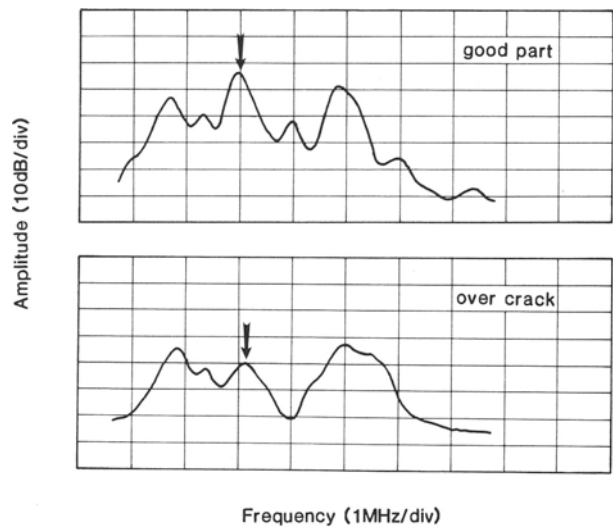
Fig. 8. Ultrasonic transmission spectra at 20° angle of incidence thru a composite plate with a single long crack (sample #AMD 1357).

Fairly strong, five-ply single cracks give only about 3 dB contrast at normal incidence. Considerable improvement can be achieved by Lamb wave inspection. Fig. 8 shows the frequency spectra of the double transmitted signals through a composite plate at 20° angle of incidence at a defect-free part and over a single five-ply high transverse crack. All modes are more-or-less attenuated by the crack, but the one at 3 MHz seems to be affected much more than the others. Fig. 9(a) shows the normal incidence 5 MHz C-scan of a 2" by 2" area of the same sample. The only apparent long crack produces a meager 3 dB contrast on this conventional C-scan, but gives a strong 16 dB peak on the Lamb mode picture shown in Fig. 9(b). Naturally, the increased sensitivity reveals otherwise hidden inhomogeneities as well, i.e. the long crack of Fig. 9(b) is not

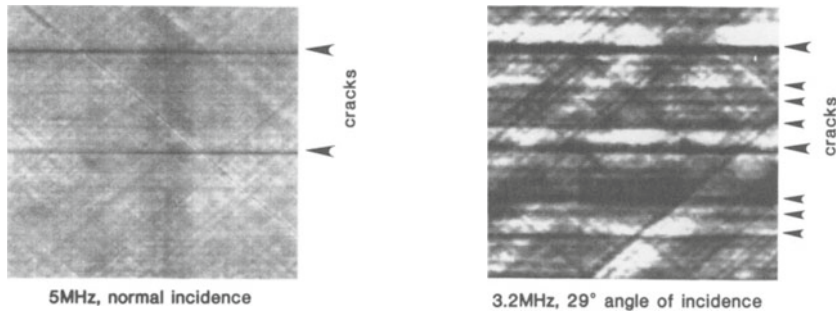
Fig. 10. Conventional and Lamb mode C-scans of a composite plate with transverse cracks (sample #AMD 1332).

As a last example, Fig. 10 compares the conventional normal incidence and Lamb mode C-scans of a composite plate with many transverse cracks.

The normal incidence C-scan was taken at 5 MHz and it features very good lateral resolution. There are two strong cracks of about 1.5 - 2 dB contrast running at horizontal direction and the background is fairly even. At first glance, the Lamb mode C-scan seems to be much worse, mainly because it has lower lateral resolution and its contrast is much higher. On the other hand, this C-scan reveals a number of additional cracks actually present in the plate, which is much more important than simply producing a nice picture.
